**ROADS SUB-COMMITTEE
SPECIAL MEETING AGENDA
WEDNESDAY, OCTOBER 2, 2019 - 1:30 P.M.
MEETING HELD IN THE COUNCIL CHAMBERS**

Road Management Plan

Township of Melancthon

**September 2019
300043927.0000**

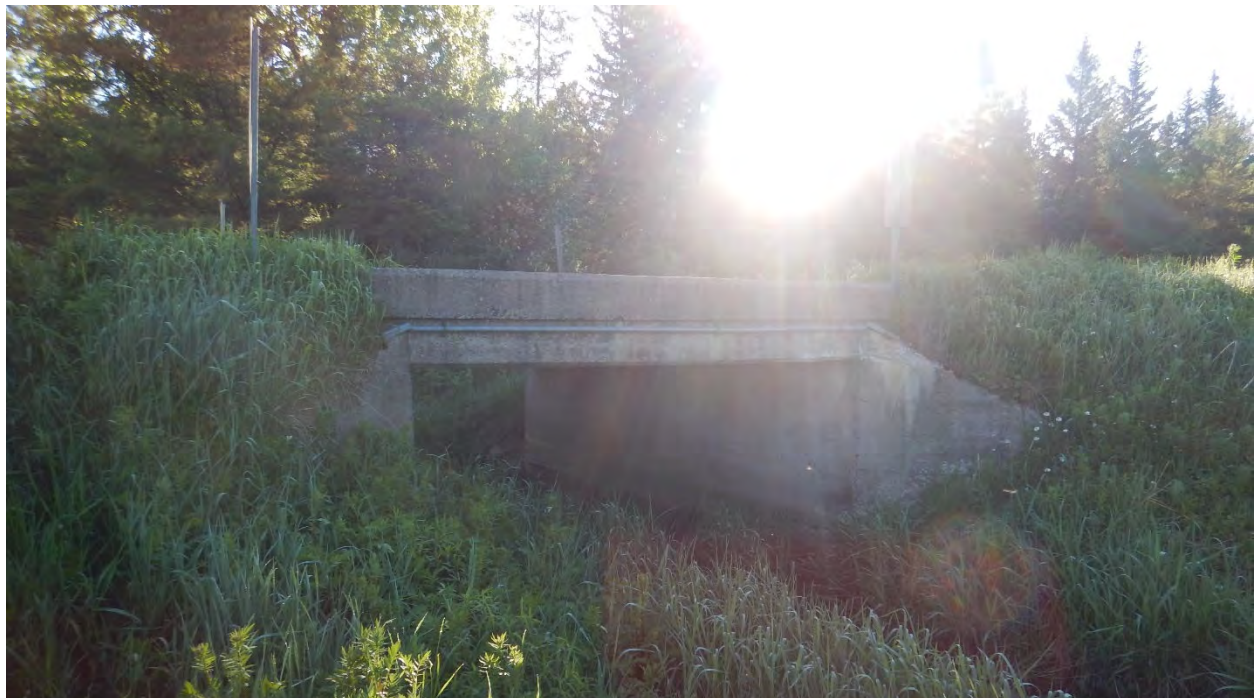
Maintenance Need	Element and Comments	Estimated Cost
Bridge Cleaning	Remove overgrown vegetation along curbs and wingwalls.	\$1,500.00
Erosion Control	Install rock protection along abutments.	\$5,000.00
Maintenance Needs Total		\$6,500.00

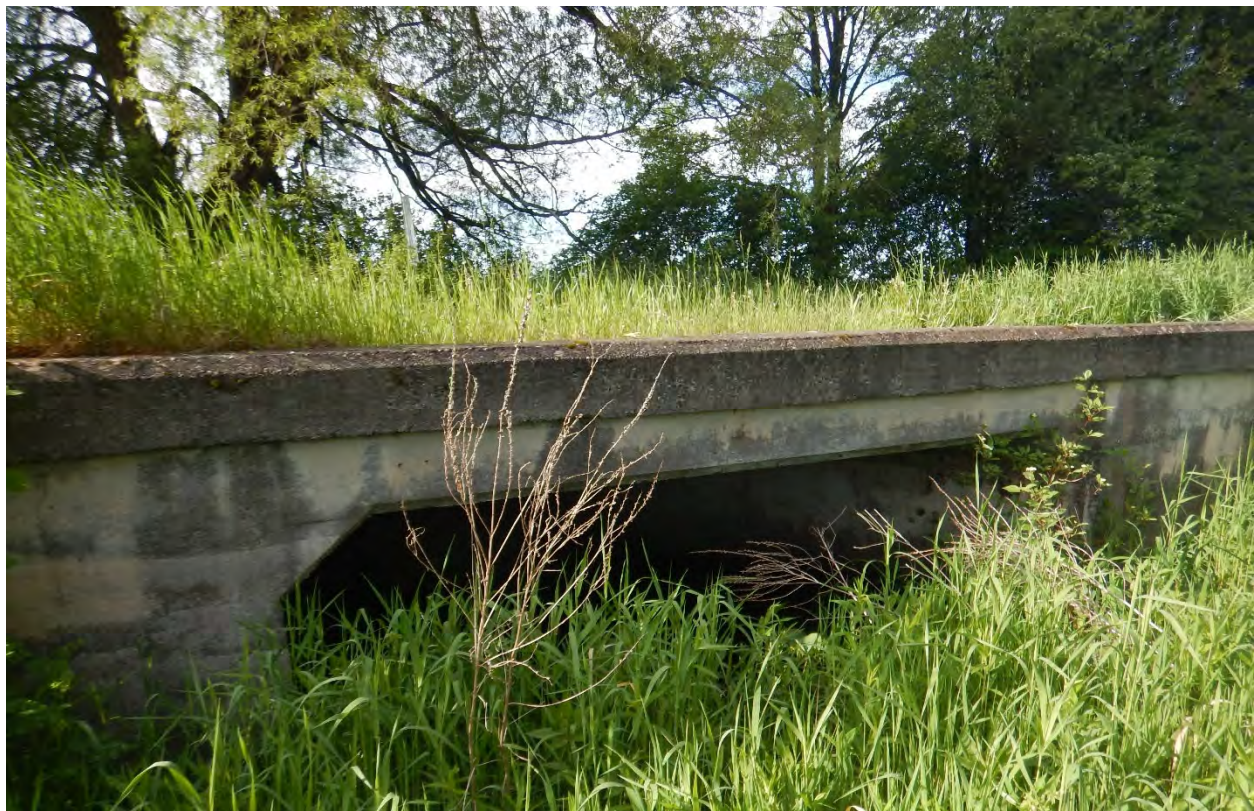
Maintenance Need	Element and Comments	Estimated Cost
Bridge Cleaning	Remove overgrown vegetation along curbs.	\$500.00
Erosion Control	Repair washouts on NE & SE embankments. Install rock protection along abutments.	\$5,000.00
Maintenance Needs Total		\$5,500.00

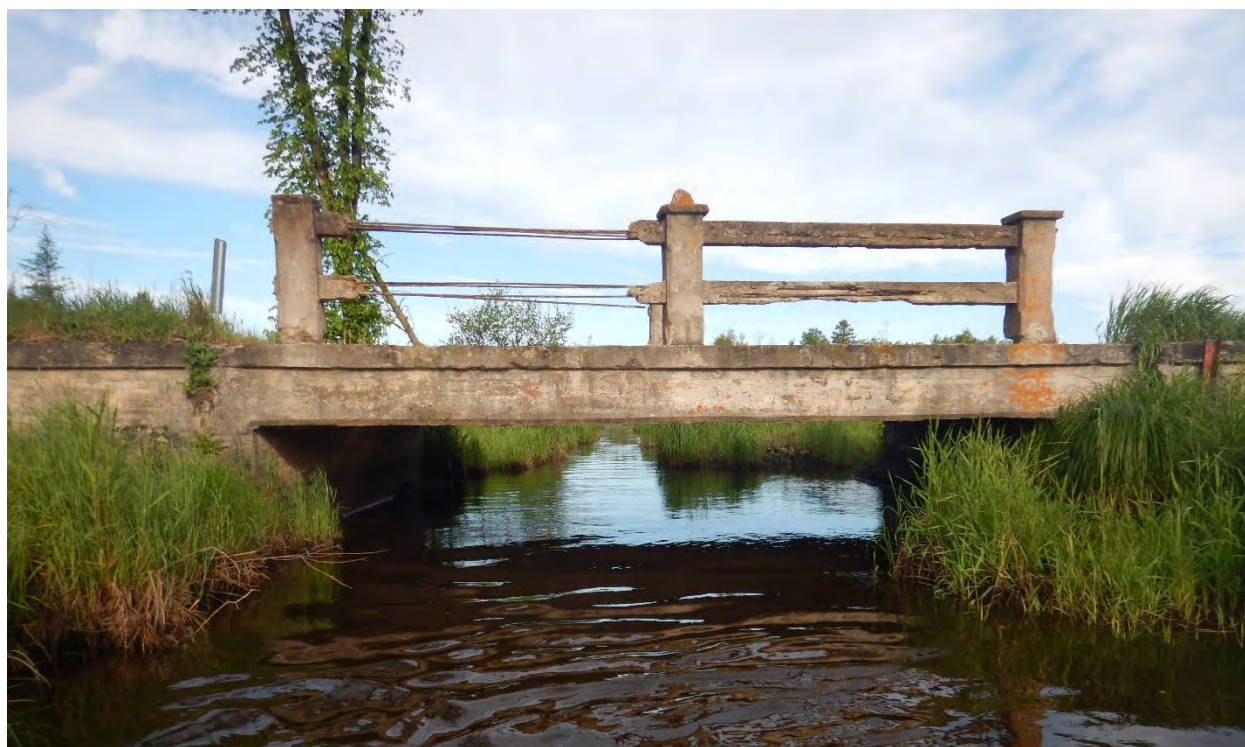
Maintenance Need	Element and Comments	Estimated Cost
Erosion Control	Repair Washouts on South Embankments.	\$1,500.00
Hazard Signs	Install "narrow bridge" signs at structure.	\$500.00
Other	Install a temporary barrier/delineation system.	\$5,000.00
Maintenance Needs Total		\$7,000.00

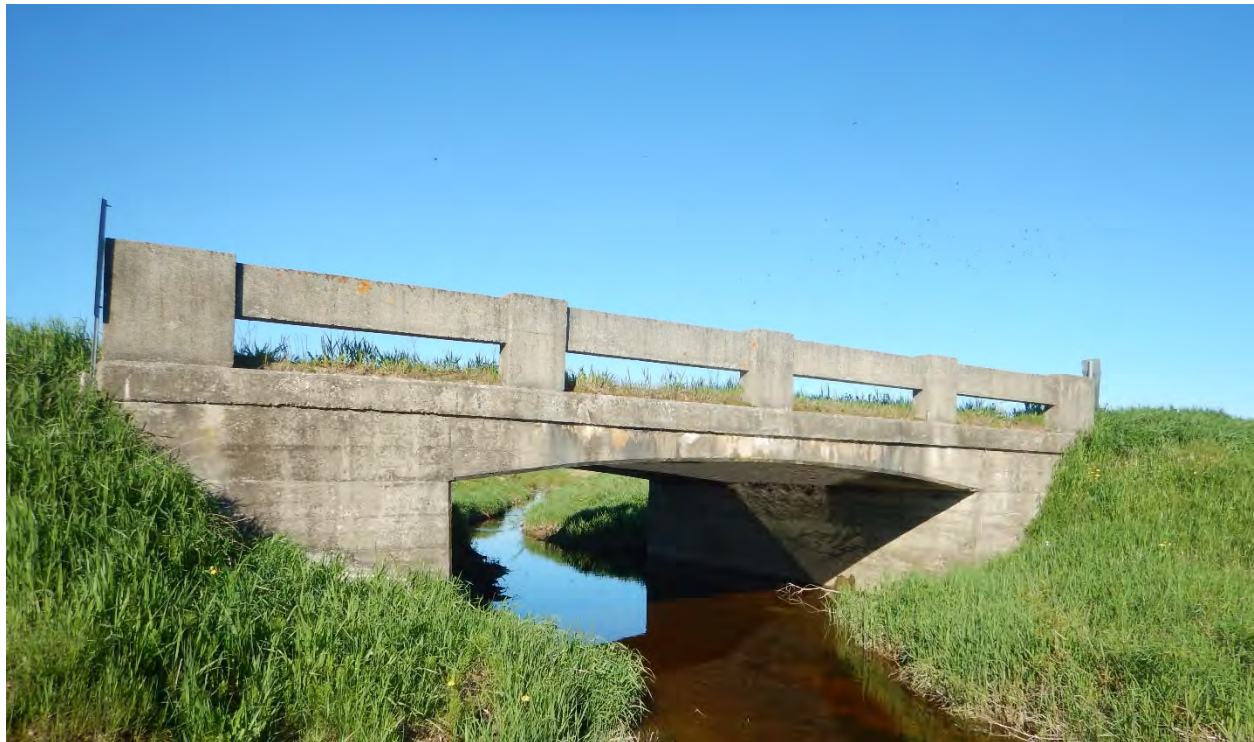
Maintenance Need	Element and Comments	Estimated Cost
Bridge Cleaning	Sweep deck wearing surface, remove vegetation along curbs.	\$1,000.00
Hazard Signs	Raise hazard warning signs at structure.	\$500.00
Maintenance Needs Total		\$1,500.00

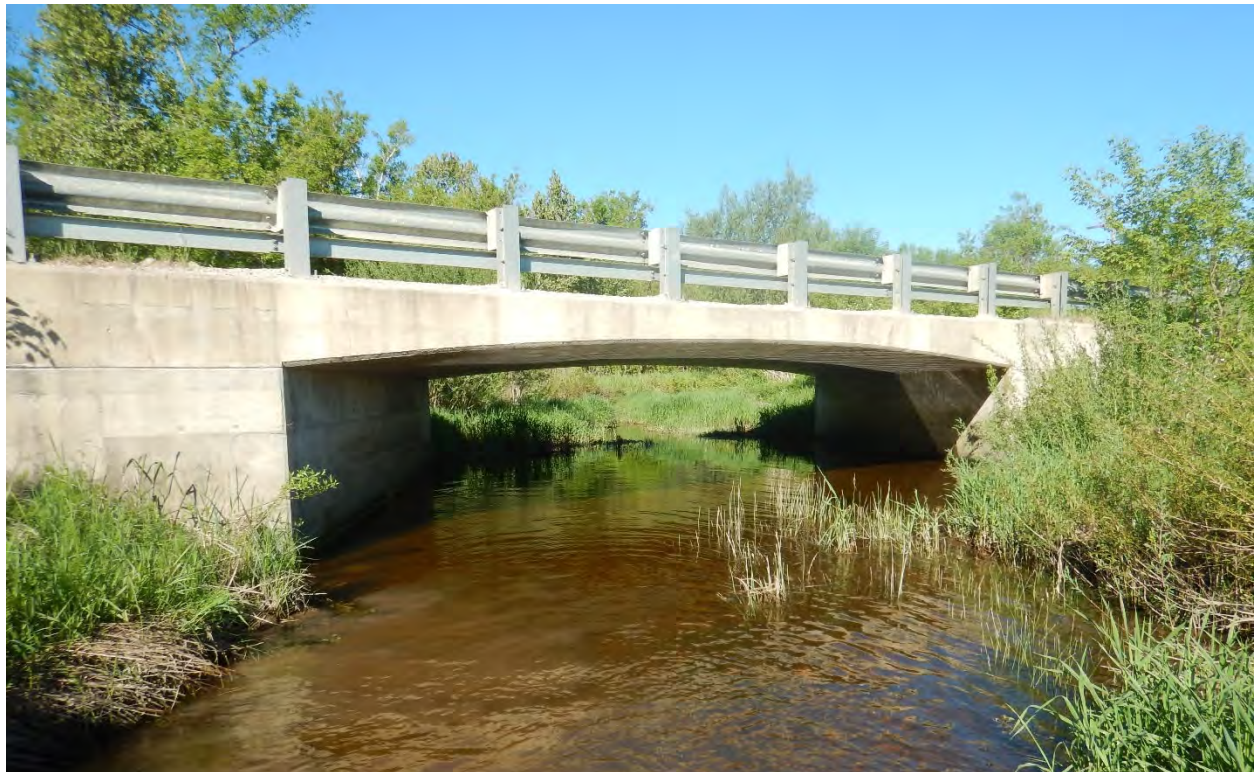
Maintenance Need	Element and Comments	Estimated Cost
Bridge Cleaning	Sweep Deck Top.	\$1,000.00
Erosion Control	Install rock protection along abutments & wingwalls.	\$8,000.00
Maintenance Needs Total		\$9,000.00

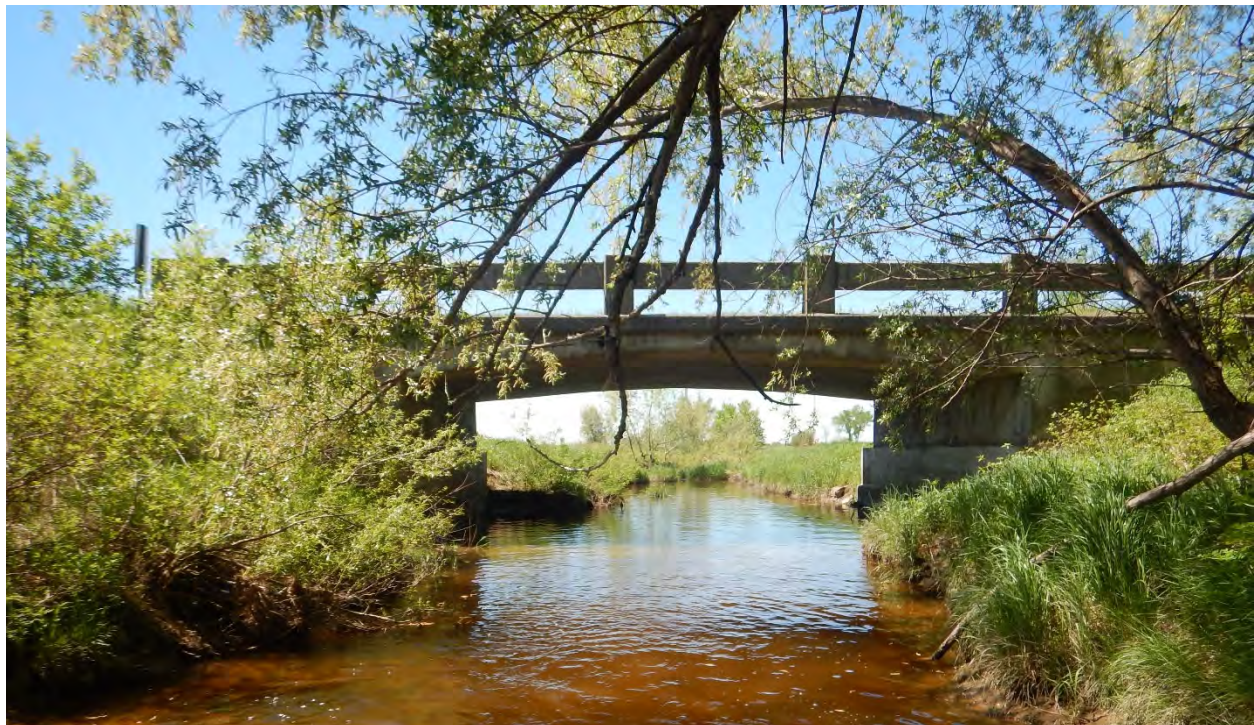
Maintenance Need	Element and Comments	Estimated Cost
Bridge Cleaning	Remove vegetation along curbs.	\$1,000.00
Hazard Signs	Replace hazard warning signs at structure.	\$1,000.00
Maintenance Needs Total		\$2,000.00

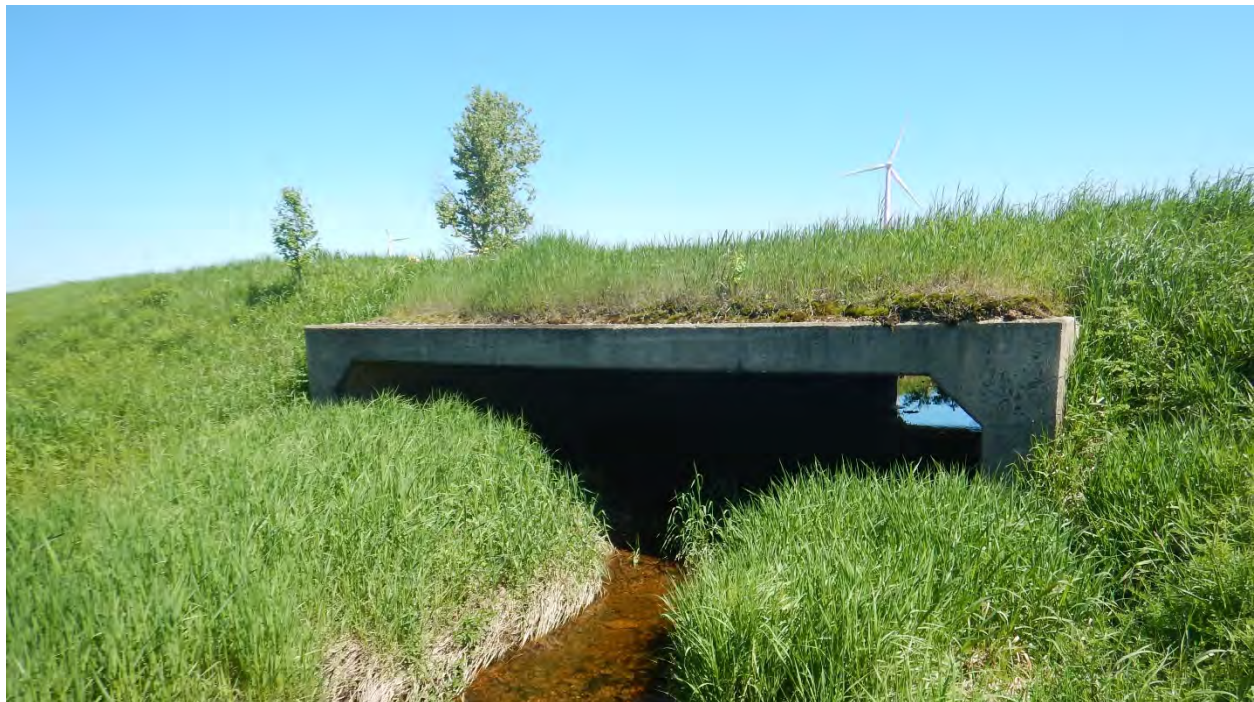
Maintenance Need	Element and Comments	Estimated Cost
Bridge Cleaning	Remove fill over exposed deck top ends.	\$1,000.00
Hazard Signs	Install hazard warning signs at structure.	\$1,000.00
Maintenance Needs Total		\$2,000.00

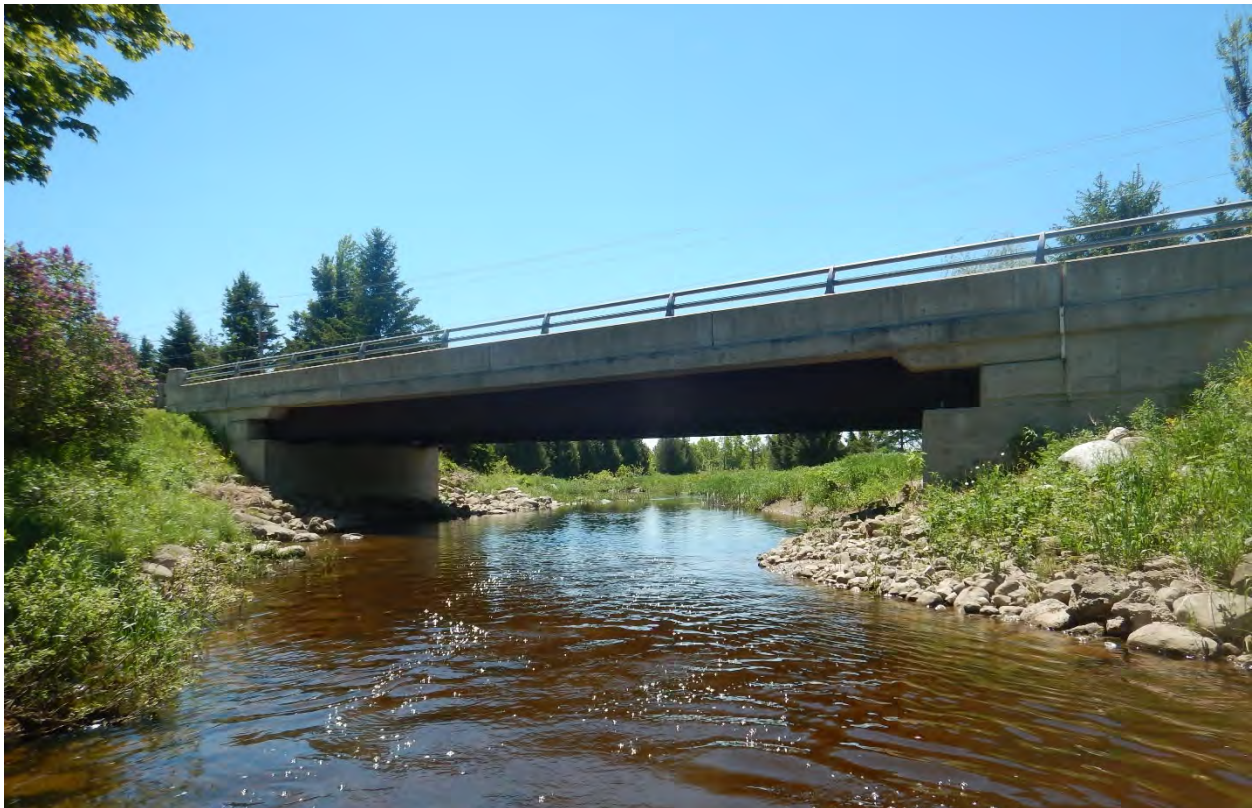
Maintenance Need	Element and Comments	Estimated Cost
Rout and Seal	Repairs required to approach wearing surface and deck wearing surface.	\$1,000.00
Maintenance Needs Total		\$1,000.00

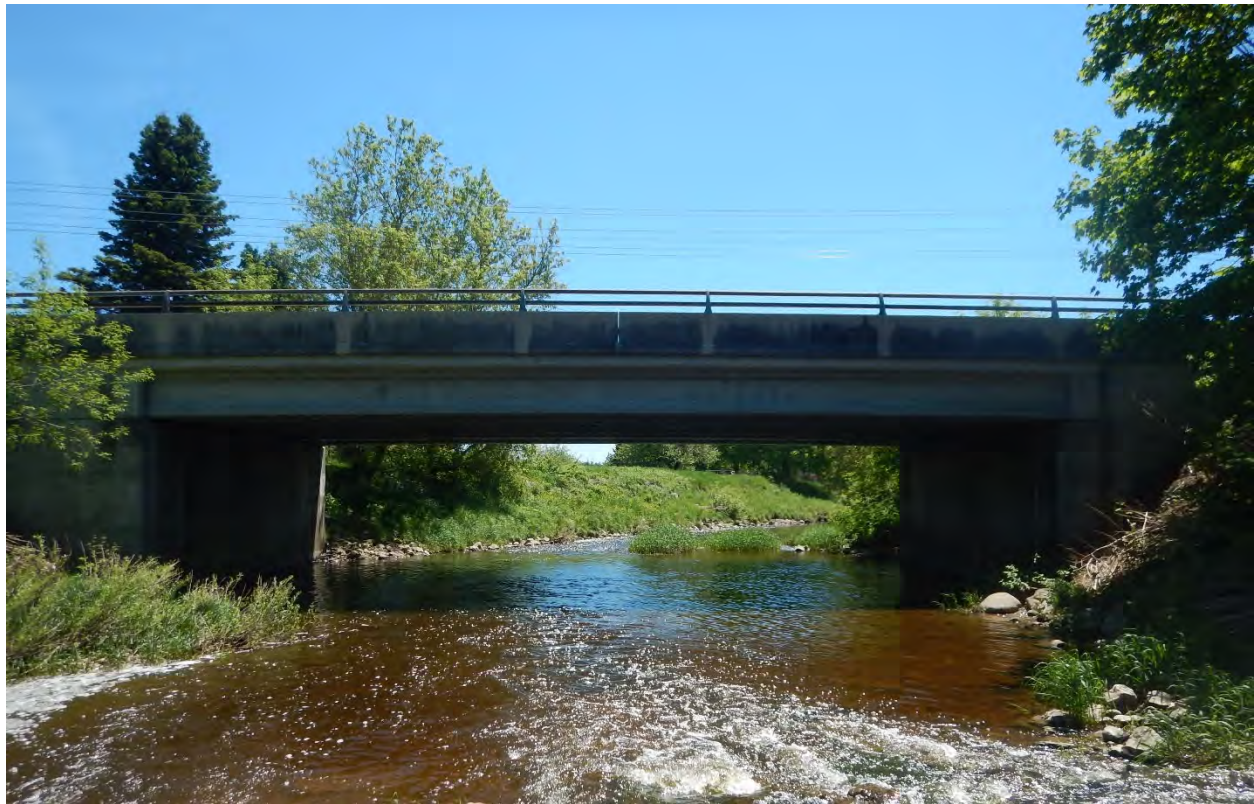
Maintenance Need	Element and Comments	Estimated Cost
Bridge Cleaning	Sweep Sidewalk/Curbs.	\$500.00
Deck Drains	Flush deck drains.	\$250.00
Parapet Walls	Replace deteriorated joint sealant, powerwash barriers.	\$1,250.00
Maintenance Needs Total		\$2,000.00

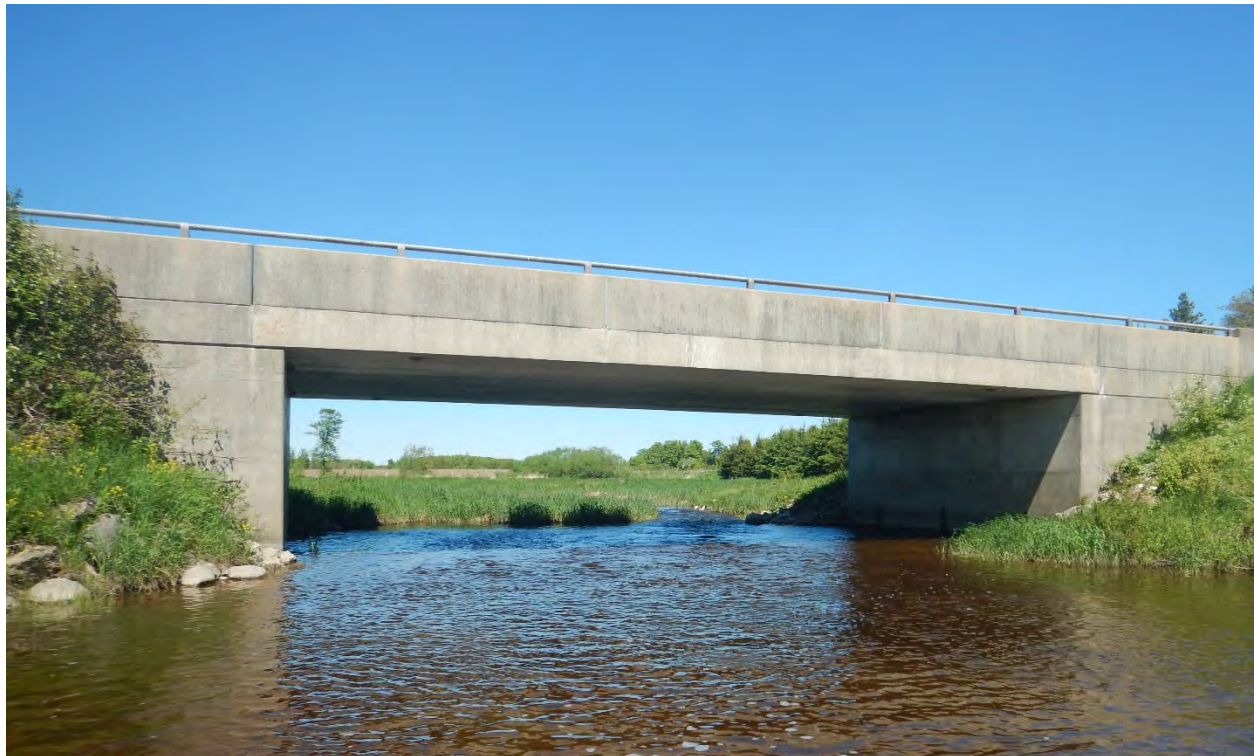
Maintenance Need	Element and Comments	Estimated Cost
Bridge Cleaning	Clean Deck Top and Flush expansion joints.	\$1,500.00
Joint Sealant	Replace deteriorated barrier joint sealant.	\$1,500.00
Maintenance Needs Total		\$3,000.00

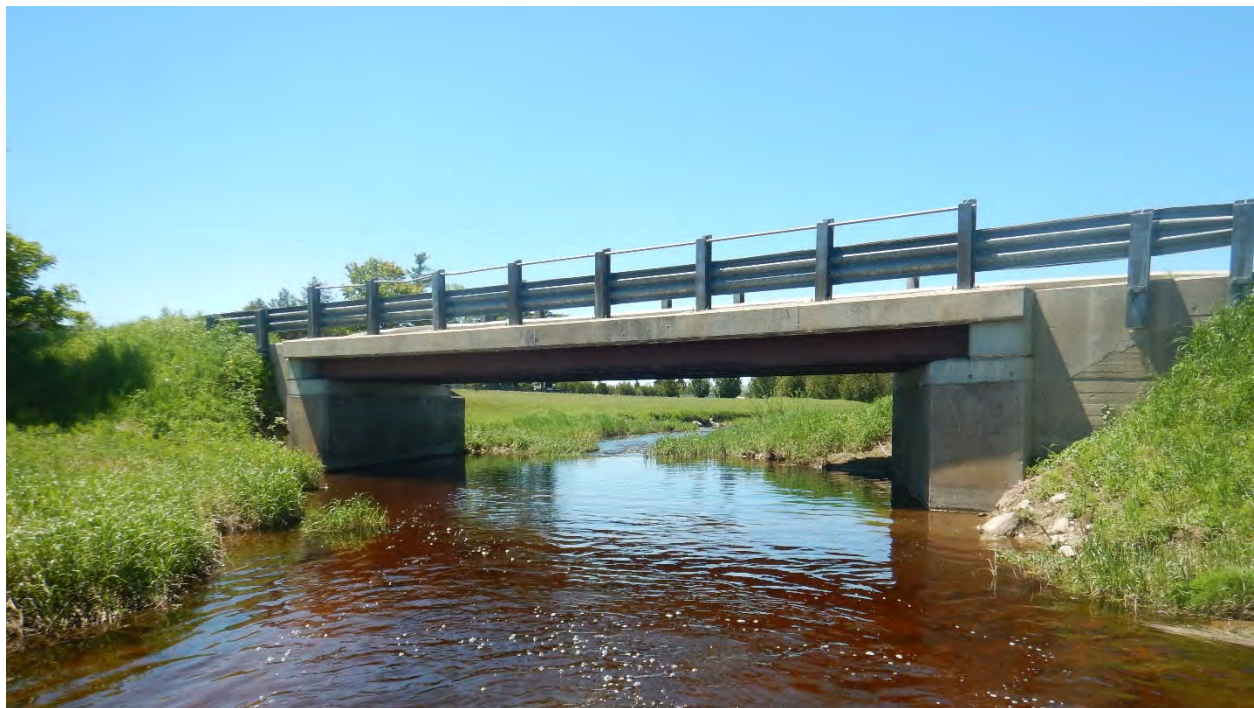
Maintenance Need	Element and Comments	Estimated Cost
Bridge Cleaning	Clean deck top.	\$1,000.00
Handrail Maintenance	Repair hand railings.	\$1,000.00
Hazard Signs	Raise hazard warning signs and install narrow structure signs.	\$1,000.00
Guide Rail	Replace missing bolts on NE and replace damaged posts.	\$1,500.00
Maintenance Needs Total		\$4,500.00

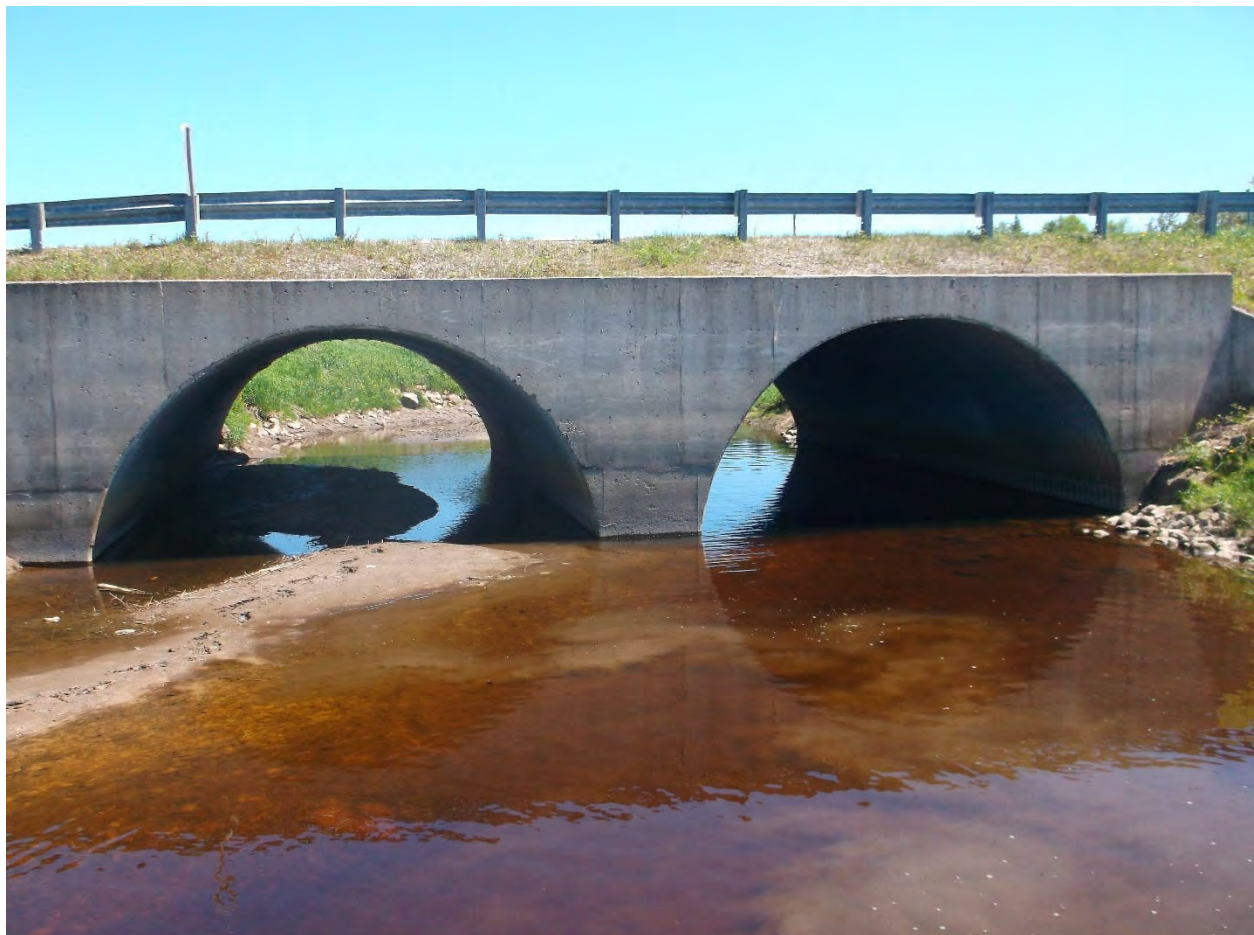
Roadside Protection Repairs	Priority	Estimated Cost
Install Guide Rail, end treatments and replace damaged sections.	1 to 5 Years	\$20,000.00

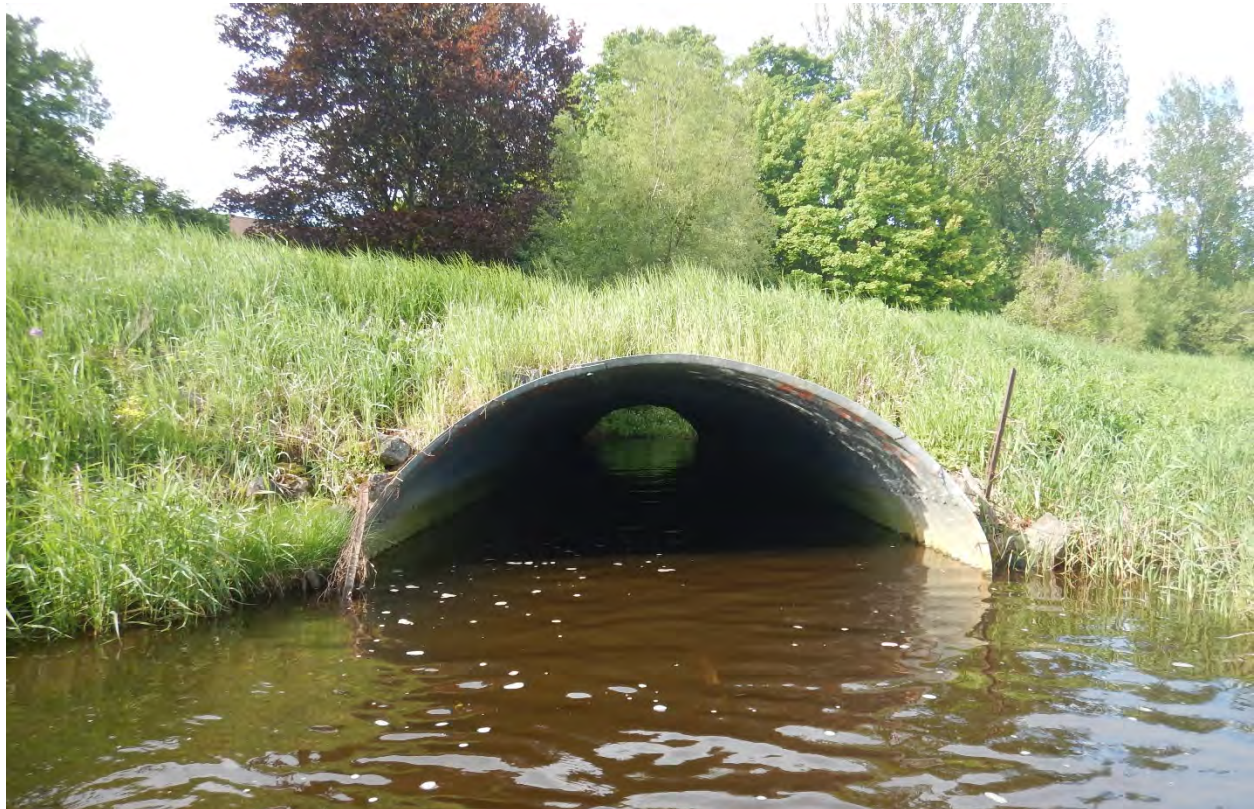
Maintenance Need	Element and Comments	Estimated Cost
Erosion Control	Remove tree growing close to inlet.	\$1,000.00
Hazard Signs	Install hazard warning signs at structure.	\$1,000.00
Other	Tighten loose nuts in barrel.	\$250.00
Maintenance Needs Total		\$2,250.00

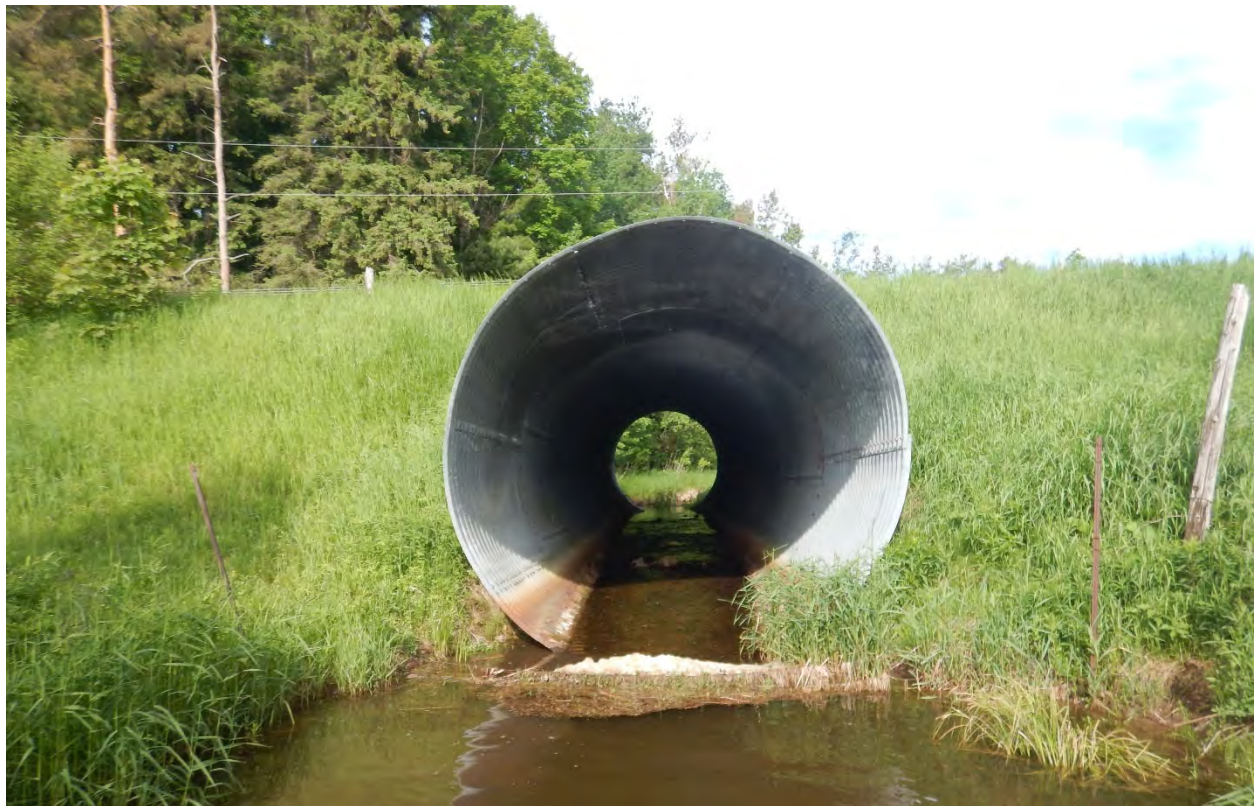
Maintenance Need	Element and Comments	Estimated Cost
Erosion Control	Install rock protection on SE and SW embankments.	\$2,500.00
Hazard Signs	Install hazard warning signs at structure.	\$1,000.00
Maintenance Needs Total		\$3,500.00

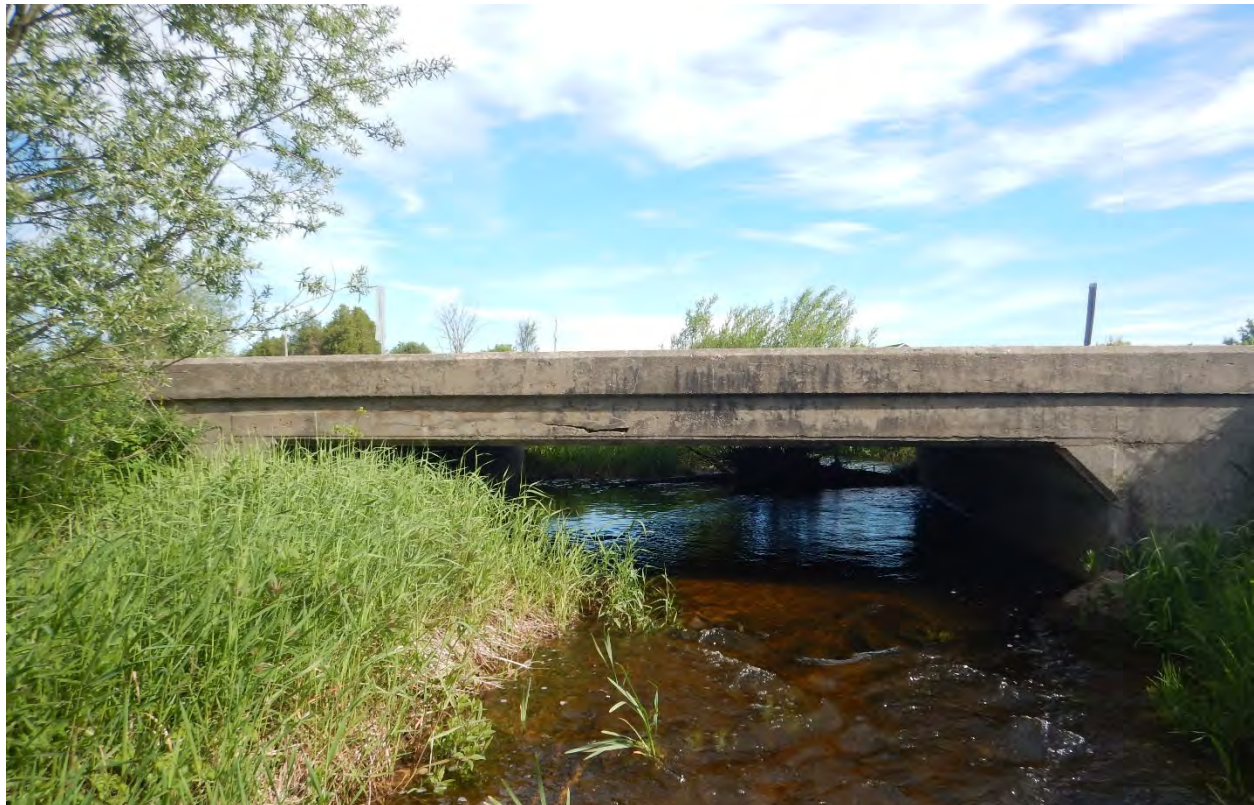
Maintenance Need	Element and Comments	Estimated Cost
Streams and Waterways	Remove blockage at inlet, remove silt and vegetation build-up.	\$2,500.00
Maintenance Needs Total		\$2,500.00

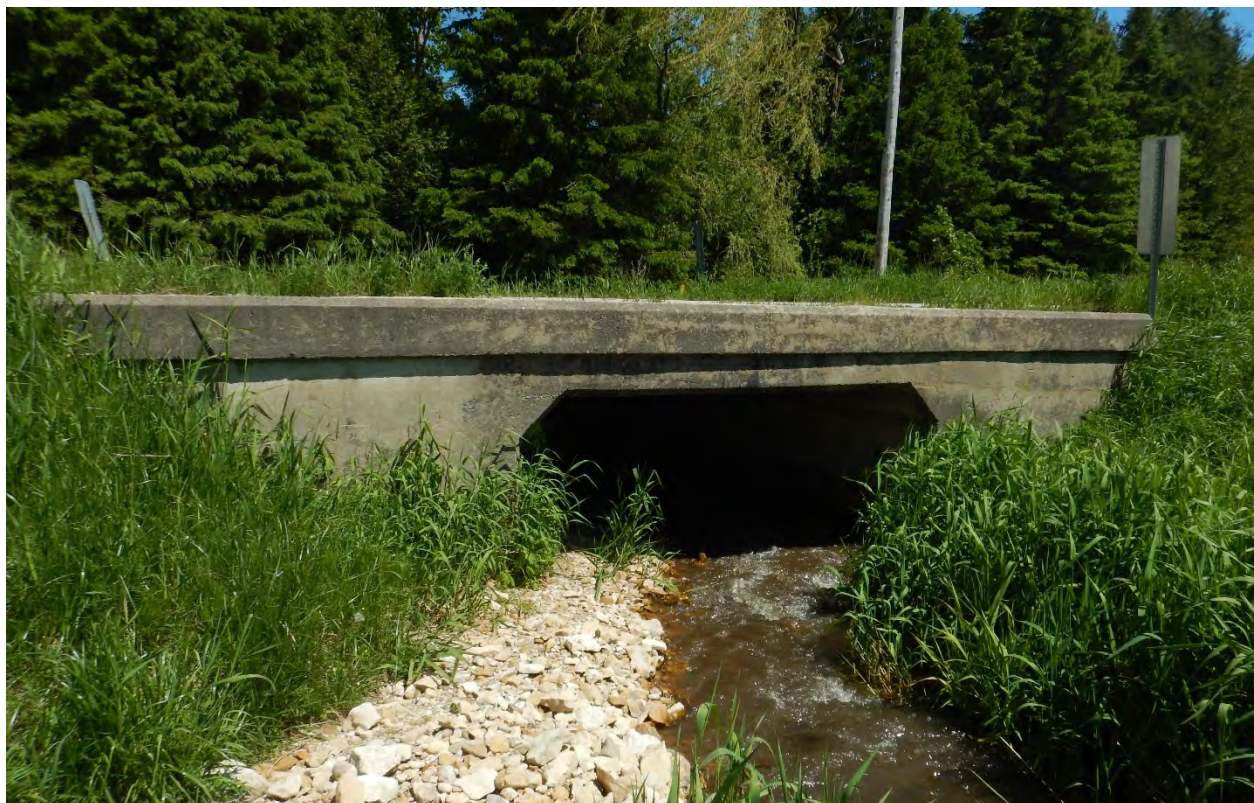
Maintenance Need	Element and Comments	Estimated Cost
Rout and Seal	Repairs required to approach wearing surface.	\$500.00
Hazard Signs	Reinstate hazard warning signs at structure.	\$500.00
Other	Remove excess silt and vegetation build-up in stream.	\$2,000.00
Maintenance Needs Total		\$3,000.00

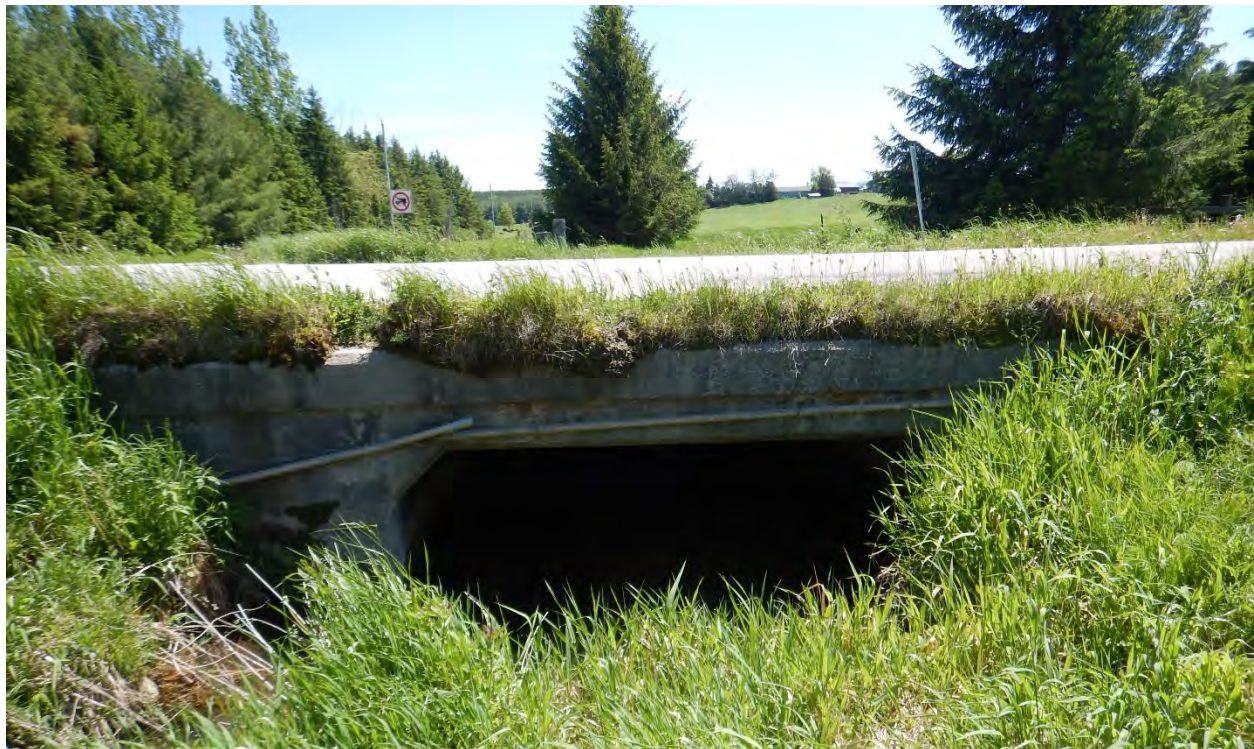
Maintenance Need	Element and Comments	Estimated Cost
Erosion Control	Repair washout on SE embankment.	\$1,000.00
Hazard Signs	Straighten hazard warning signs at structure and raise SE hazard warning sign.	\$250.00
Maintenance Needs Total		\$1,250.00

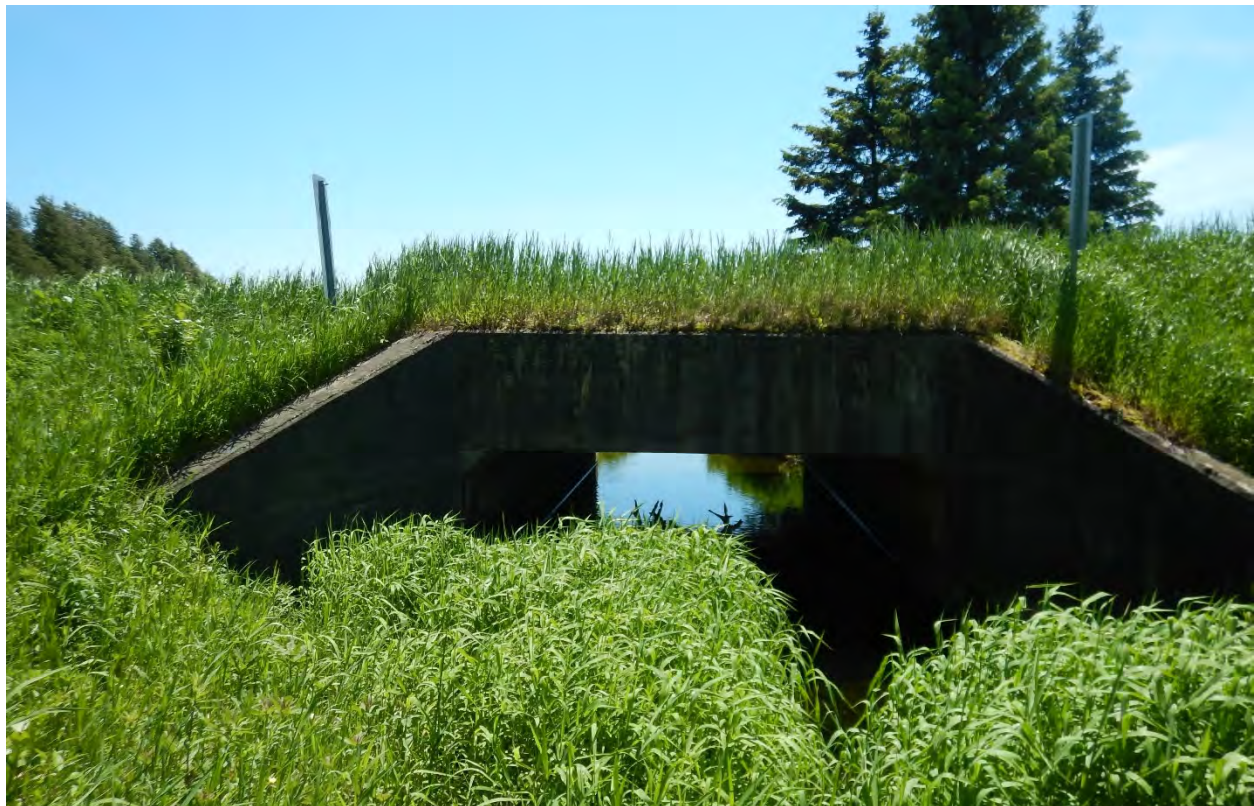
Maintenance Need	Element and Comments	Estimated Cost
Streams and Waterways	Remove fallen trees blocking inlet,	\$500.00
Maintenance Needs Total		\$500.00

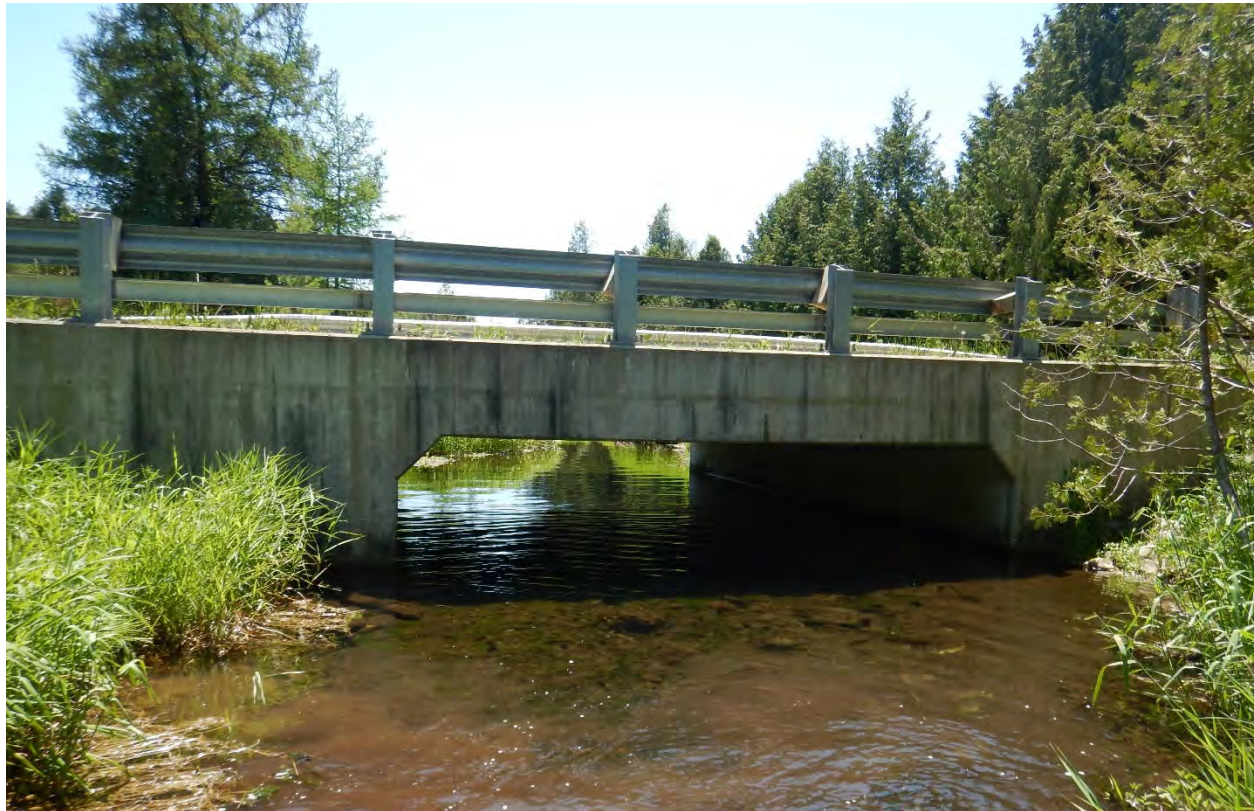
Maintenance Need	Element and Comments	Estimated Cost
Rout and Seal	Rout and seal cracks in deck wearing surface.	\$1,000.00
Other	Consider installing drip edge detail in soffit.	\$2,500.00
Maintenance Needs Total		\$3,500.00

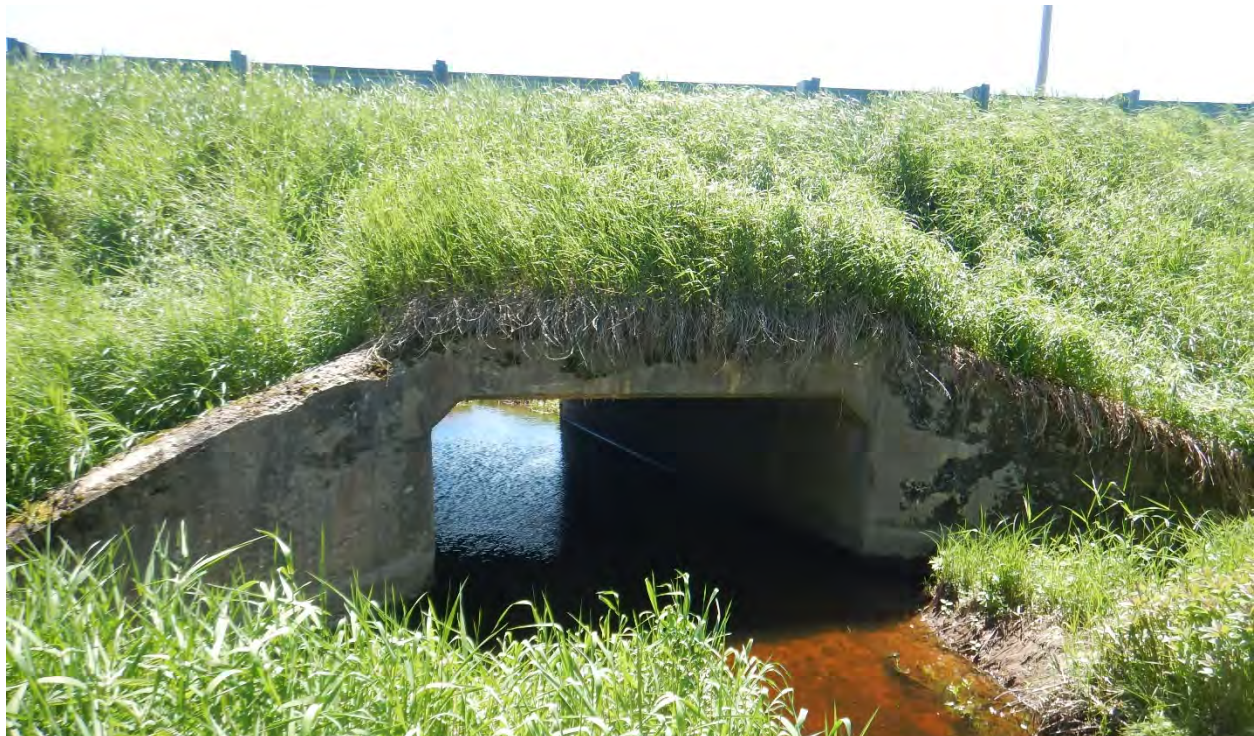
Maintenance Need	Element and Comments	Estimated Cost
Bridge Cleaning	Remove overgrown vegetation above wingwalls and fascia.	\$4,000.00
Hazard Signs	Install hazard warning signs at structure.	\$250.00
Guide Rail (End Treatments)	Tighten guide rail end treatment cables.	\$500.00
Guide Rail	Consider raising SBGR to adequate height.	\$6,000.00
Maintenance Needs Total		\$10,750.00

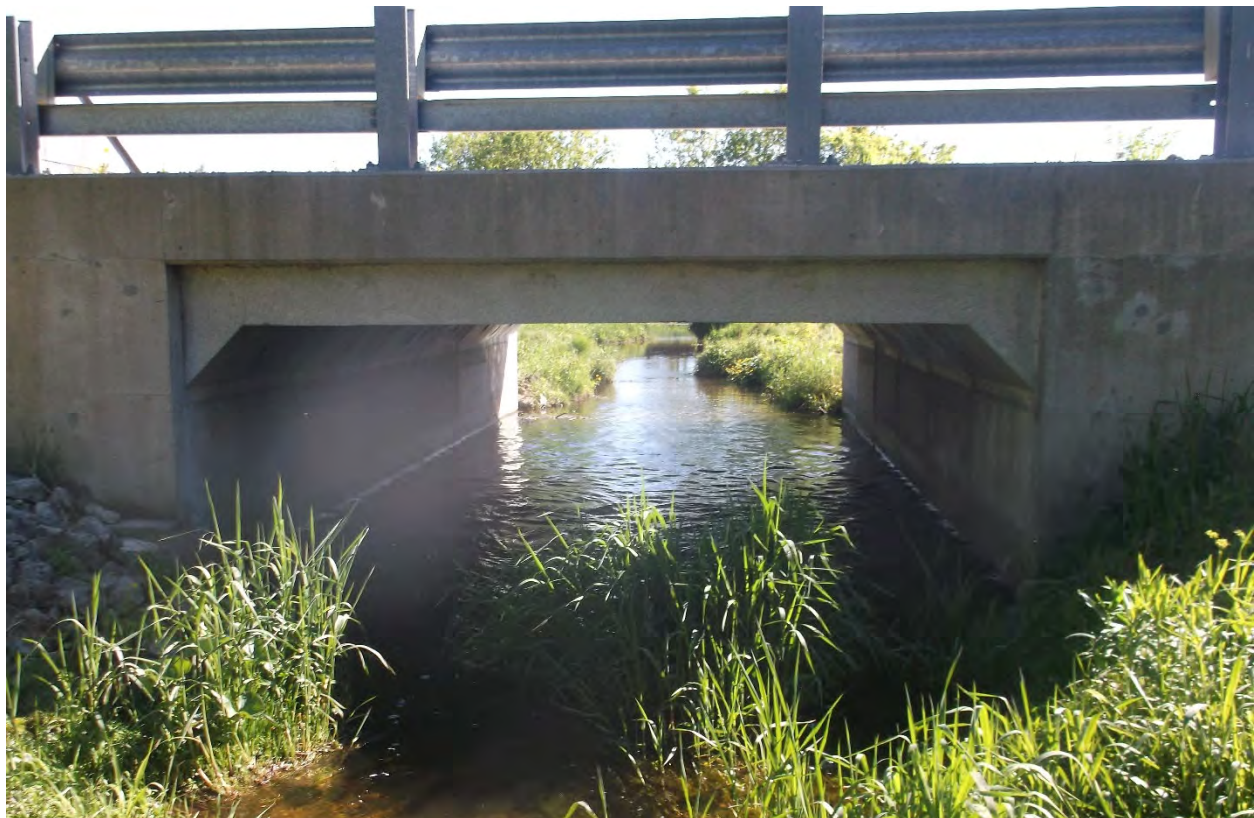
Maintenance Need	Element and Comments	Estimated Cost
Bridge Cleaning	Remove vegetation along SBGR.	\$500.00
Concrete Repair	Patch large spall on interior precast unit.	\$1,500.00
Erosion Control	Place rock protection along abutments.	\$2,000.00
Other	Install missing nuts/bolts in barrier posts.	\$250.00
Maintenance Needs Total		\$4,250.00

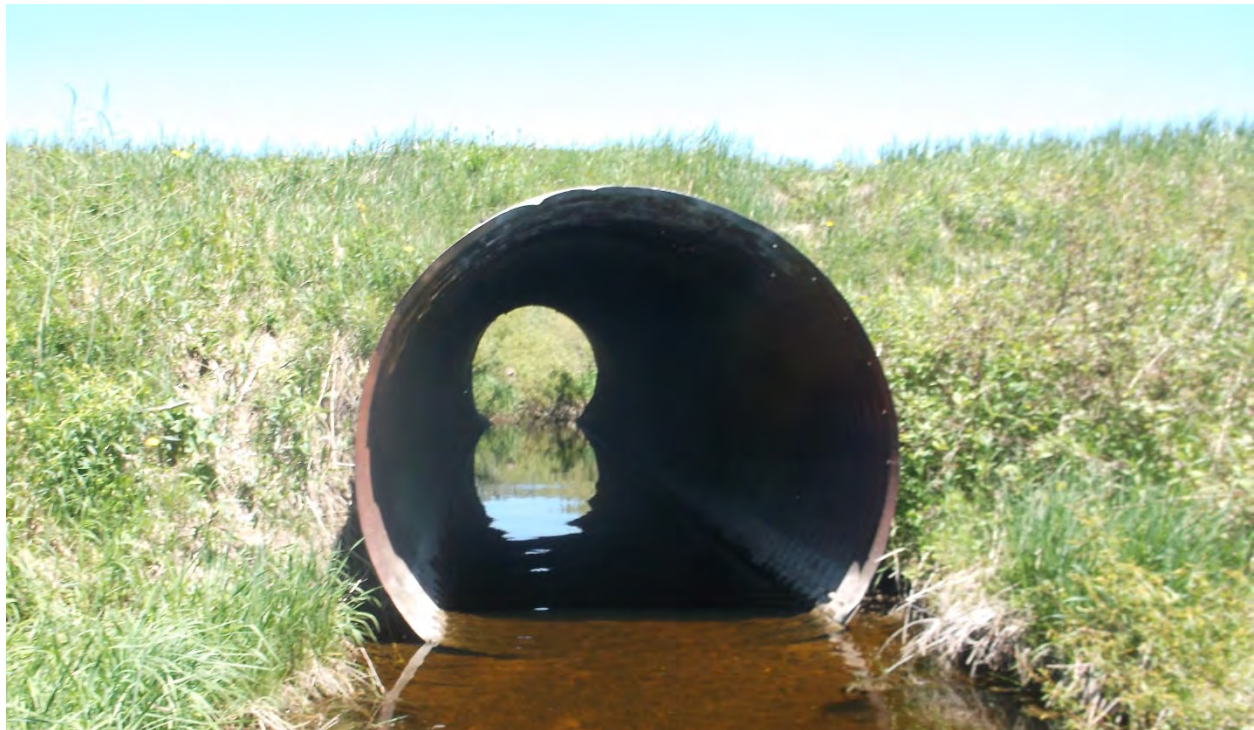
Maintenance Need	Element and Comments	Estimated Cost
Erosion Control	Repair washouts on east embankments.	\$1,500.00
Hazard Signs	Install hazard warning signs at structure.	\$1,000.00
Maintenance Needs Total		\$2,500.00
