**ROADS SUB-COMMITTEE
SPECIAL MEETING AGENDA
WEDNESDAY, OCTOBER 2, 2019 - 1:30 P.M.
MEETING HELD IN THE COUNCIL CHAMBERS**

Road Management Plan

Township of Melancthon

**September 2019
300043927.0000**

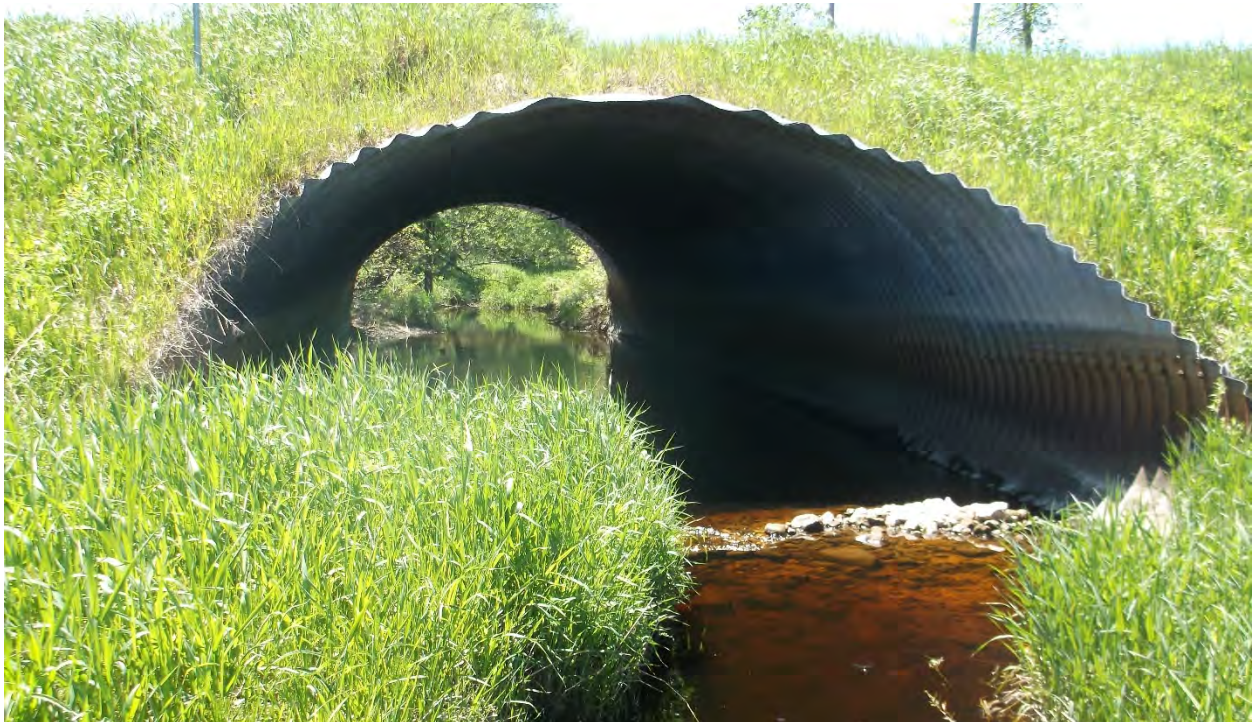
Additional Investigations	Priority	Estimated Cost
Monitoring Crack Widths.	Normal	\$5,000.00

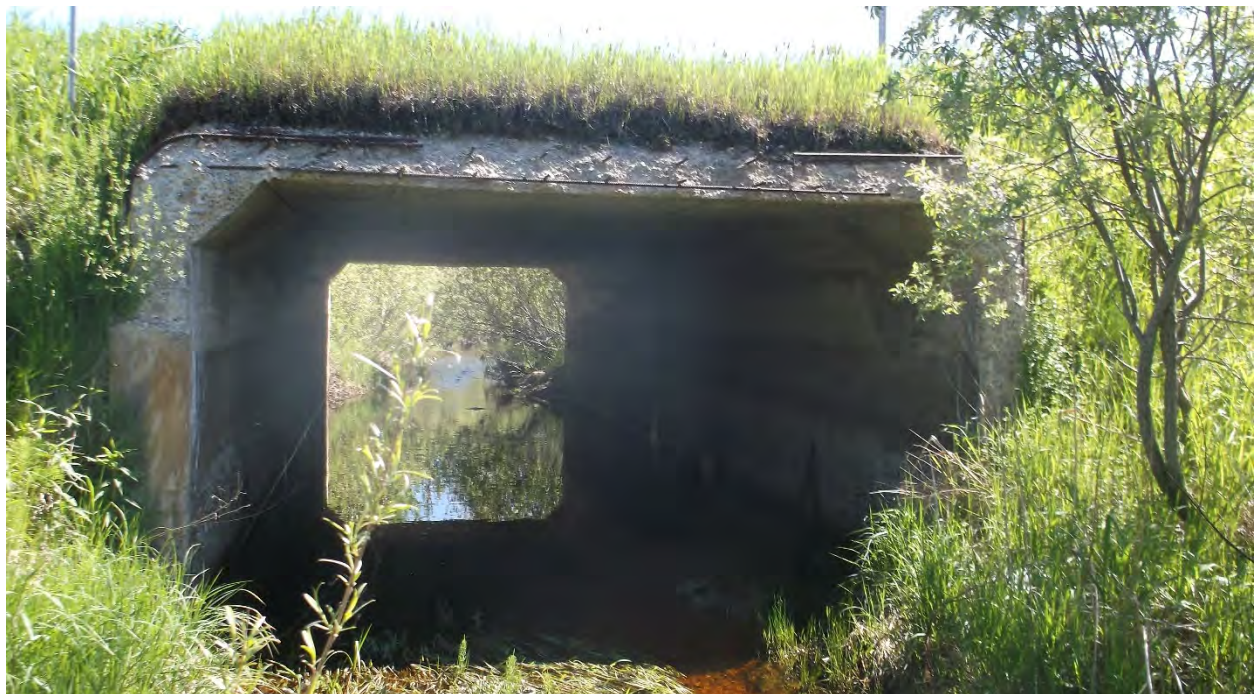
Maintenance Need	Element and Comments	Estimated Cost
Bridge Cleaning	Remove fill and overgrown vegetation over culvert ends.	\$2,000.00
Maintenance Needs Total		\$2,000.00

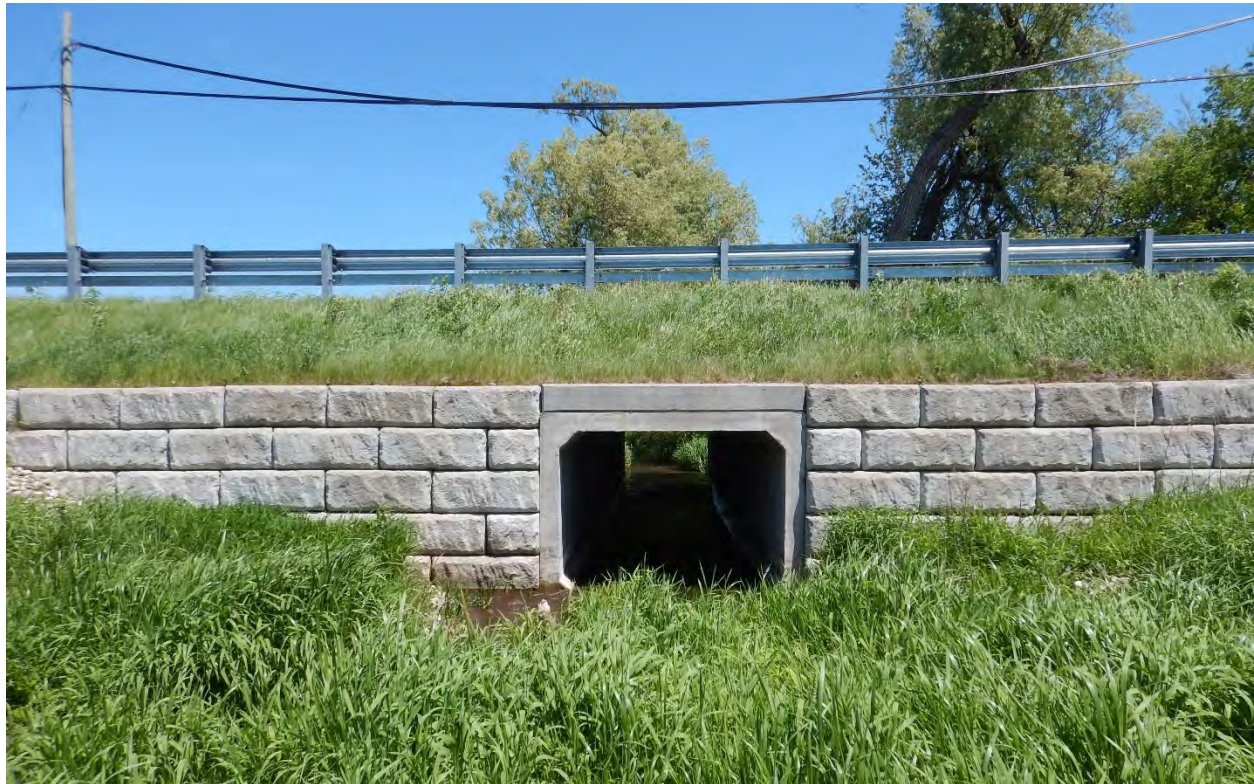
Maintenance Need	Element and Comments	Estimated Cost
Erosion Control	Install additional rock protection at inlet.	\$1,000.00
Other	Trim exposed filter fabric on east retaining wall.	\$250.00
Maintenance Needs Total		\$1,250.00

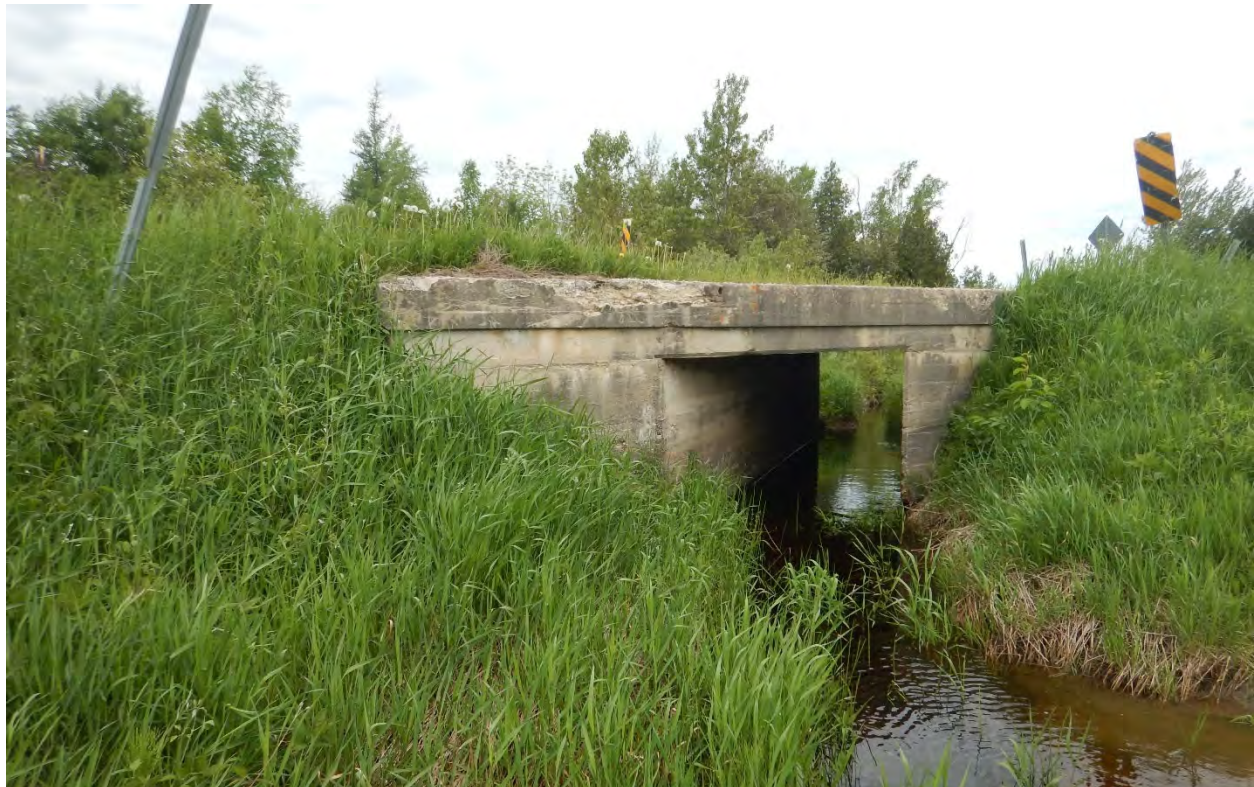
Maintenance Need	Element and Comments	Estimated Cost
Erosion Control	Install rock protection along abutments.	\$2,500.00
Hazard Signs	Install narrow bridge sign on approach.	\$250.00
Maintenance Needs Total		\$2,750.00

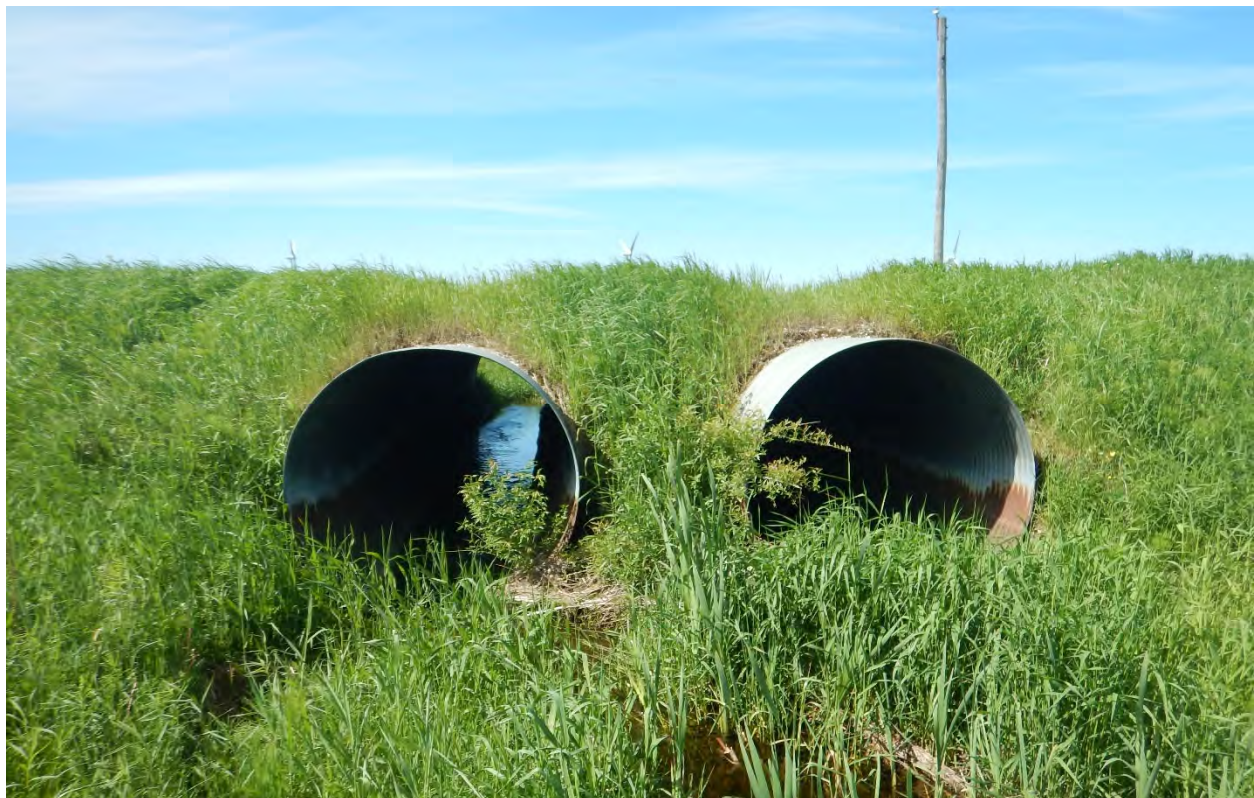
Maintenance Need	Element and Comments	Estimated Cost
Erosion Control	Repair erosion on NE embankment.	\$1,000.00
Hazard Signs	Install hazard warning signs at structure.	\$1,000.00
Maintenance Needs Total		\$2,000.00

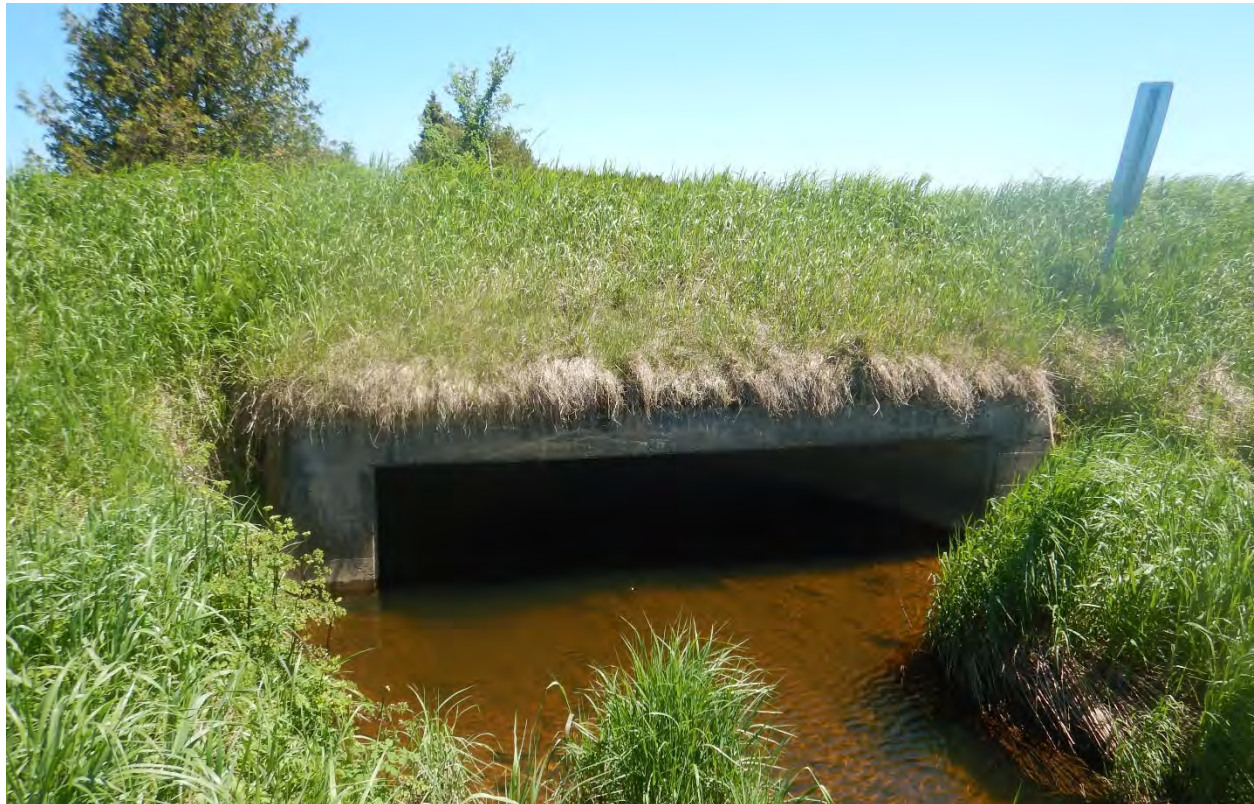
Maintenance Need	Element and Comments	Estimated Cost
Bridge Cleaning	Remove tree growing over inlet.	\$1,000.00
Hazard Signs	Raise hazard warning signs on west side of structure.	\$250.00
Maintenance Needs Total		\$1,250.00

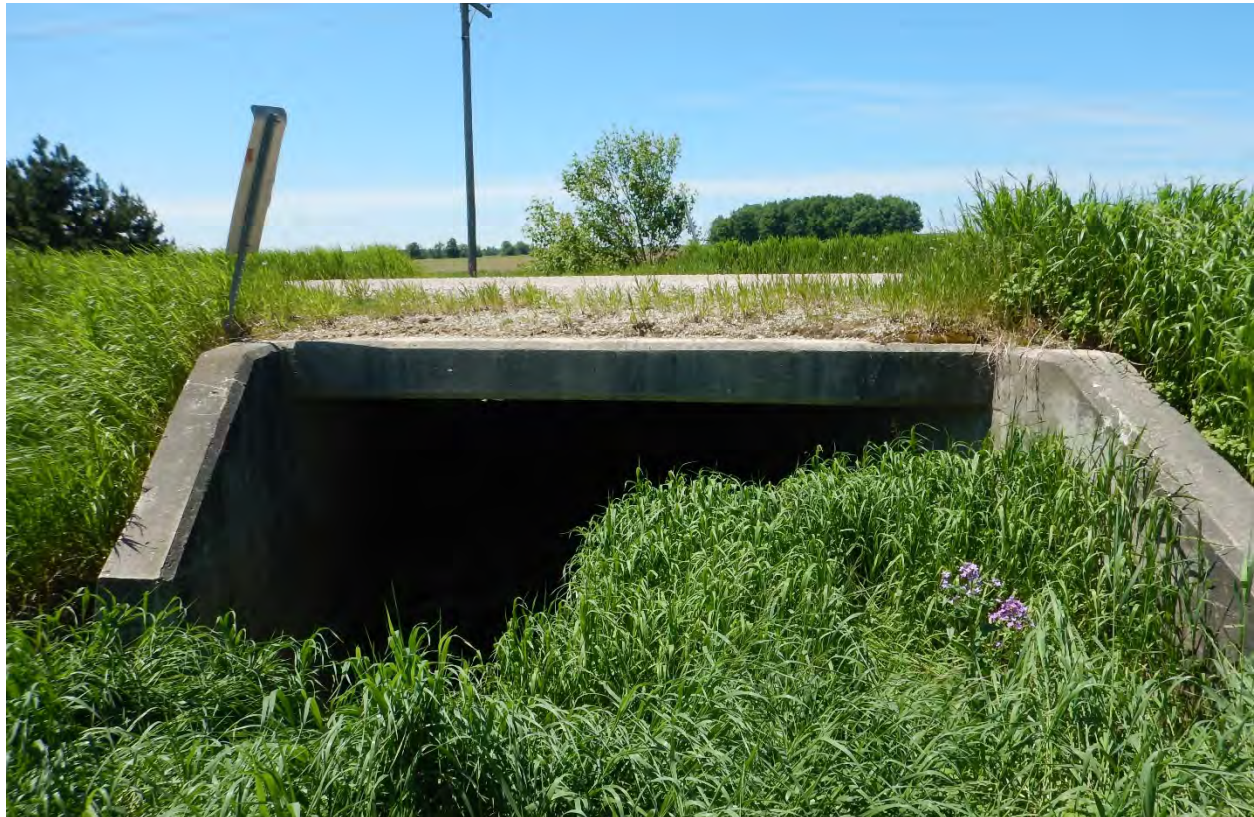
Maintenance Need	Element and Comments	Estimated Cost
Bridge Cleaning	Remove excess vegetation blocking waterway.	\$2,500.00
Erosion Control	Repairs erosion on SE embankment.	\$1,000.00
Hazard Signs	Install additional hazard warning signs at structure.	\$1,000.00
Maintenance Needs Total		\$4,500.00
