Township of Melancthon

Bridge Inventory Update (Specific to Bridge 11 and 13)
January 21, 2021

Bridge 13 (Riverview)

Bridge 11 (8th Line SW)

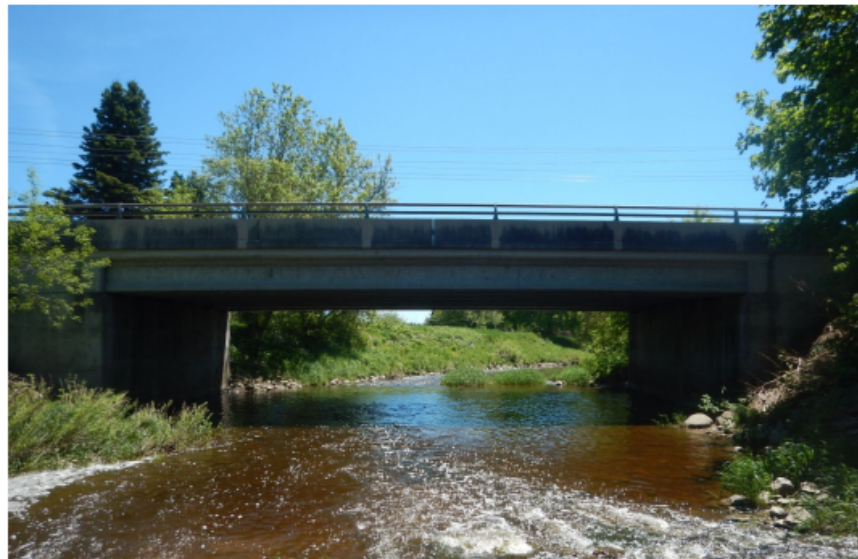
1.12 Structure No. 13

2019 BCI: 63.7

<u>Structure Name:</u>	Structure 013		
<u>Road Name:</u>	260 Sideroad		
<u>Location:</u>	200 m East of 7th Line SW (Lot 21 & 22, Con. 6 & 7 SW)		
<u>Structure Type:</u>	Precast Concrete I-Girder		
<u>Number of Spans:</u>	1	<u>Span Lengths:</u>	17.8 m
<u>Overall Structure Width:</u>	10.7 m	<u>Roadway Width:</u>	8.6 m
<u>Year of Construction:</u>	1968	<u>Current Load Limit:</u>	N/A

Recommendation: Major Rehabilitation is recommended within 2 years.

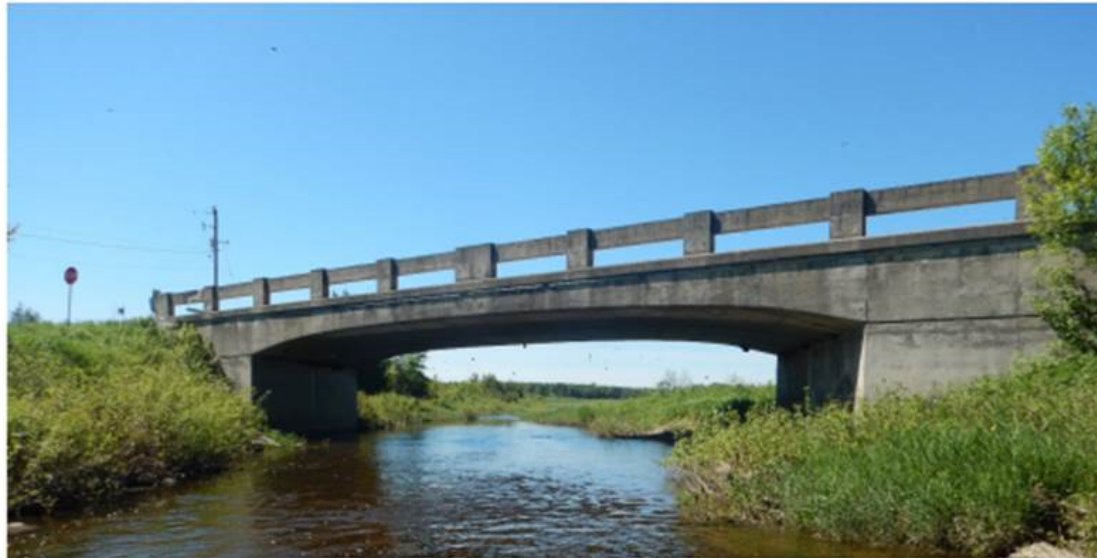
1.10 Structure No. 11

2019 BCI: 69.6

<u>Structure Name:</u>	Structure 011		
<u>Road Name:</u>	8th Line SW		
<u>Location:</u>	3.4 km North of HWY 89 (Lot 16, Con. 8 & 9 SW)		
<u>Structure Type:</u>	Cast-In-Place Conc. Rigid Frame		
<u>Number of Spans:</u>	1	<u>Span Lengths:</u>	16.2 (skew = 19.8) m
<u>Overall Structure Width:</u>	8.5 m	<u>Roadway Width:</u>	7.3 m
<u>Year of Construction:</u>	1960	<u>Current Load Limit:</u>	N/A

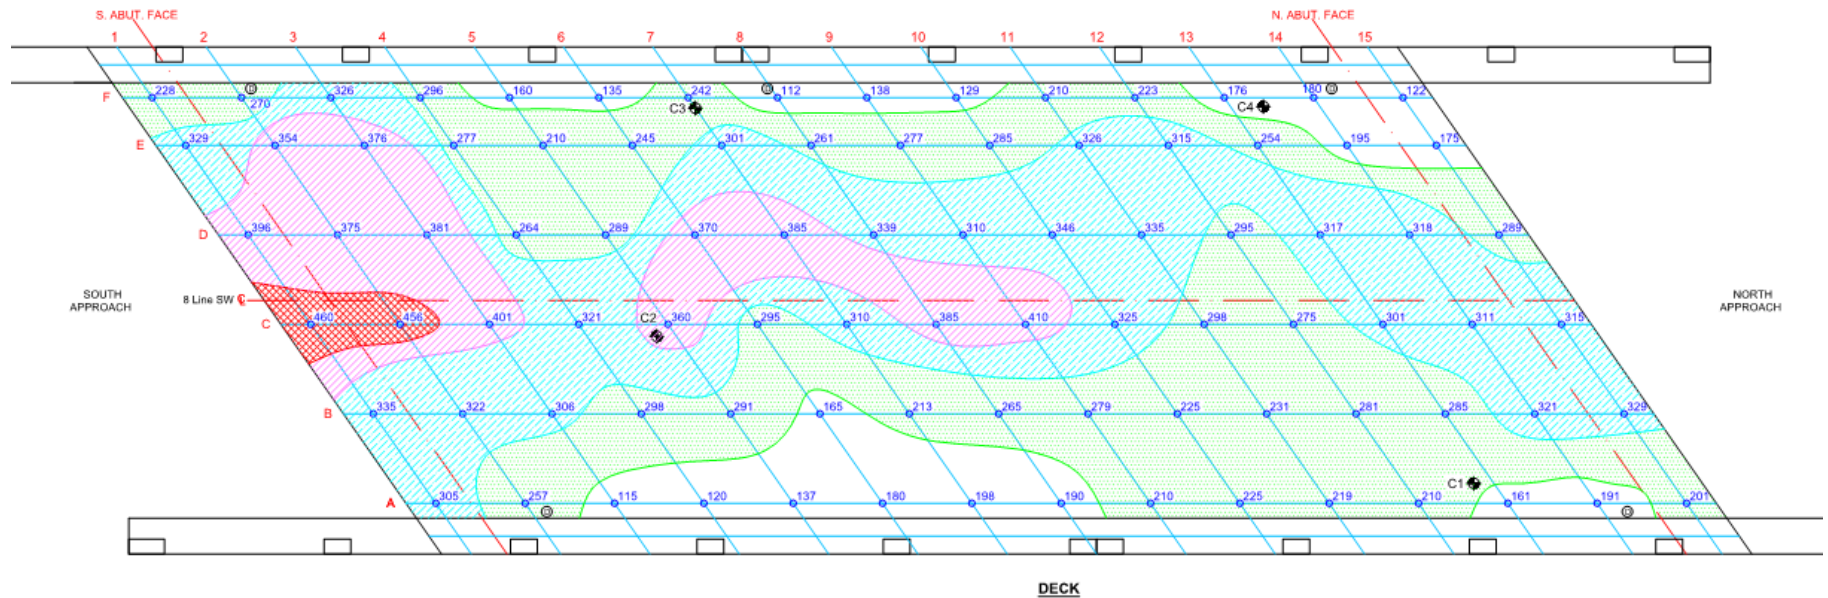
Corrosion Potential (Bridge 11)

Asphalt Thickness (mm)	Waterproofing Present	Compressive Strength (MPa)	Corrosion Potential (% of deck)			Corrected Chloride Content (%)	
				0.00V to -0.199V (likely no corrosion)	-0.200V to -0.349V (uncertain low corrosion)	-0.350V or Greater (probable active corrosion)		
Bridge 11	N/A	No	40	21.1%	64.5%	14.4%	Core 1 0	Core 2 0.158
Bridge 13	20-60	No	62	16.7%	70.5%	12.8%	Core 2 0.077	Core 7 0.026

If the chloride content is greater than **0.05%** by mass, there is an indication that the chloride contamination has extended to the steel reinforcing in that particular area.

MTO Structural Rehab Manual recommends removing sound concrete in areas with high corrosion potential (pink areas) **and** heavily chloride contamination, as they are at risk for continued corrosion activity

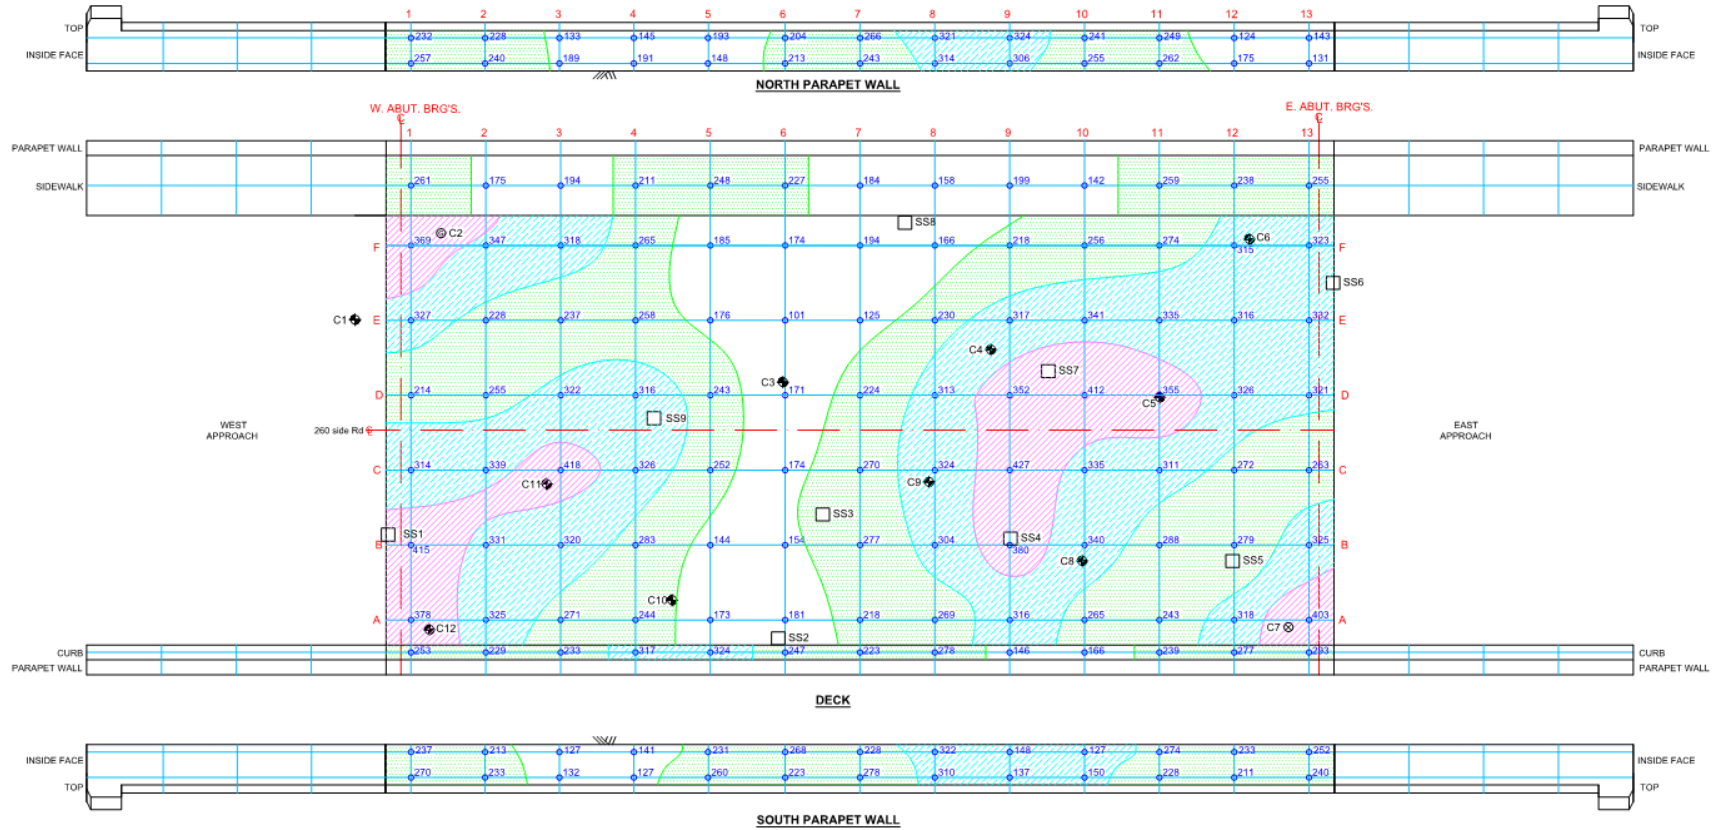
Corrosion Potential (Bridge 13)

The **good news** was that the existing concrete at both sites are suitable to rehabilitate, full deck replacement not required.
