**2021 OSIM Bridge Inspection Report**

**Township of Melancthon  
157101 Highway 10  
Melancthon, ON L9V 2E6**

**December 2021  
30052974.0000**

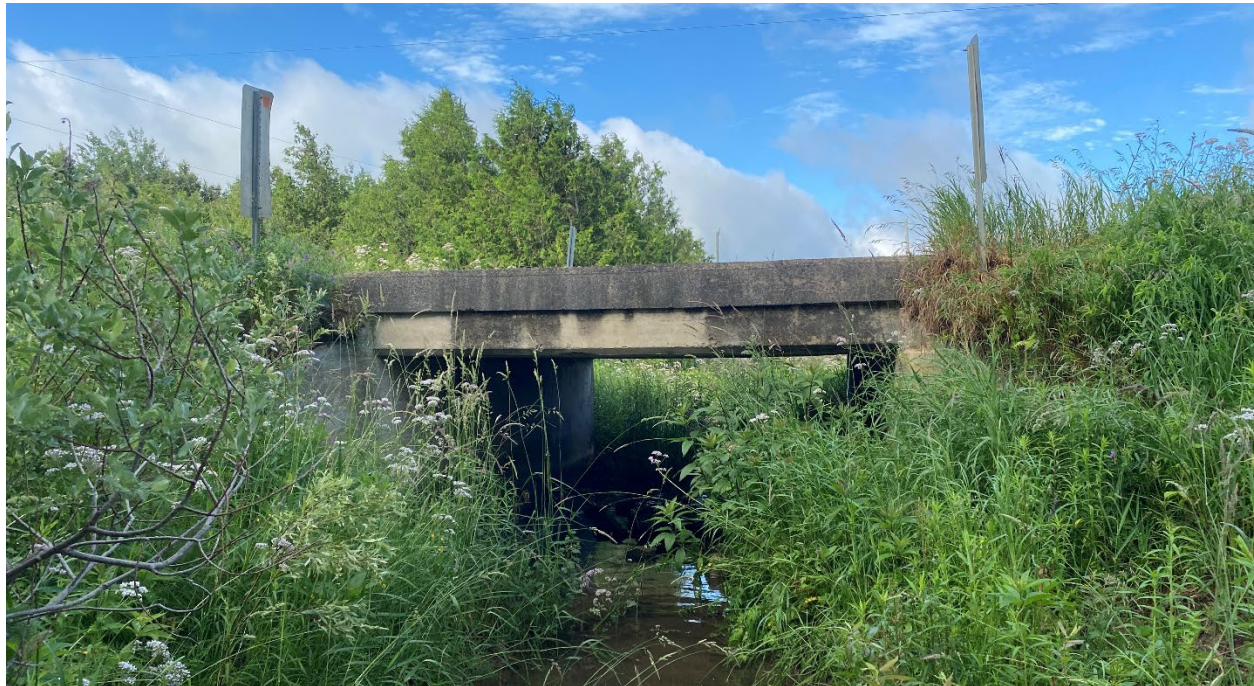
Structure 001 is generally in good condition but is demonstrating signs of concrete deterioration and erosion specifically on the abutments, wingwalls and exposed portion of the foundation. The Township should consider installing rock protection along the abutments and wingwalls to prevent further concrete deterioration and help extend the service life of the structure. It is also recommended that erosion of the abutments & footings be monitored during future biennial inspections. The repairs listed above may be considered to help extend the lifespan of the structure; however, based on the current BCI, span, and low clearance a rehabilitation is not recommended and replacement of the structure is recommended once the BCI reaches 40, in approximately 16 years.

**Recommendation:** No Capital Works is estimated to be required within the next 10 years.

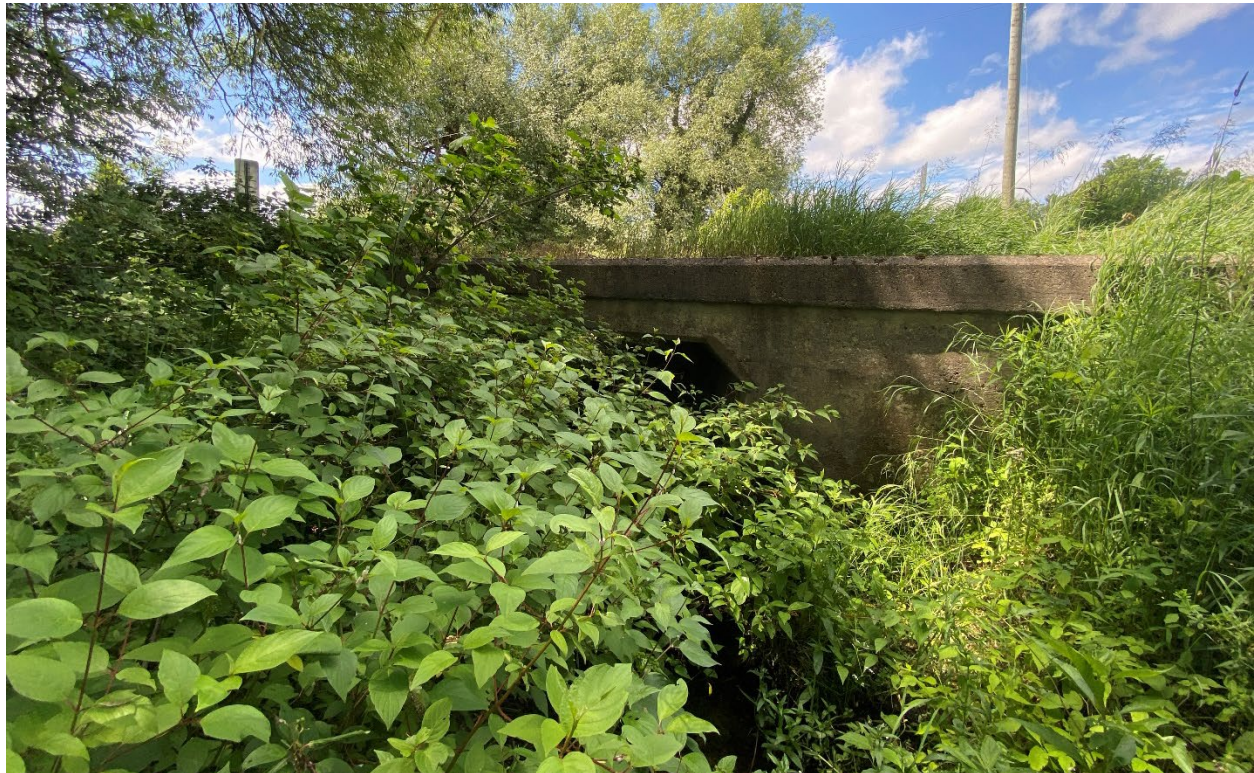
Structure 003 is generally in good to fair condition but is demonstrating signs of concrete deterioration, and moisture penetration through the deck based on delaminations noted on the soffit. Based on the current BCI, span, narrow driving platform and low clearance, a rehabilitation is not recommended and replacement of the structure is recommended once the BCI reaches 40, in approximately 13 years. However, the repairs listed above may be completed to help extend the lifespan of the structure.

**Recommendation:** No Capital Works is estimated to be required within the next 10 years.

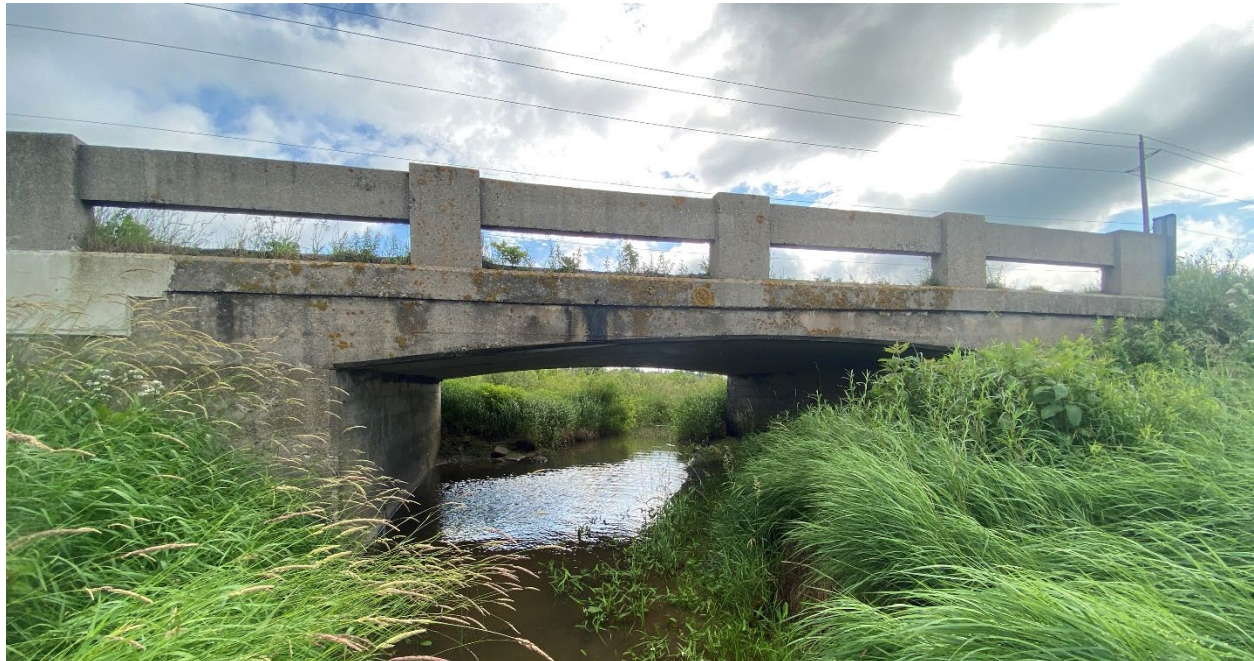
Structure 005 is generally in good condition but is beginning to demonstrate signs of concrete deterioration, and moisture penetration on the soffit indicating that water is likely penetrating through the existing wearing course and waterproofing system (if waterproofing was completed during original structure) and requires replacement. Based on the current BCI, minor rehabilitation should be considered as the BCI approaches 60 to ensure the structure does not deteriorate beyond repair. Concrete repairs, waterproofing and paving, and barrier replacement should be included in the rehabilitation project within approximately 6 years. Consideration should be given to investigating the need for a steel beam guide rail system with end treatments and structure connections to help protect oncoming traffic.

**Recommendation:** Minor Rehabilitation is recommended within 6 years.

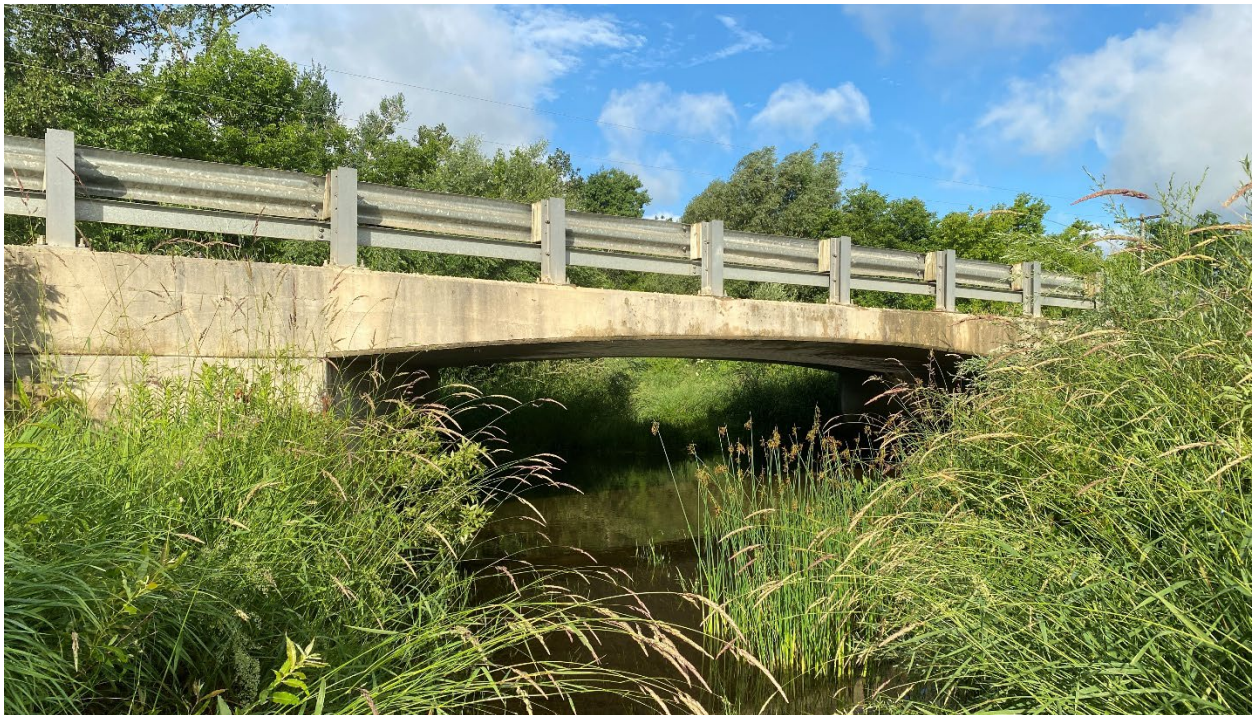
Structure 006 is generally in good condition with only minor maintenance recommended at this time. The Township should consider waterproofing and paving the deck top to help maximize the lifespan of the structure.

**Recommendation:** No Capital Works estimated to be required within 10 years. Future structure rehabilitation should be considered.

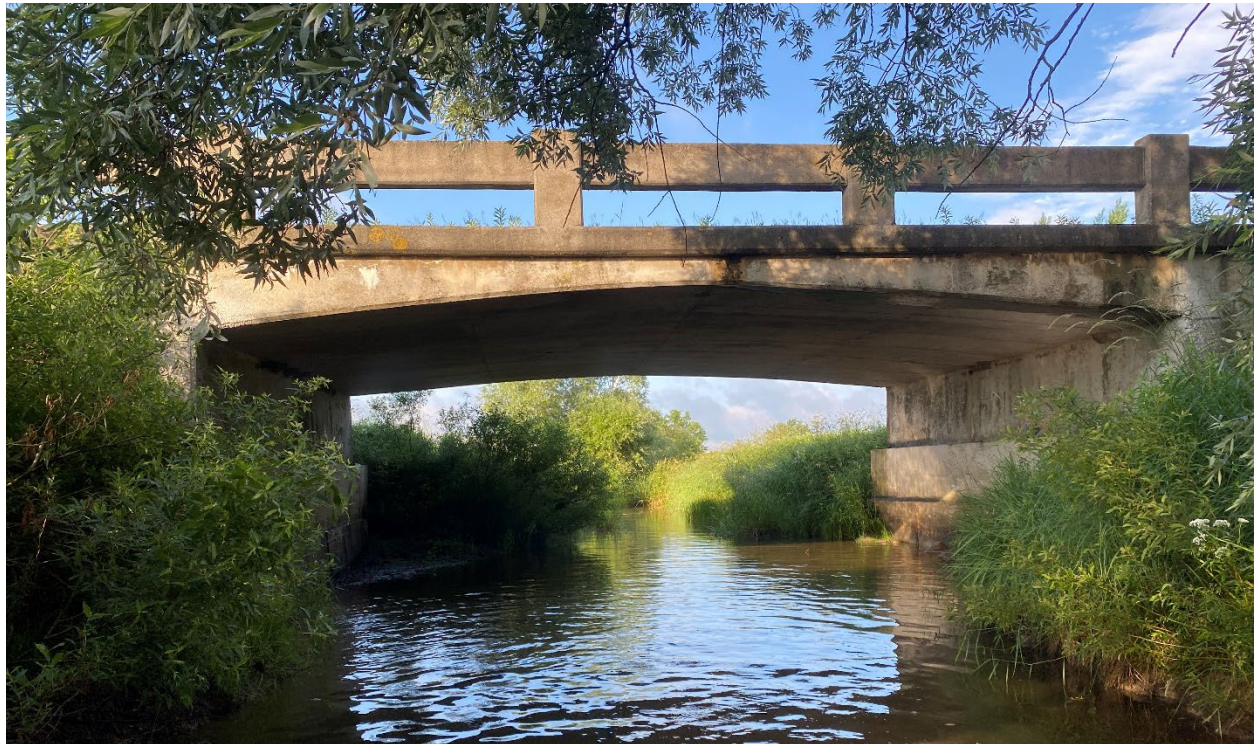
Structure 007 is generally in good to fair condition but is demonstrating signs of concrete deterioration throughout, and moisture penetration on the soffit. A minor rehabilitation should be considered as the BCI approaches 60 to ensure the structure does not deteriorate beyond repair. Concrete repairs, waterproofing and paving, and barrier replacement should be included in the rehabilitation project within approximately 3 years. However, given the narrow, sub-standard driving platform width, consideration may be given to forgoing the rehabilitation and scheduling the replacement of the structure within 13 years.

**Recommendation:** Minor Rehabilitation is recommended within 3 years.

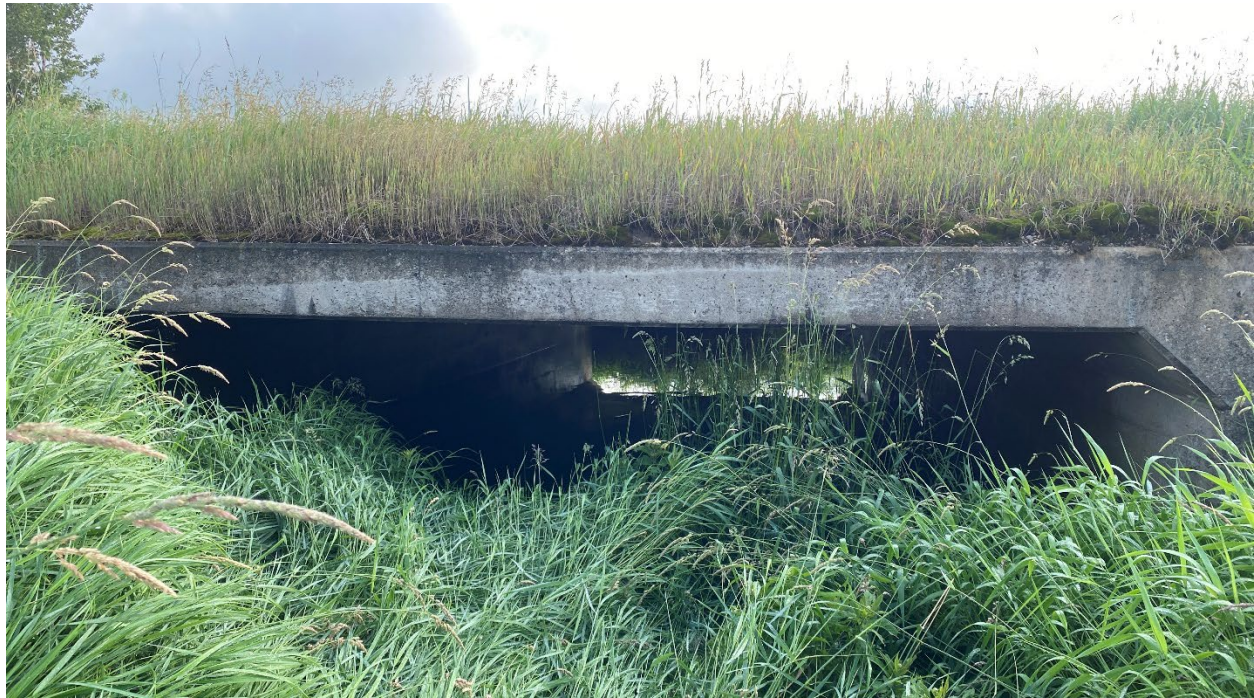
Structure 008 is generally in good to fair condition. Wet cracks were noted on the soffit which indicate a potential of moisture penetration through the deck but may also be due to the humid environment within the barrel. These cracks should be monitored during future inspections and consideration may be given to removing the fill from over the culvert to waterproof the deck top surface and help extend the service life of the structure. If the Township wishes to complete this work and associated paving/concrete repairs, the work is recommended to be completed within 5 years. Otherwise, the Township may wish to forgo rehabilitation due to the narrow driving platform width and schedule to replace the structure in approximately 15 years. Consideration should be given to investigating the need for a steel beam guide rail system with end treatments to help protect oncoming traffic.

**Recommendation:** No Capital Works is estimated to be required within the next 10 years.

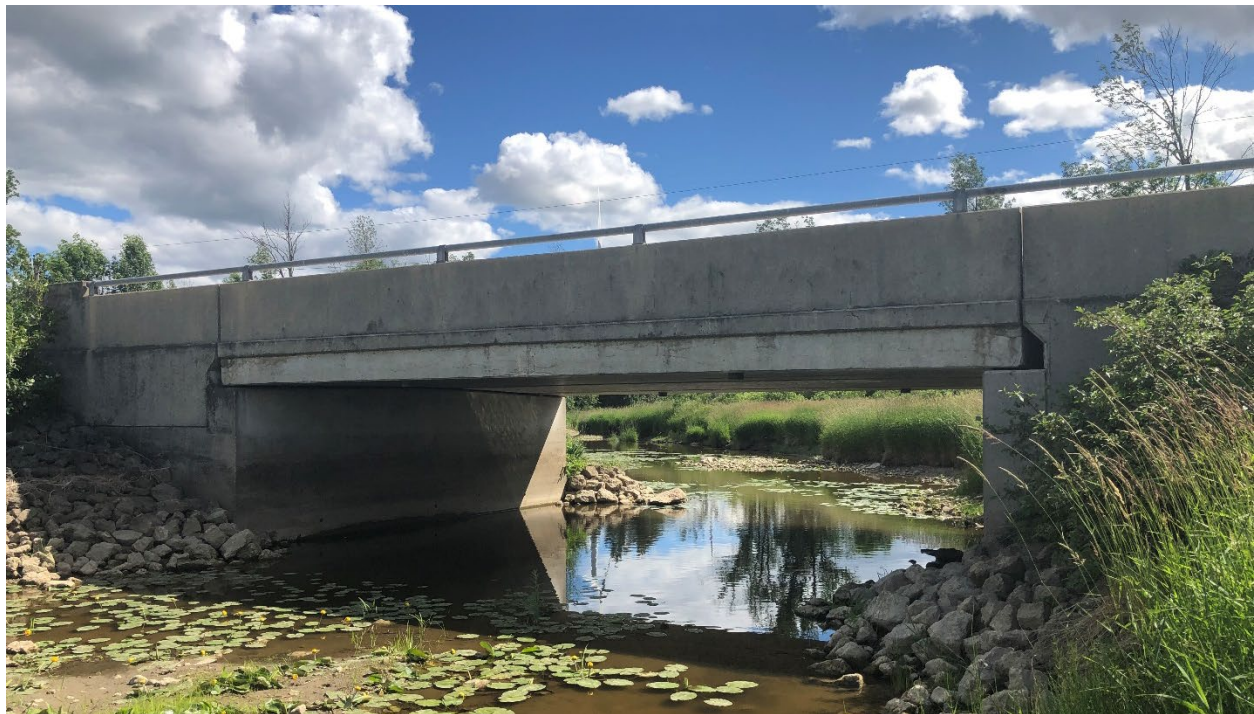
Structure 009 is generally in good condition but is demonstrating signs of concrete deterioration caused by the salt laden water leaking through the expansion joints. Based on the current BCI, a minor rehabilitation should be considered as the BCI approaches 60 to ensure the structure does not deteriorate beyond repair. Concrete repairs, waterproofing and paving, and expansion joint replacement should be included in the rehabilitation project within approximately 6 years. Additionally, the Township should consider conversion of the structure to a semi-integral configuration during the rehabilitation work in order to eliminate future maintenance and repairs associated with the expansion joint system (a cost estimate for this work can be provided upon request).

**Recommendation:** Minor Rehabilitation is recommended within 6 years.

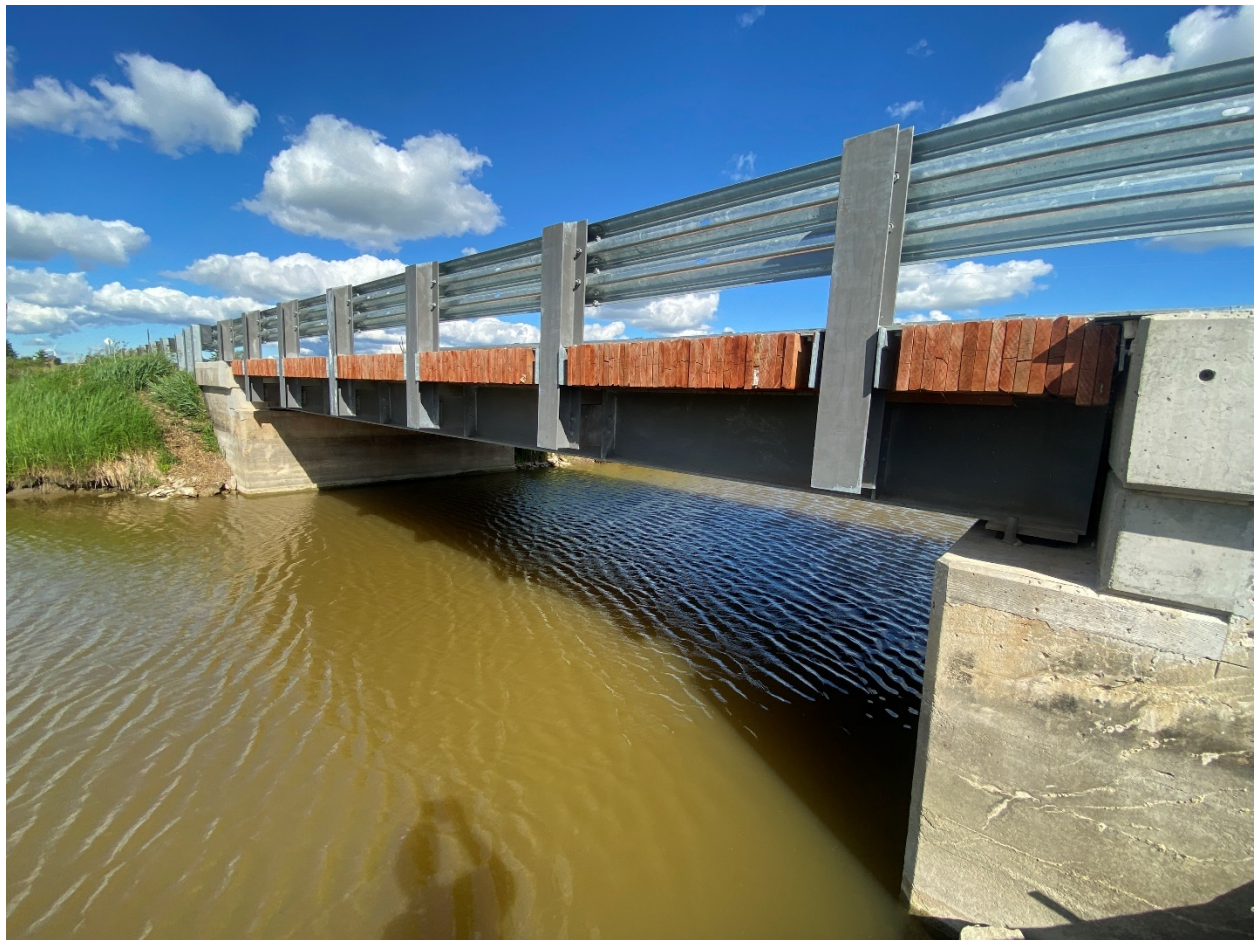
Structure 010 was rehabilitated in 2018 and is generally in excellent condition with only minor maintenance recommended at this time. The Township should ensure routine maintenance is completed to help maximize the lifespan of the structure.

**Recommendation:** No Capital Works is estimated to be required within the next 10 years.

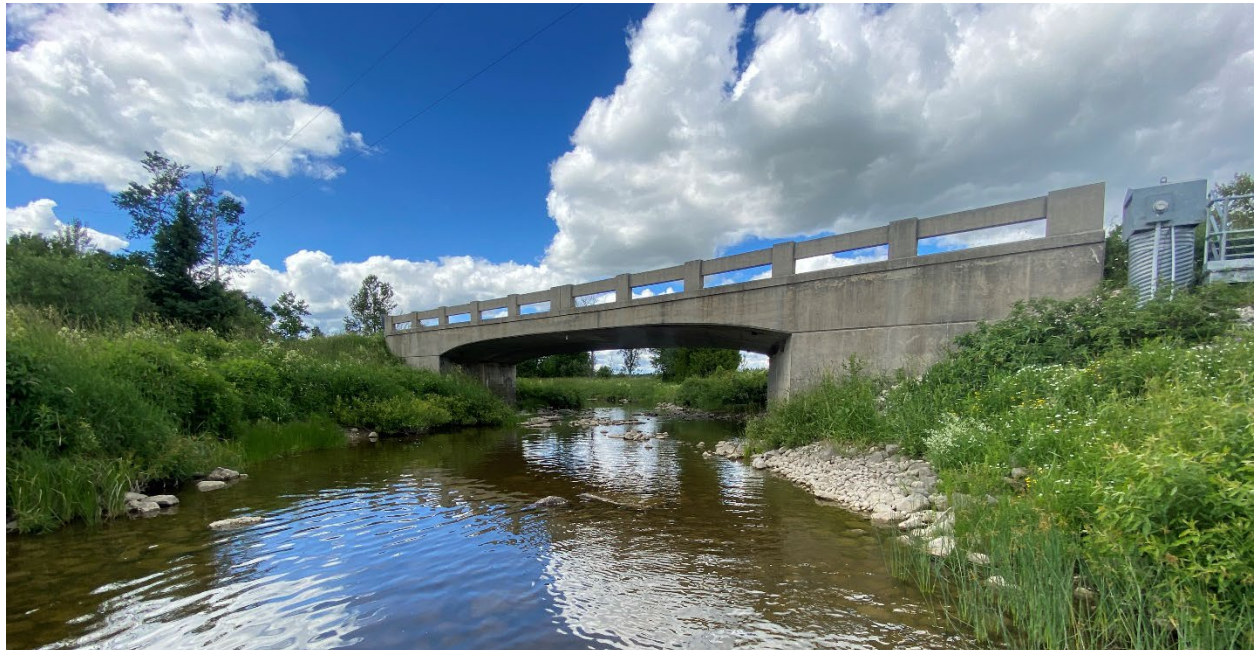
Structure 011 is generally in good to fair condition but is demonstrating signs of concrete deterioration on the deck top, and moisture penetration primarily through the deck construction joint. The rehabilitation of Bridge 11 is tentatively scheduled for 2022 and is currently in design phase. Based on the presence of swallow nests noted during the inspection, it is recommended that bird netting be installed on the structure in the season ahead of the scheduled rehabilitation work.

**Recommendation:** Minor Rehabilitation is recommended within 5 years.

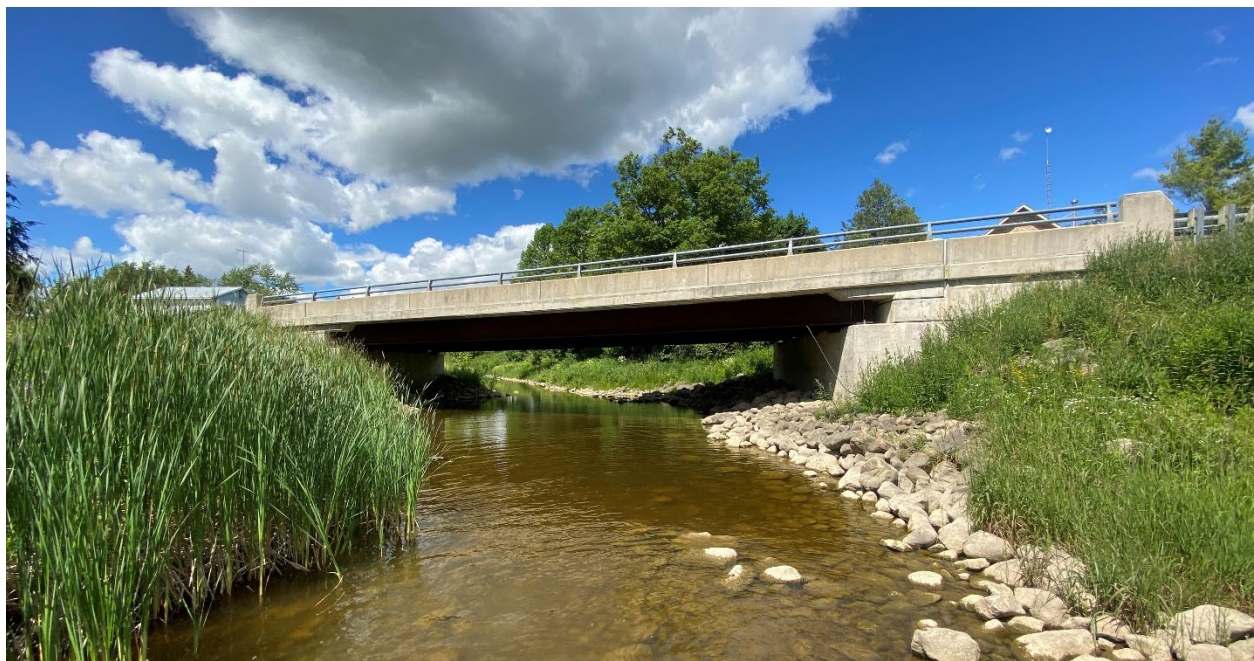
Structure 012, which was erected in 2007, is generally in excellent to good condition with only minor maintenance recommended at this time. The Township should ensure routine maintenance is completed to maximize the lifespan of the structure.

**Recommendation:** No Capital Works estimated to be required within 10 years. Future structure rehabilitation should be considered.

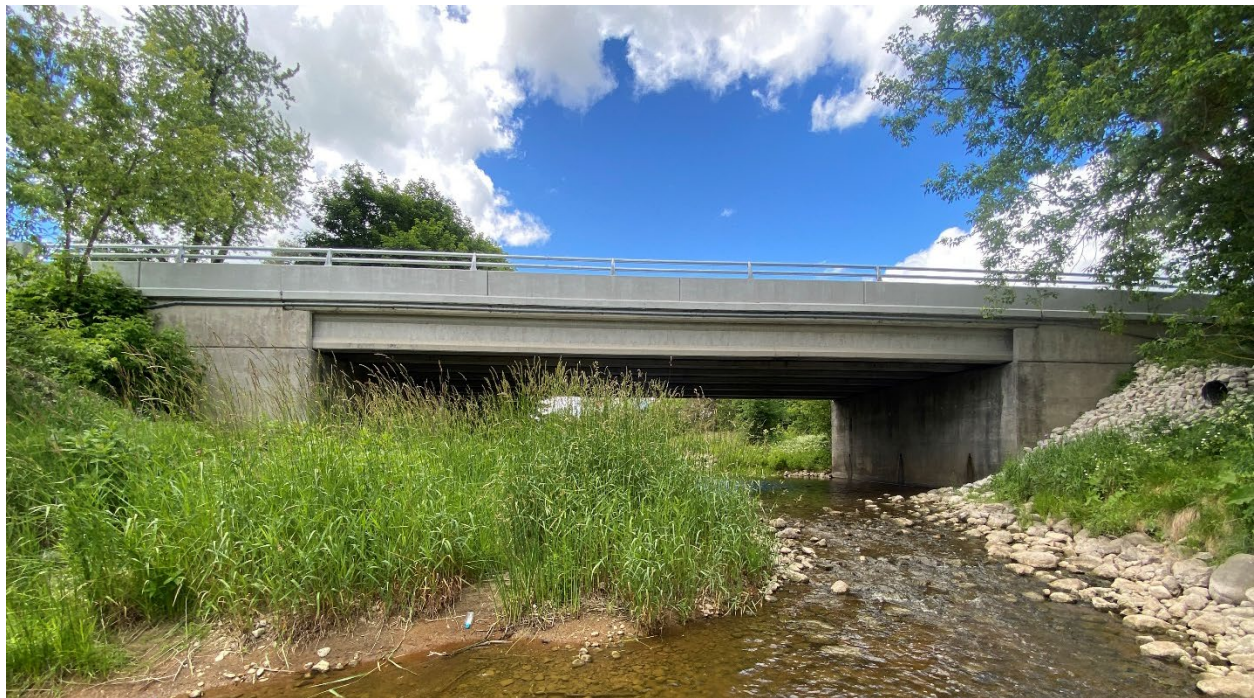
Structure 013 is generally in good condition with no capital works required at this time. A rehabilitation was completed in 2021 that consisted of concrete patch repairs, expansion joints replacement, waterproofing and paving, and erosion protection. Routine maintenance should be ongoing to help maximize the lifespan of the structure.

**Recommendation:** No Capital Works is estimated to be required within the next 10 years.

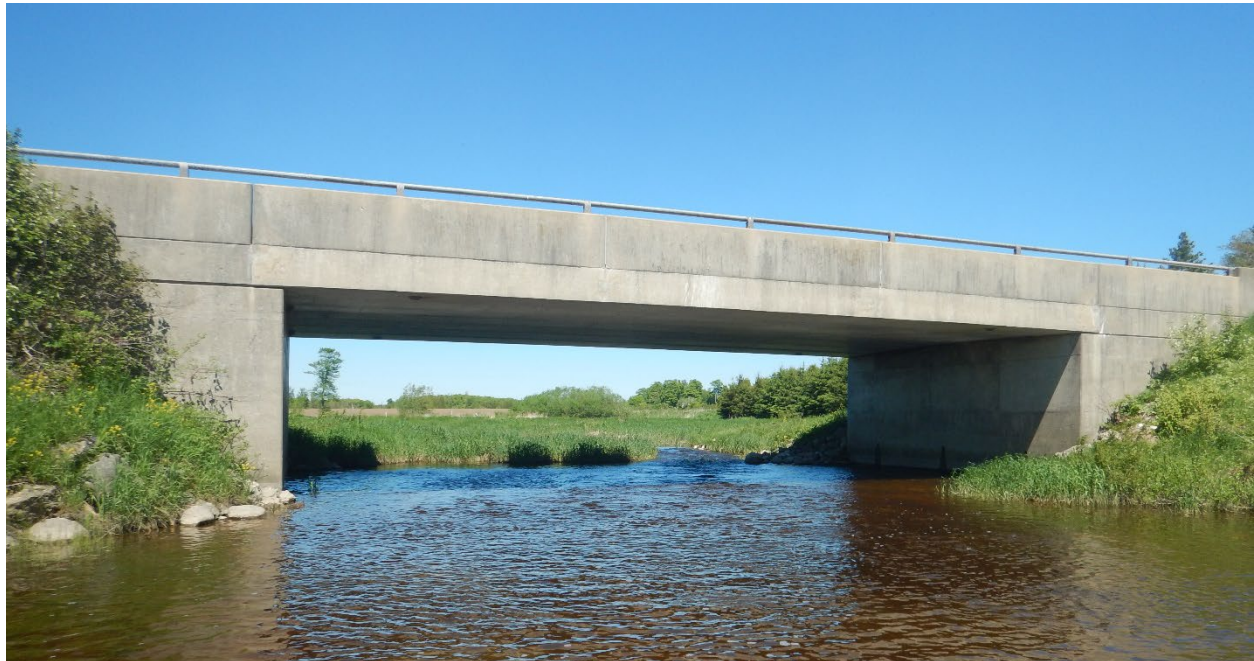
Structure 014 is generally in good condition but is demonstrating signs of concrete deterioration on the deck top and seized expansion joints. The majority of defects were noted to be in areas adjacent to leaking or unsealed joints in the barrier or deck. As such, a minor rehabilitation to seal the joints, waterproof and pave, and complete concrete repairs to help slow the rate of deterioration is recommended within the next 6 years. Additionally, the Township should consider conversion of the structure to a semi-integral configuration during the rehabilitation work in order to eliminate future maintenance and repairs associated with the expansion joint system (a cost estimate for this work can be provided upon request).

**Recommendation:** Minor Rehabilitation is recommended within 6 years.

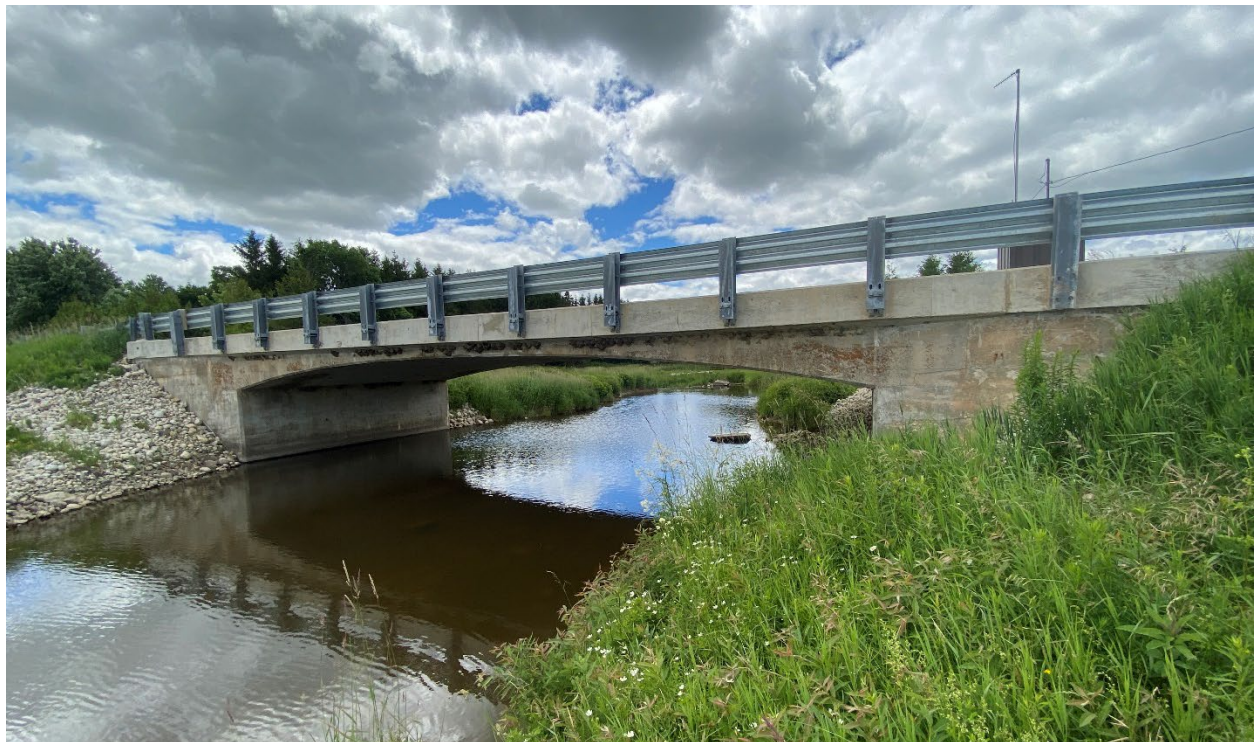
Structure 015, which was rehabilitated in 2017, is generally in good condition with no capital works required at this time. The Township should ensure routine maintenance is completed to help maximize the service life of the structure.

**Recommendation:** No Capital Works is estimated to be required within the next 10 years.

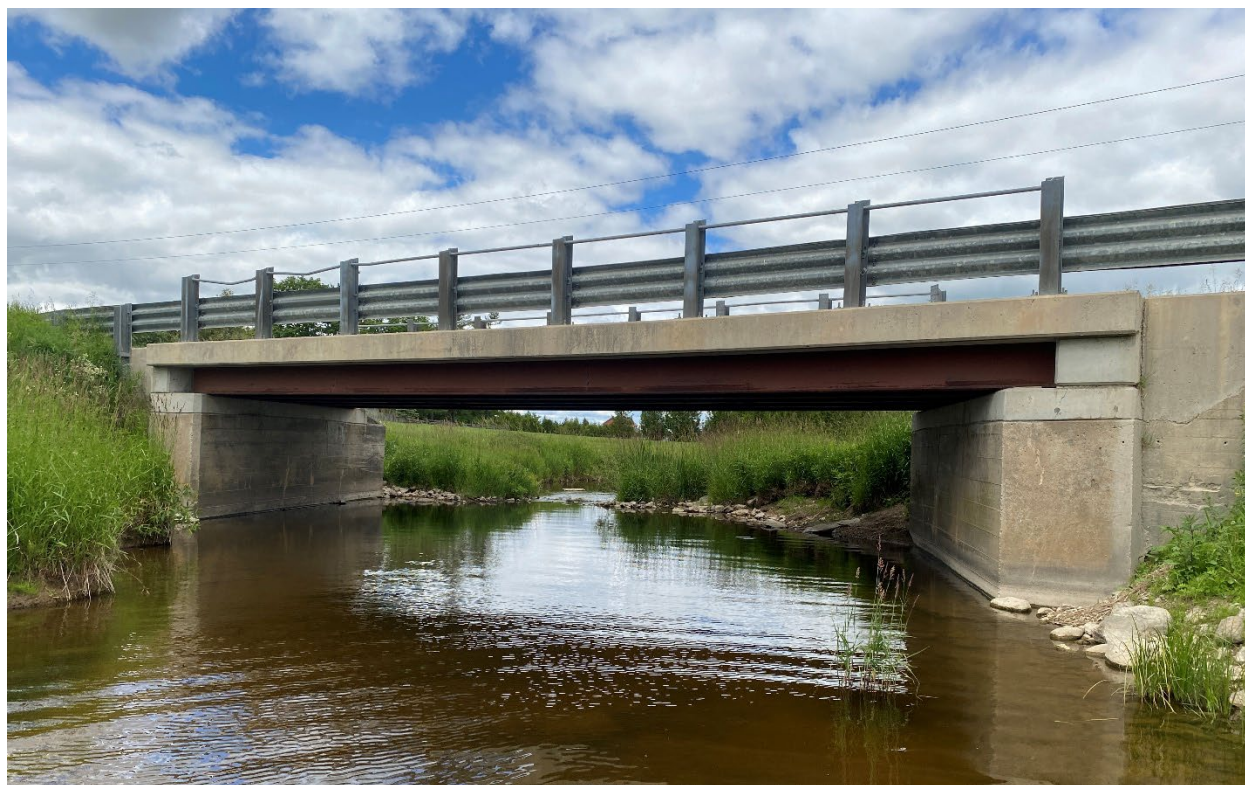
Structure 016, which was rehabilitated in 1990, is generally in good condition but is demonstrating signs of concrete deterioration, and peeling/flaking of structural steel coating. Based on the current BCI, and the size of the structure, an additional minor rehabilitation should be considered as the BCI approaches 60 to ensure the structure does not deteriorate beyond repair. Concrete repairs, waterproofing and paving, abrasive blasting and re-painting structural steel, and erosion protection should be included in the rehabilitation project within approximately 5 years. However, given the narrow, sub-standard driving platform width, consideration may be given to forgoing the rehabilitation and scheduling the replacement of the structure within 15 years.

**Recommendation:** Minor Rehabilitation is recommended within 5 years.

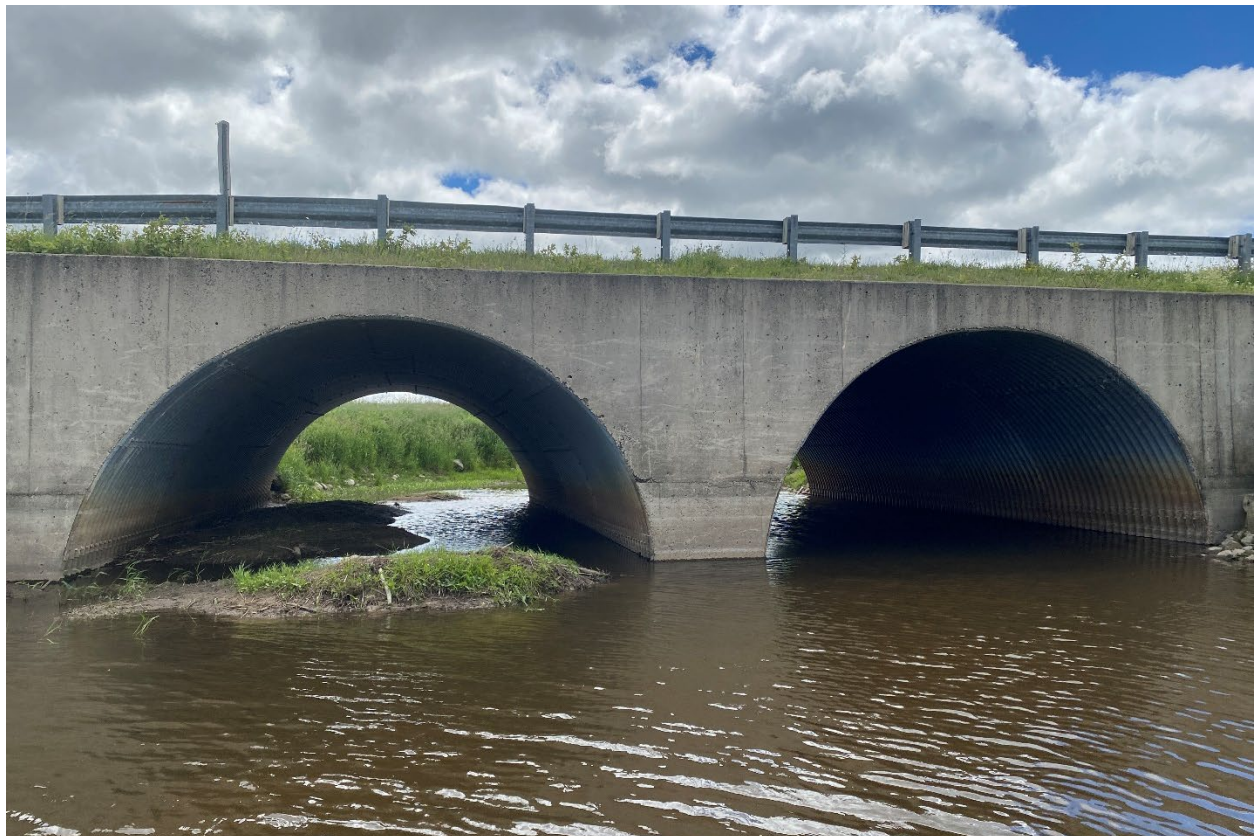
Structure 017 is generally in good condition with only roadside safety upgrades recommended at this time. The Township should ensure routine maintenance is completed to help maximize the service life of the structure. Consideration should be given to replacing the guide rail with a current code conforming steel beam guide rail system and end treatments to help protect oncoming traffic.

**Recommendation:** Minor Rehabilitation is recommended within 7 years.

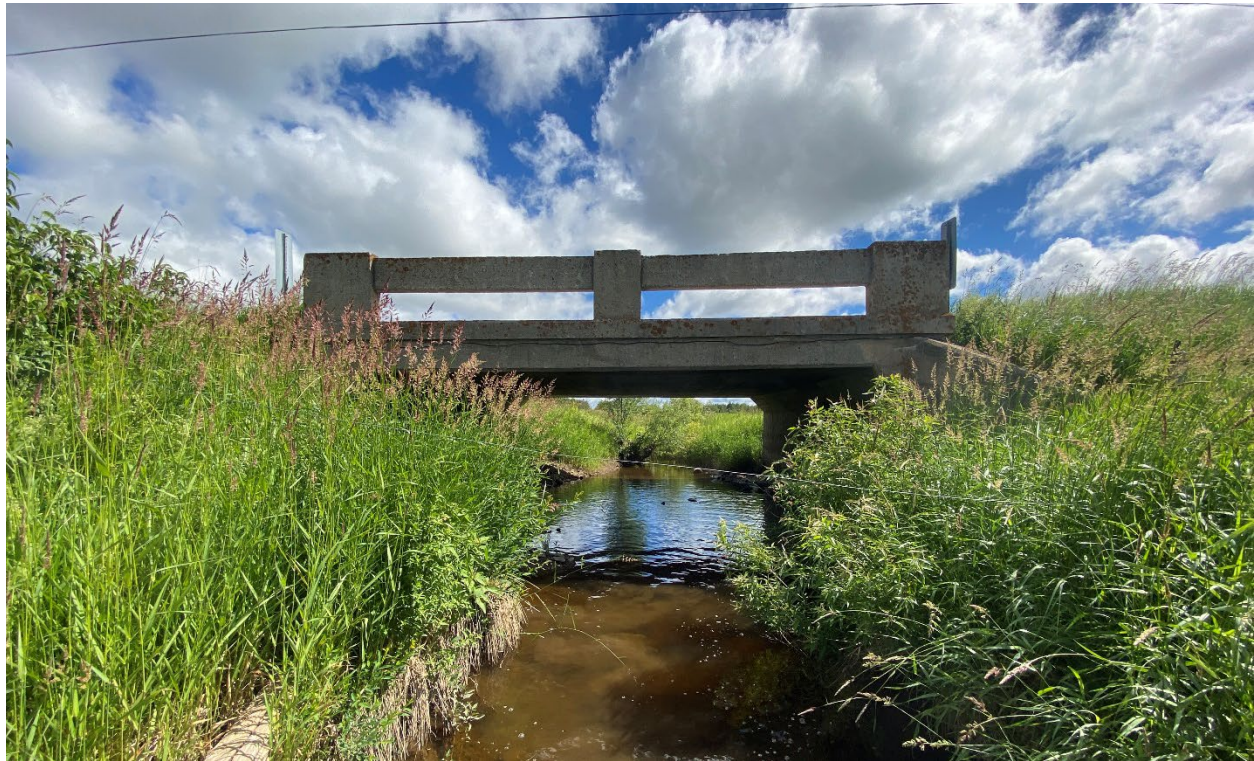
Structure 018 is generally in good to fair condition but is demonstrating signs of concrete deterioration, and moisture penetration. Based on the current BCI, a minor rehabilitation should be considered as the BCI approaches 60 to ensure the structure does not deteriorate beyond repair. Concrete repairs, waterproofing and paving, barrier replacement, and erosion protection should be included in the rehabilitation project within approximately 4 years. However, given the narrow, sub-standard driving platform width, consideration may be given to forgoing the rehabilitation and scheduling the replacement of the structure within 14 years.

**Recommendation:** Minor Rehabilitation is recommended within 5 years.

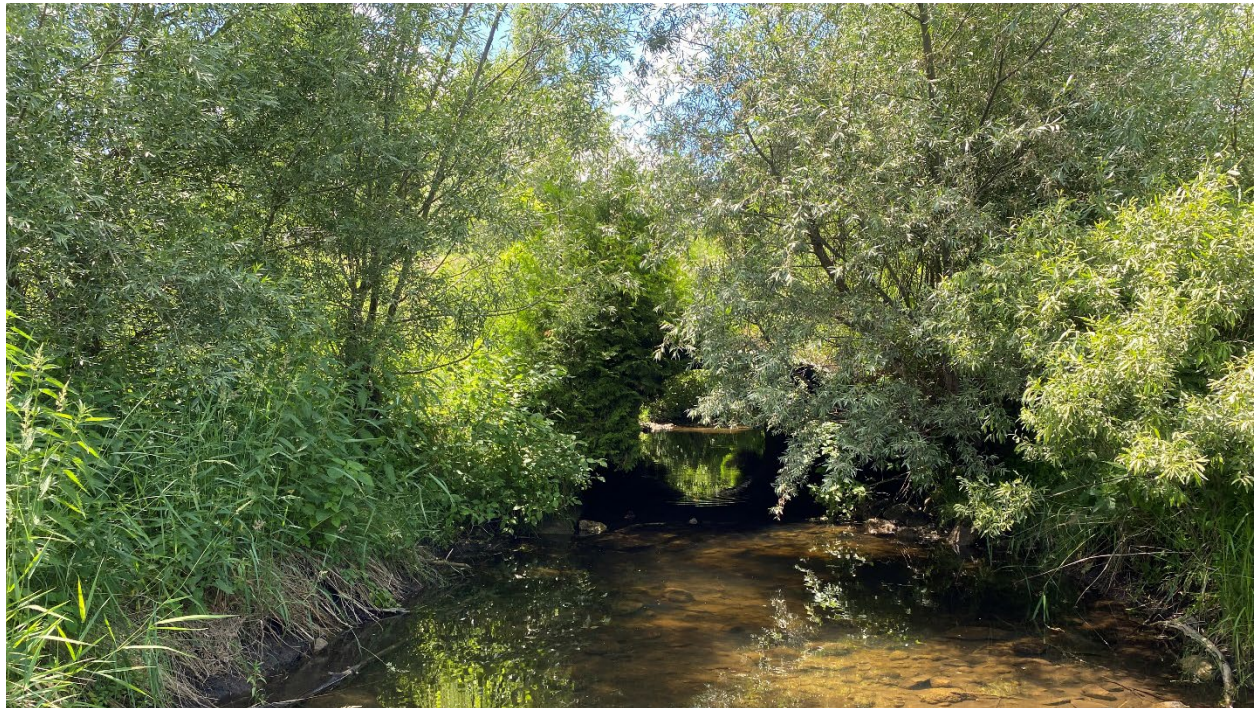
Structure 2001 is generally in good condition but is demonstrating signs of light to moderate surface corrosion along the waterline. Based on the structure type and span a rehabilitation is not recommended and replacement of the structure is recommended once the BCI reaches 40, in approximately 15 years. Consideration should also be given to replacing the guide rail with a current code conforming steel beam guide rail system with end treatments to help protect oncoming traffic.

**Recommendation:** No Capital Works is estimated to be required within the next 10 years.

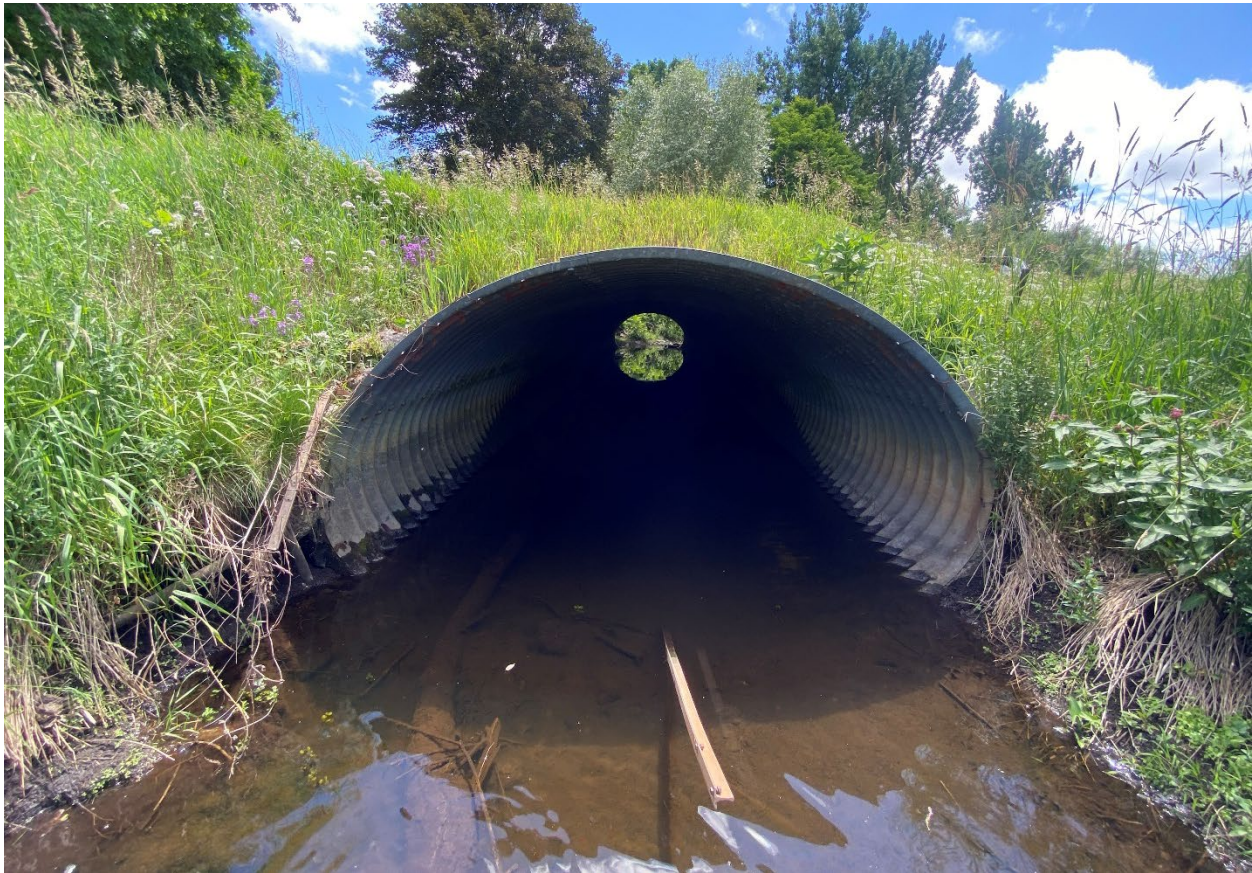
Structure 2002 is generally in good condition with only minor maintenance recommended at this time. It is also recommended that the slight sag in the culvert barrel be monitored during future biennial inspections.

**Recommendation:** No Capital Works is estimated to be required within the next 10 years.

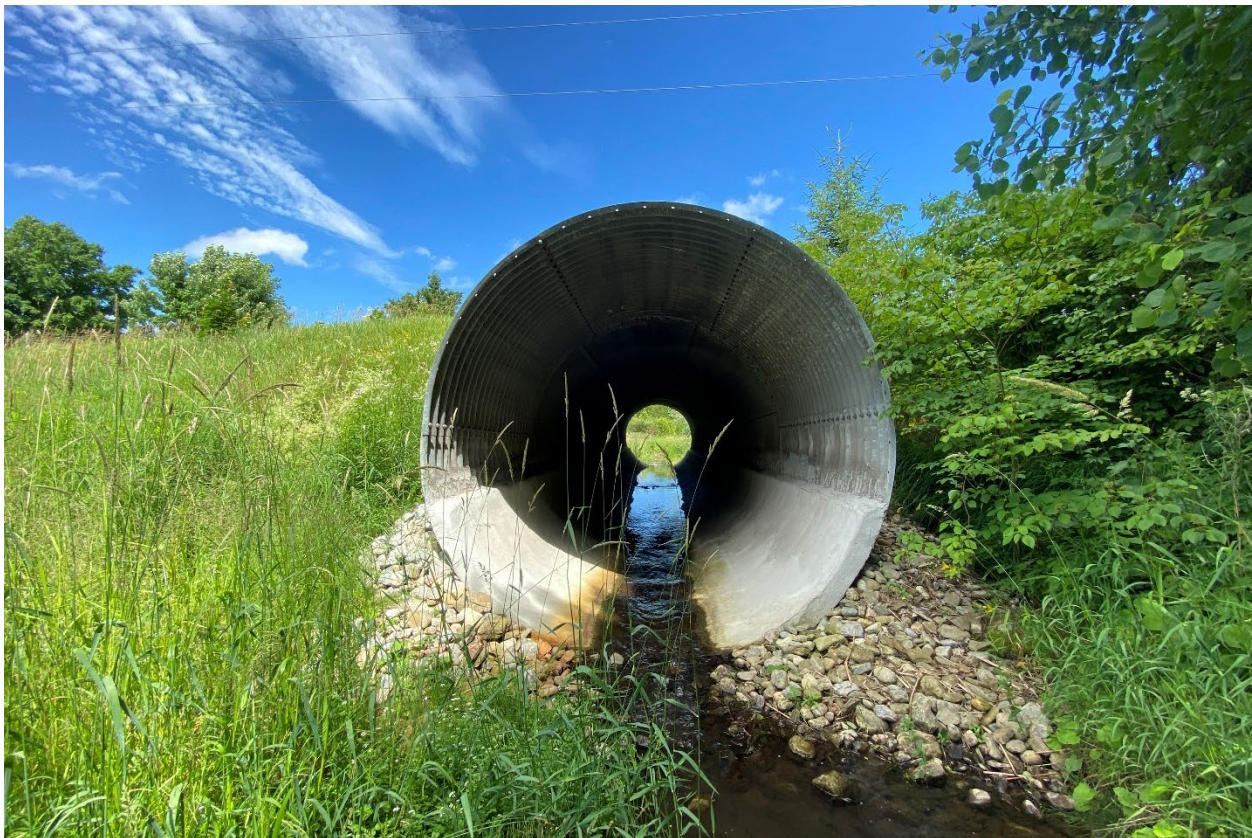
Structure 2003 is generally in good condition after steel reinforced invert paving was completed in 2019. The Township should ensure routine maintenance is completed to help maximize the service life of the structure. Consideration should be given to repairing the 3-cable guide rail system to help protect oncoming traffic.

**Recommendation:** Forgo rehabilitation and replace structure in future (replacement timeline estimated to exceed 10 yrs.).
