# Thursday, July 06, 2017

## RE: Traffic Review Strada Aggregates Inc. Melancthon Pit Extension

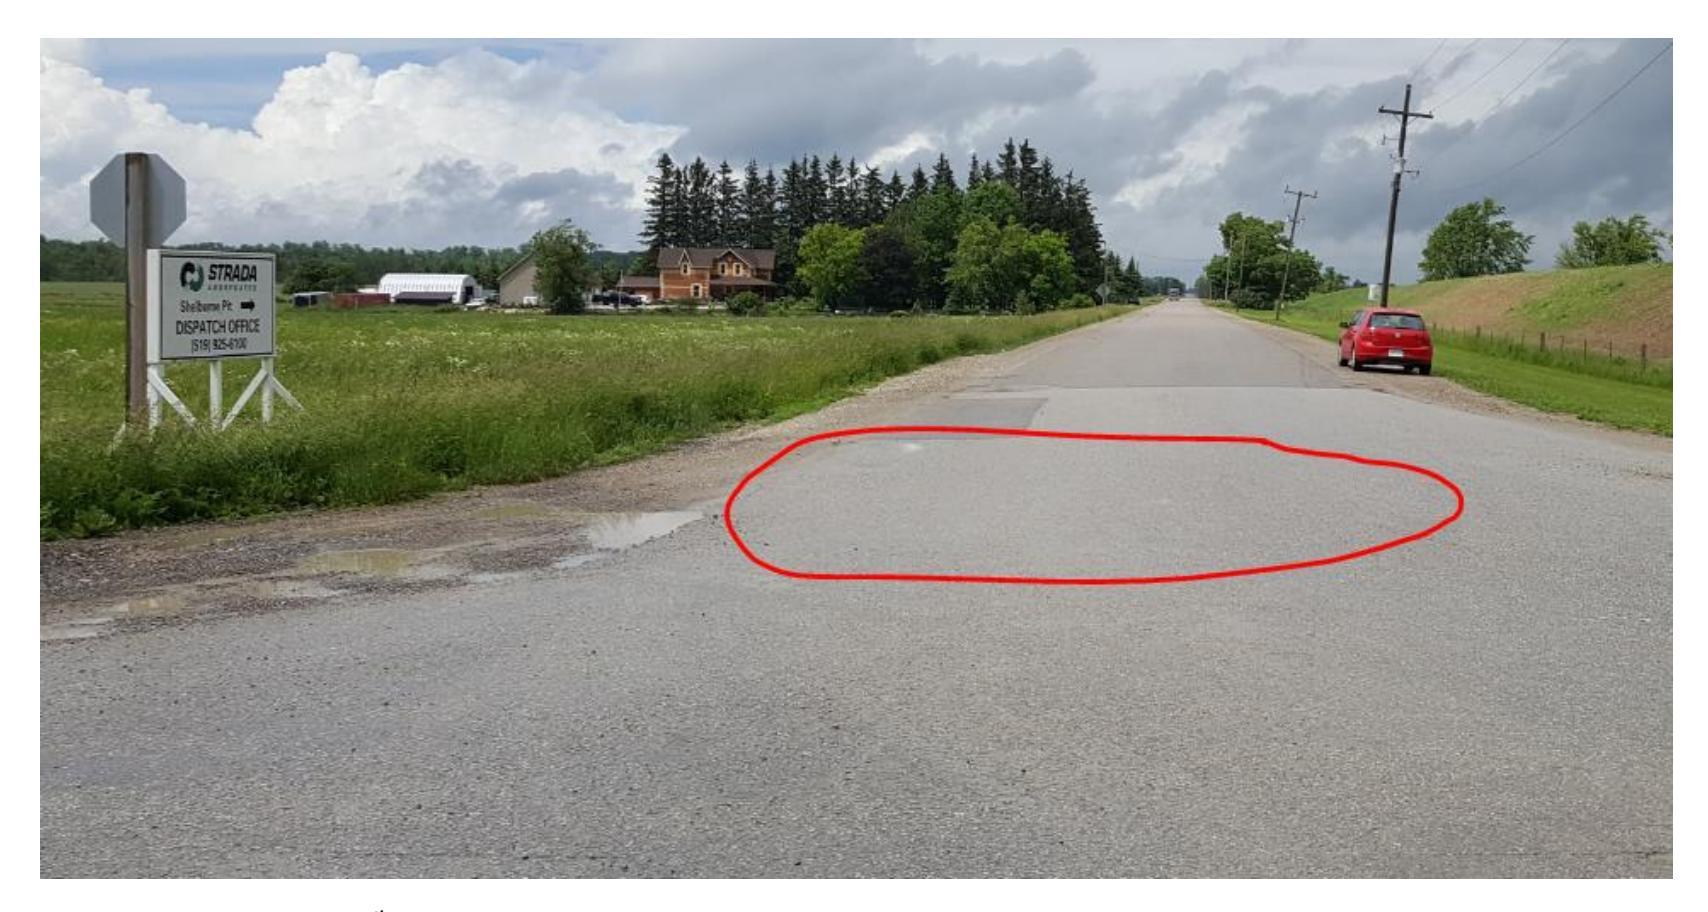
- County Road 17 @ 4<sup>th</sup> Line: the southbound approach stop bar was not visible (Exhibit 1);
- County Road 17 @ County Road 124: the northbound left-turn lane, trailing left-turn arrow (nearer the stop bar) has faded and is difficult to see (Exhibit 2).

Exhibit 1: County Road 17 @ 4<sup>th</sup> Line Southbound Approach – Missing Stop Bar (Looking North)

It is recommended that the above noted pavement markings be repainted.

- It was found that the recommended road network improvements from the previous studies have been implemented correctly and remain in good functioning condition;
- There are no operational or safety concerns in the road network;
- The pavement condition along County Road 17 is acceptable. It is recommended that the pavement condition along 4<sup>th</sup> line be monitored and that potholes south of the northerly driveway be fixed; and,
- The southbound stop bar at County Road 17 and 4<sup>th</sup> Line, as well as the trailing northbound left-turn arrow at County Road 17 and County Road 124, should be repainted.

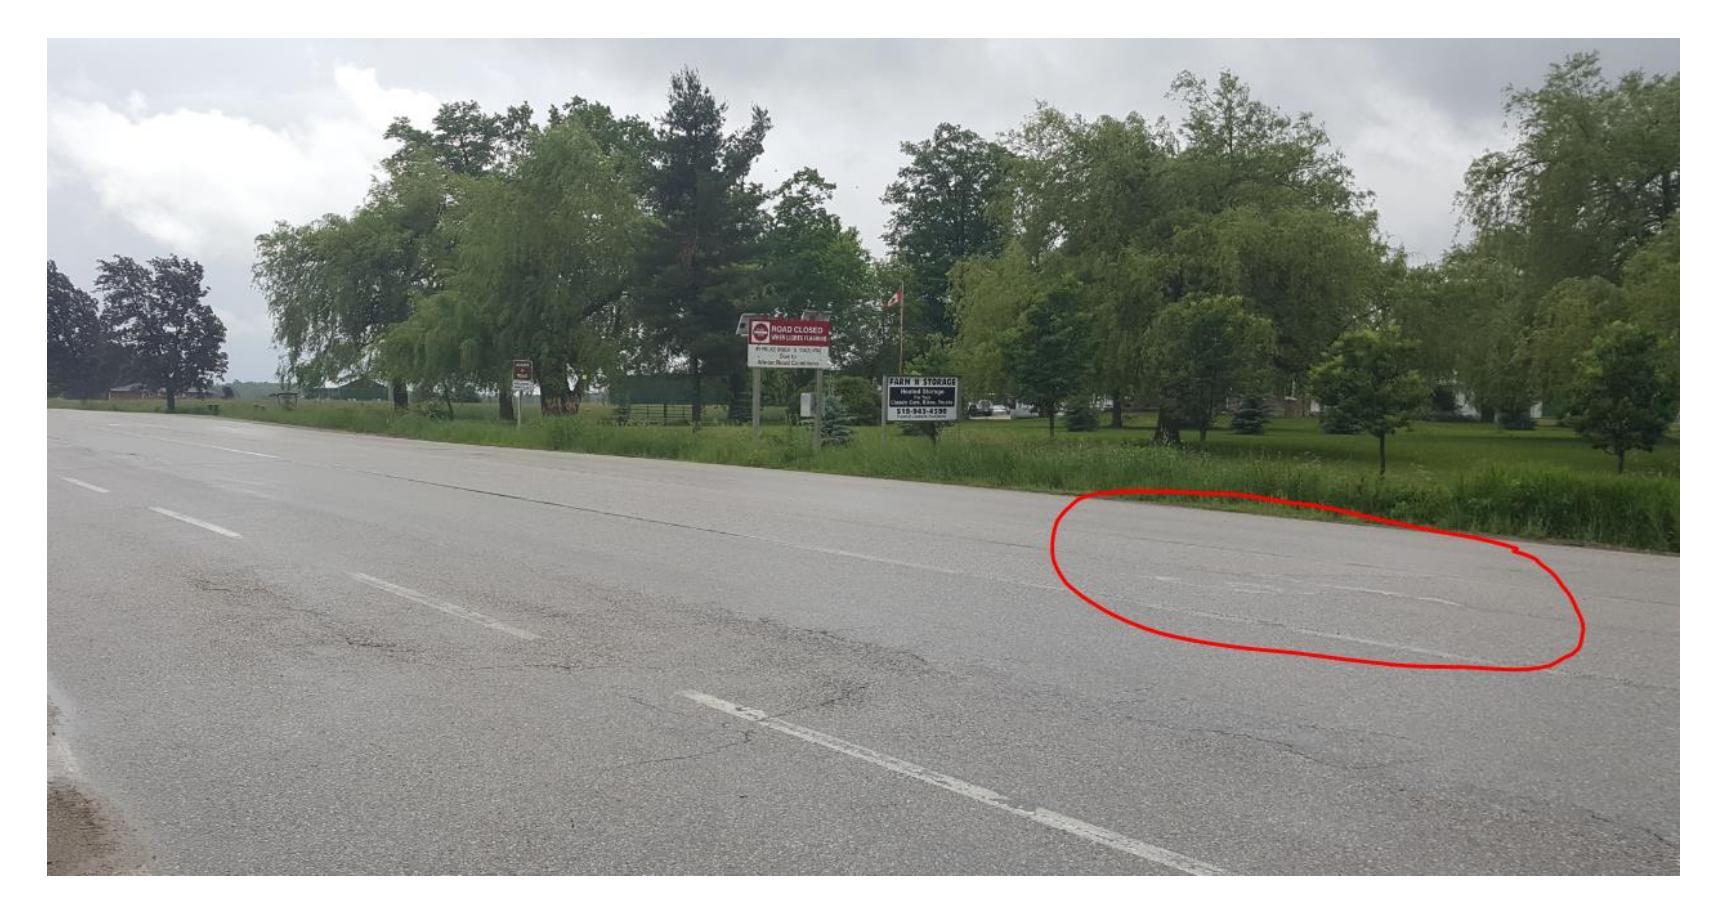
Exhibit 2: County Road 17 @ County Road 124 Northbound Trailing Left-turn Arrow (Looking South-west)

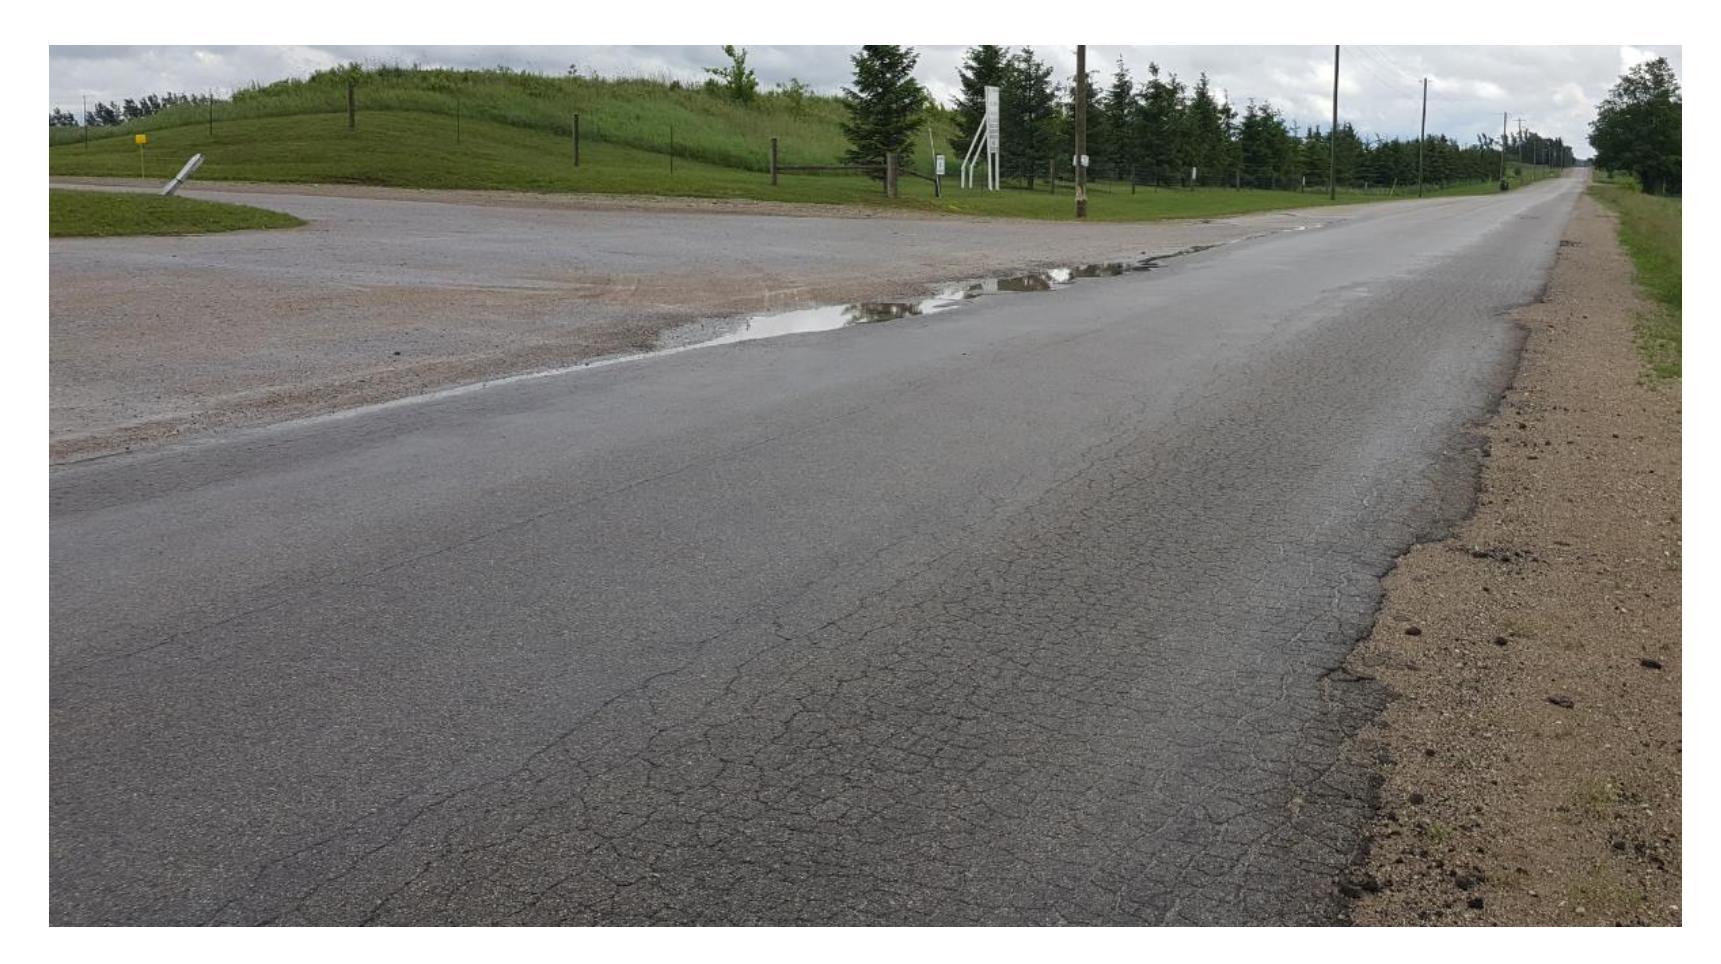
'Alligator cracking' is observed along the length of 4<sup>th</sup> line from the Northerly Driveway to County Road 17, from the edge of pavement towards the crown about 2 metres, and on both lanes of the roadway (**see Exhibit 3**).

In addition to the general pavement condition, there are some localized areas that are in poor condition due to unsupported pavement edges. Cracking is most prominent in the vicinity of the Northerly Driveway and to the south of the Northerly Driveway (see **Exhibit 3**). **Exhibit 3** demonstrates the likely problem (standing water/poor drainage) leading to the alligator cracking at this location and throughout the roadway.

Exhibit 3: Northerly Driveway 'Alligator Cracking' in the lane, standing water, and raveling pavement edges (Looking South)

It is recommended that the potholes located approximately 160 metres south of the northerly driveway on 4<sup>th</sup> Line be repaired. 'Alligator cracking' along 4<sup>th</sup> Line should be monitored for repairs in the future because they may become pot holes.

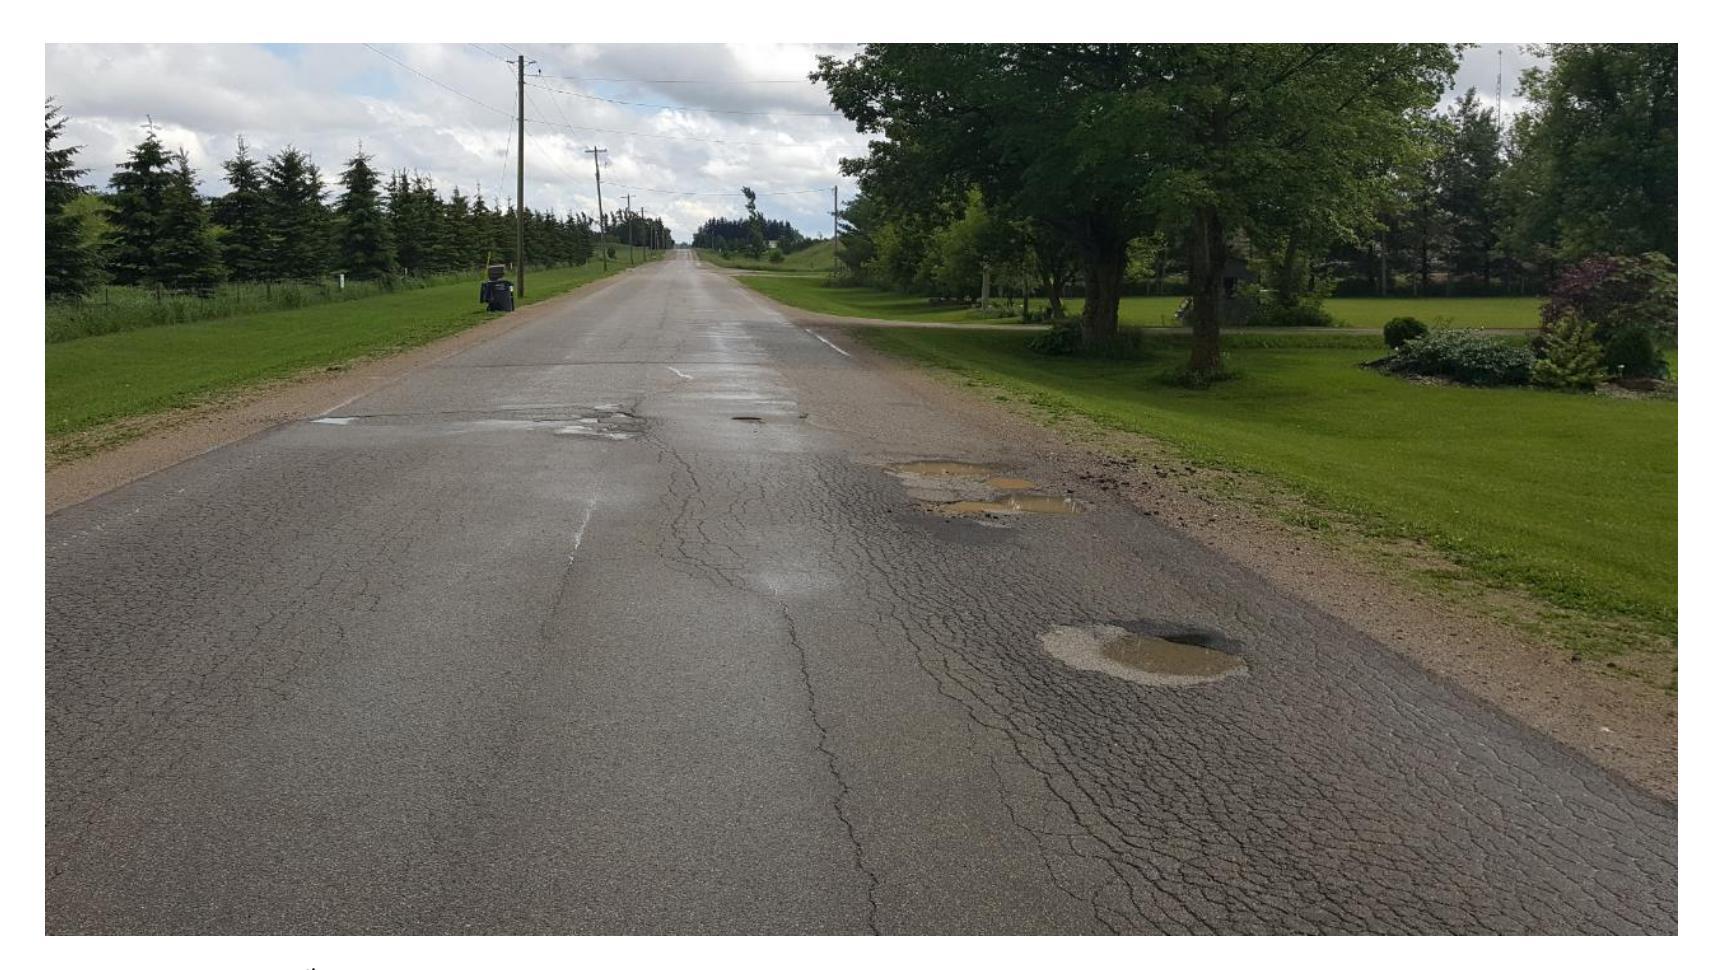
Approximately 160 metres south of the Northerly Driveway there are potholes and early signs of rutting in the roadway as shown in **Exhibit 4**.

Exhibit 4: Potholes on 4<sup>th</sup> Line Approximately 160 metres South of Northerly Driveway (Looking South)

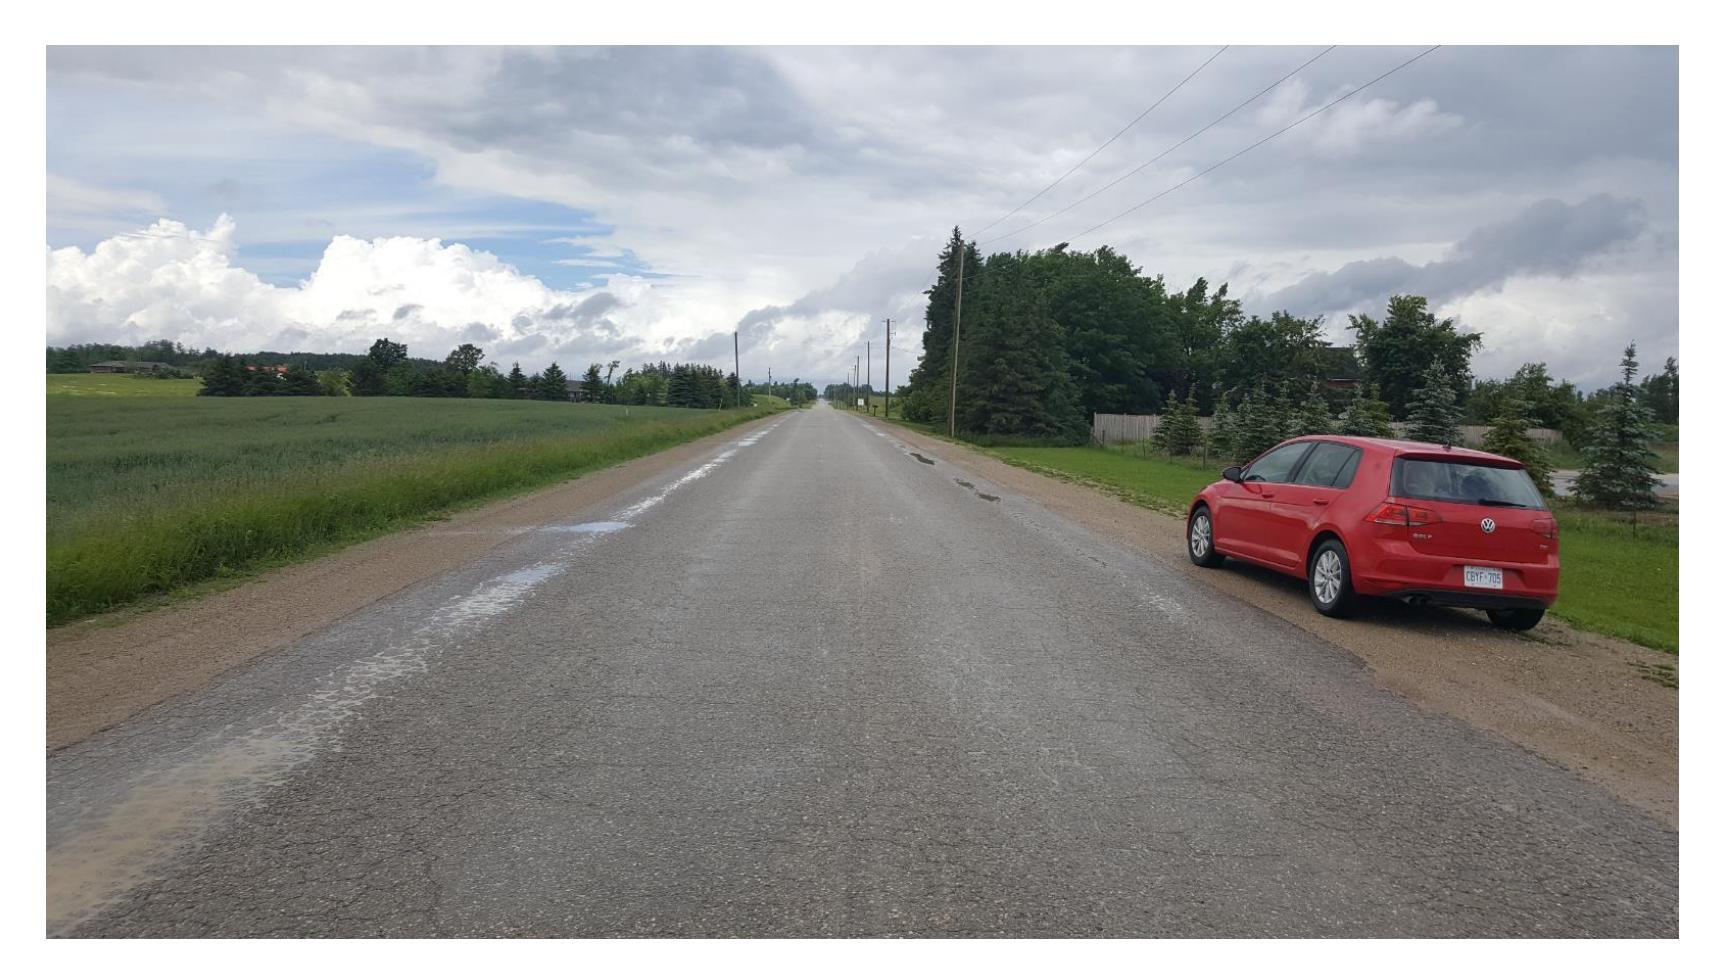
A similar 'alligator cracking' effect is occurring to the south in the vicinity of the Southerly Driveway, as shown in **Exhibit 5**.

Exhibit 5: Southerly Driveway 'Alligator Cracking' and Pooling (Looking North)

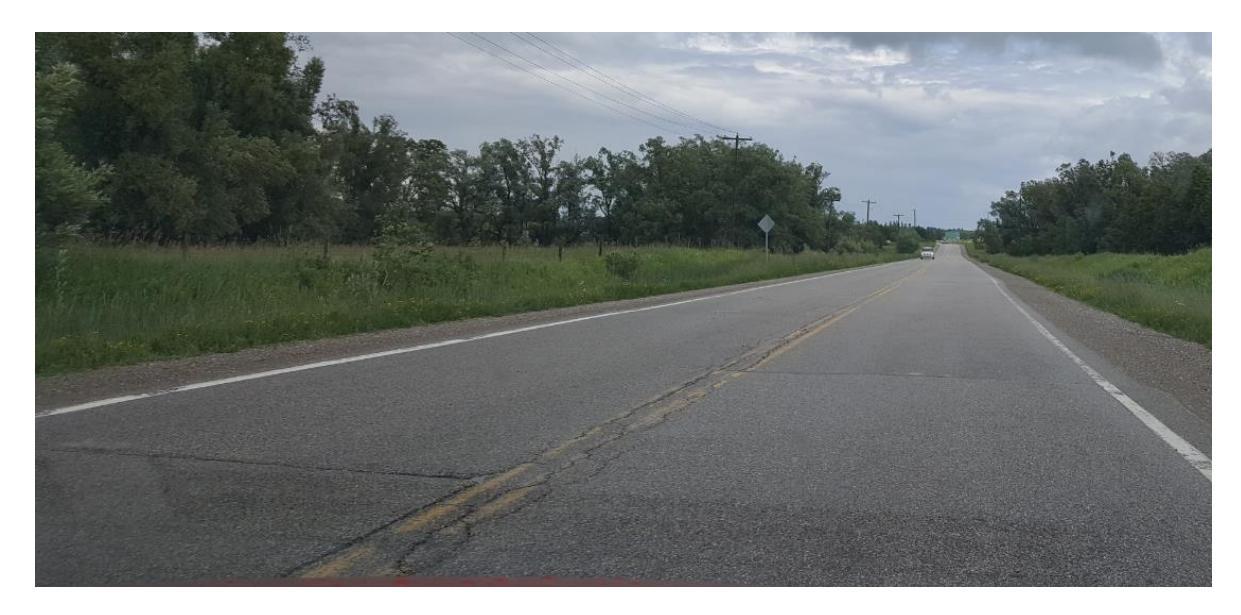
The pavement condition along County Road 17 can be characterized as good to fair. There are occasional transverse cracks in the pavement as well as longitudinal cracks along the centreline, but the pavement was observed to be in a stable and functional condition. The cracks do not appear as though they have been repaired but the condition is acceptable and should be monitored. Examples of transverse and longitudinal cracking along County Road 17 are shown in **Exhibit 6**.

Exhibit 6: Typical Transverse and Longitudinal Cracking along County Road 17 (Looking East)

The pavement condition along County Road 17 is generally acceptable and does not require immediate repairs. However, the cracking should be monitored as it could require crack repair at some future point.

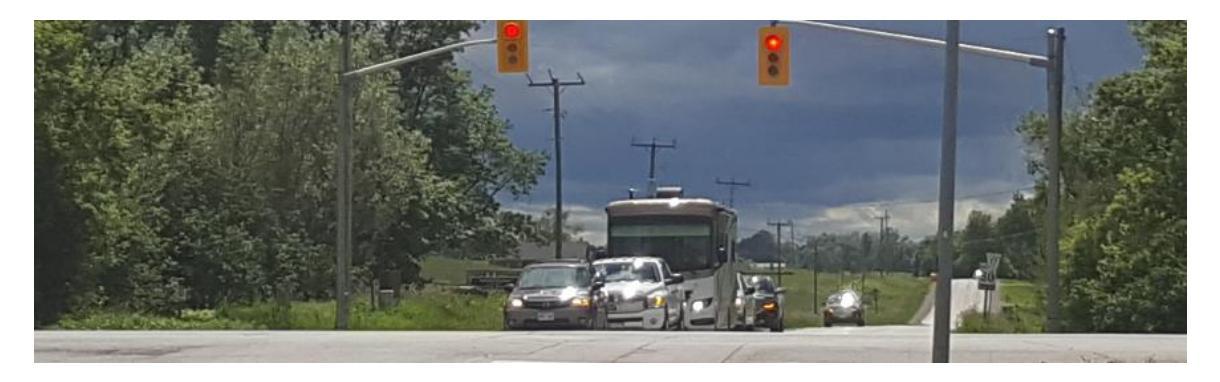
The observed six vehicle eastbound queue is shown in **Exhibit 7** with the sixth vehicle arriving but not yet queued. HDR staff confirmed that five of the six vehicles in the eastbound queue turned left. This queue was observed at 4:08pm.

Exhibit 7: County Road 124 @ County Road 17 Maximum Observed Eastbound Queue

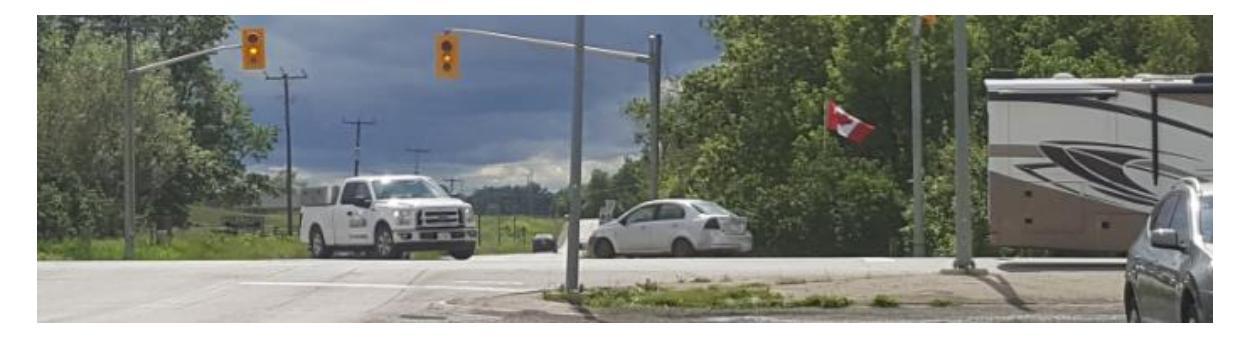
As shown in **Exhibit 8**, the vehicle behind the RV was able to clear the left-turn during the amber phase which means that two vehicles were unable to clear the queue. This was caused because the eastbound left-turning vehicle had to wait for the opposing westbound vehicles (**Exhibit 9**).

Exhibit 8: County Road 124 @ County Road 17 Maximum Observed Eastbound Queue Clearing

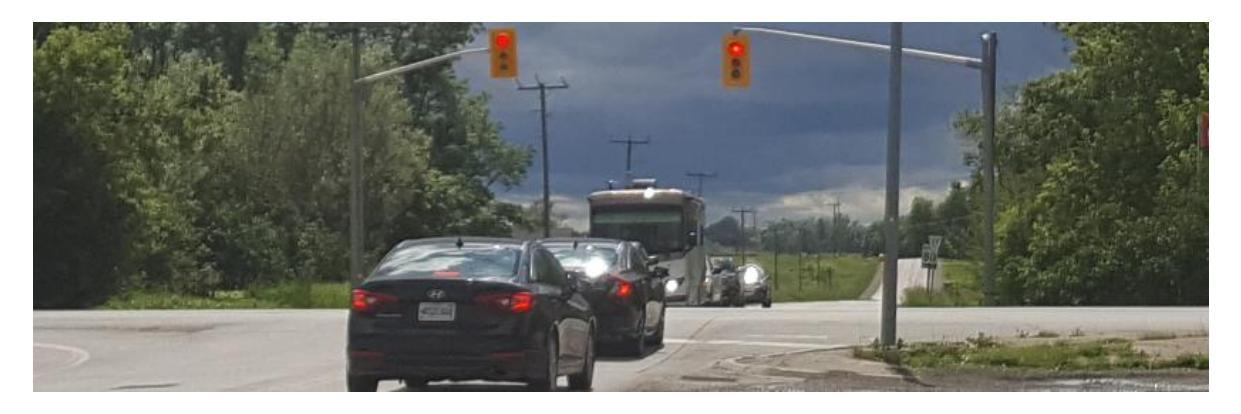
Exhibit 9: County Road 124 @ County Road 17 Eastbound and Westbound Opposing Queues
