July 2, 2025

AEC 17-178

Re: Review of Overburden Ground Water Levels, Melancthon Pit

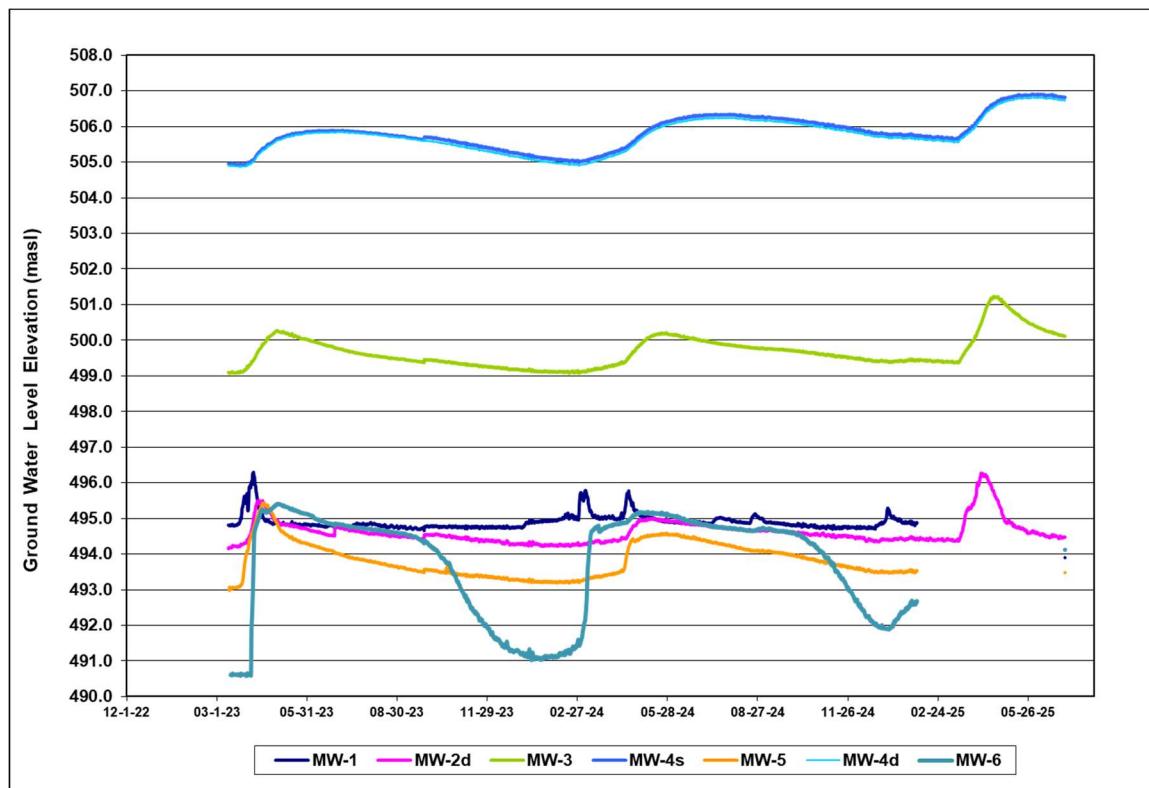
Chart A – 2023-2024 Water Levels

After drilling on March 15, 2023, water levels in MW-6 did not start to respond until April 23, 2023, a period of approximately 40 days. This initial period is interpreted to be the period when the well annulus was gradually infilling, and took time because the silt unit has lower permeability. Seasonally, the water levels in MW-6 dropped to approximately 491masl (~1m above the base) during the 2024 summer and to approximately 492masl (~2m above the base) during 2024-2025 winter. The water levels since 2024 have remained above the base of the screened zone. The hydrographs are shown in the following chart.

Therefore, the conclusion is reached that MW-6 remains saturated throughout the year, and is capable of providing a sentry function for potential hydrocarbon contamination.

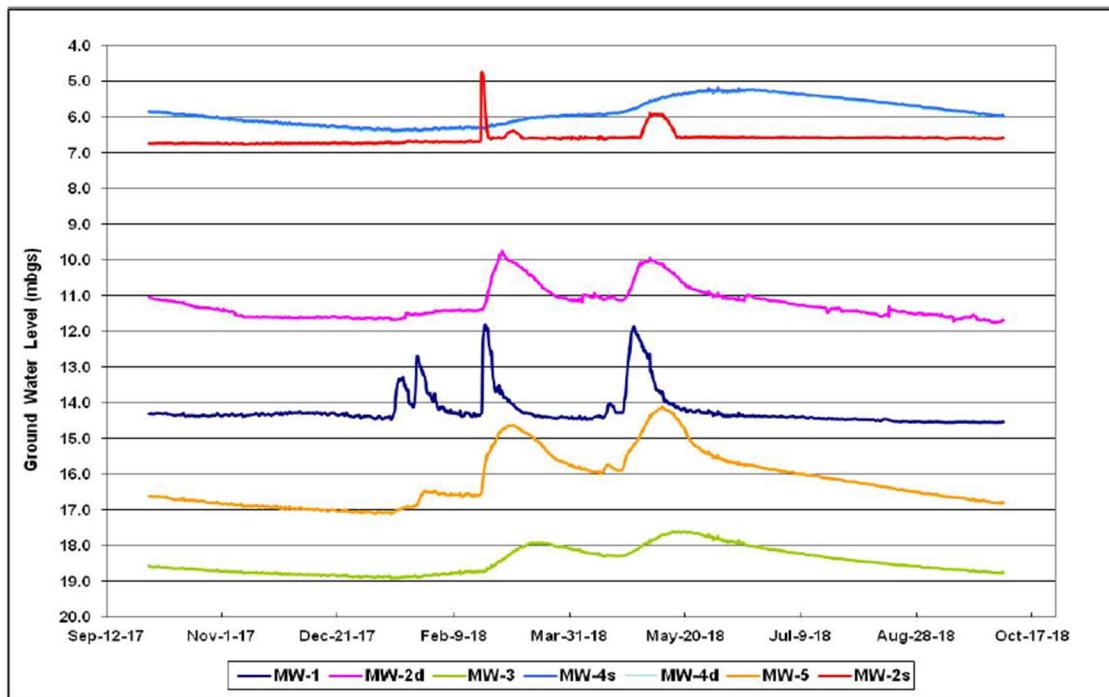
Chart B – 2017-2018 Water Levels

Based on the 2017-2018 data shown on the following hydrograph, it had been noted that the water table transitioned into the bedrock seasonally, notably at MW-1 and MW-2. In retrospect, only MW-2S shows that the water level is below the monitor (MW-2S flatlines), and the other data from MW-2D and MW-1 show that the water level is close to the bottom of the well but still present (i.e. still hydraulic responses).

The bedrock surface slopes downwards towards the east, and these locations represent higher areas of the bedrock to the south and west.
