CULTURAL HERITAGE **STUDY**

Part of Lots 12 & 14, Concession 3
Melancthon Township

Strada Aggregates Inc.

MacNaughton Hermesen Britton Clarkson Planning Limited (MHBC)

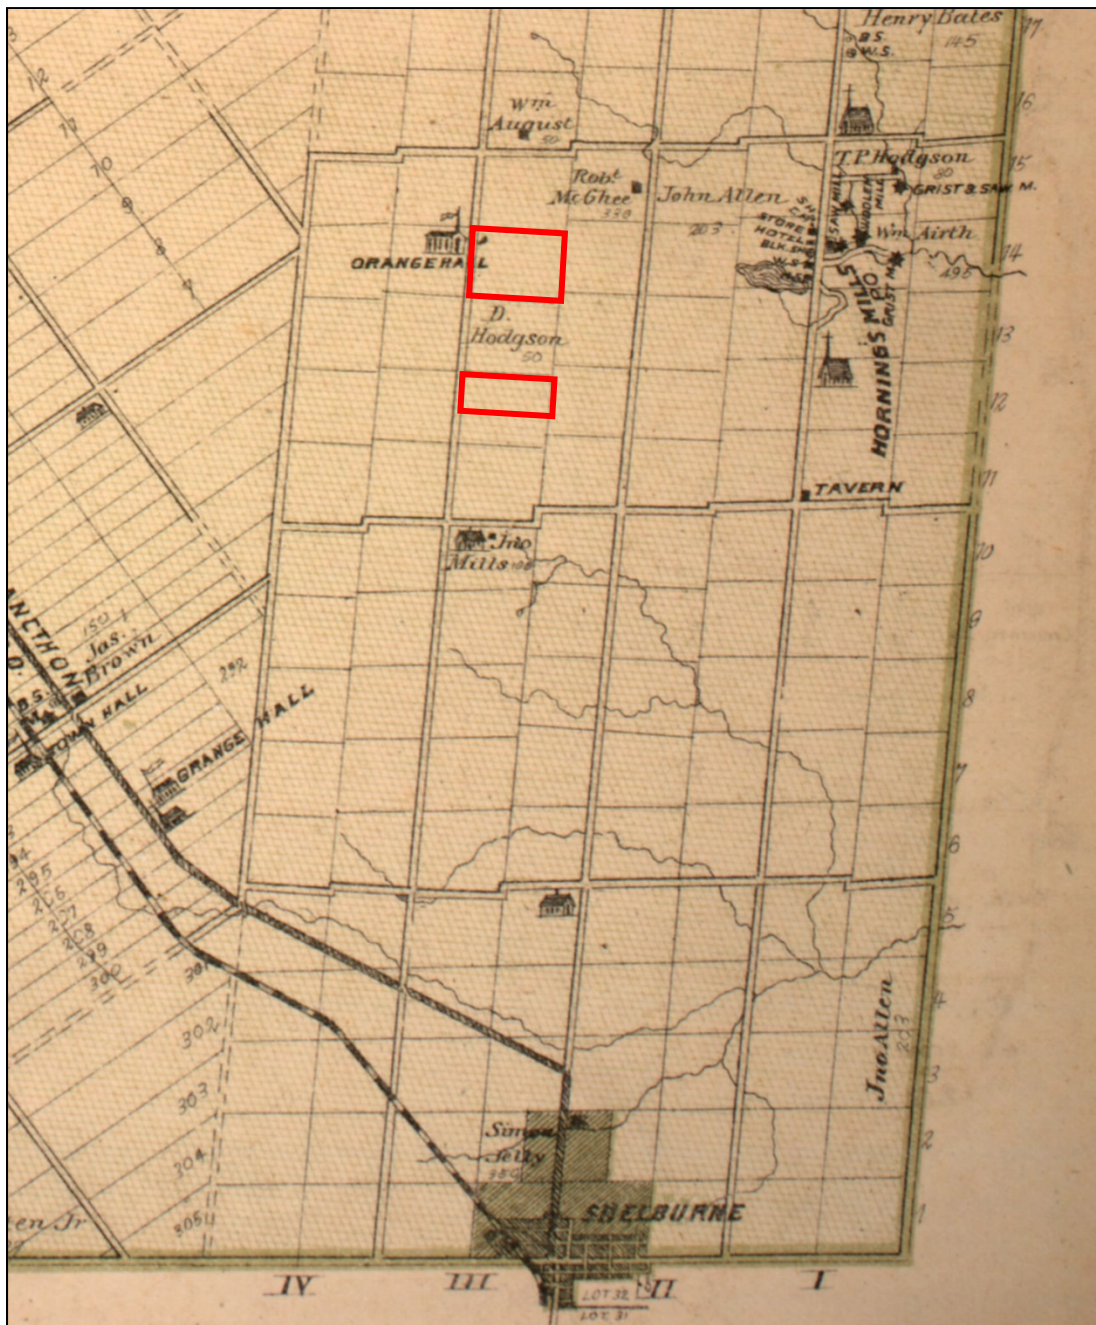
Figure 2 – Excerpt from Historical Atlas of Grey County

Mapping from the 1880 *Illustrated Historical Atlas of Grey County* shows no buildings or structures located on the subject lands, and no ownership information is provided. Based on this information and the architectural style of the house located on the northern (Prince) property, it would likely have been constructed between 1880 and 1900. The Gothic Cottage style house was most popular between the 1860s and 1880s, and as no building is evident from the 1880 Historical Atlas, it is reasonable to assume a construction date in the late 1880s.

The subject lands are located within the area covered by the ‘Old Survey’, as shown in the *Illustrated Historical Atlas of the County of Grey* (see **Figure 2** below)

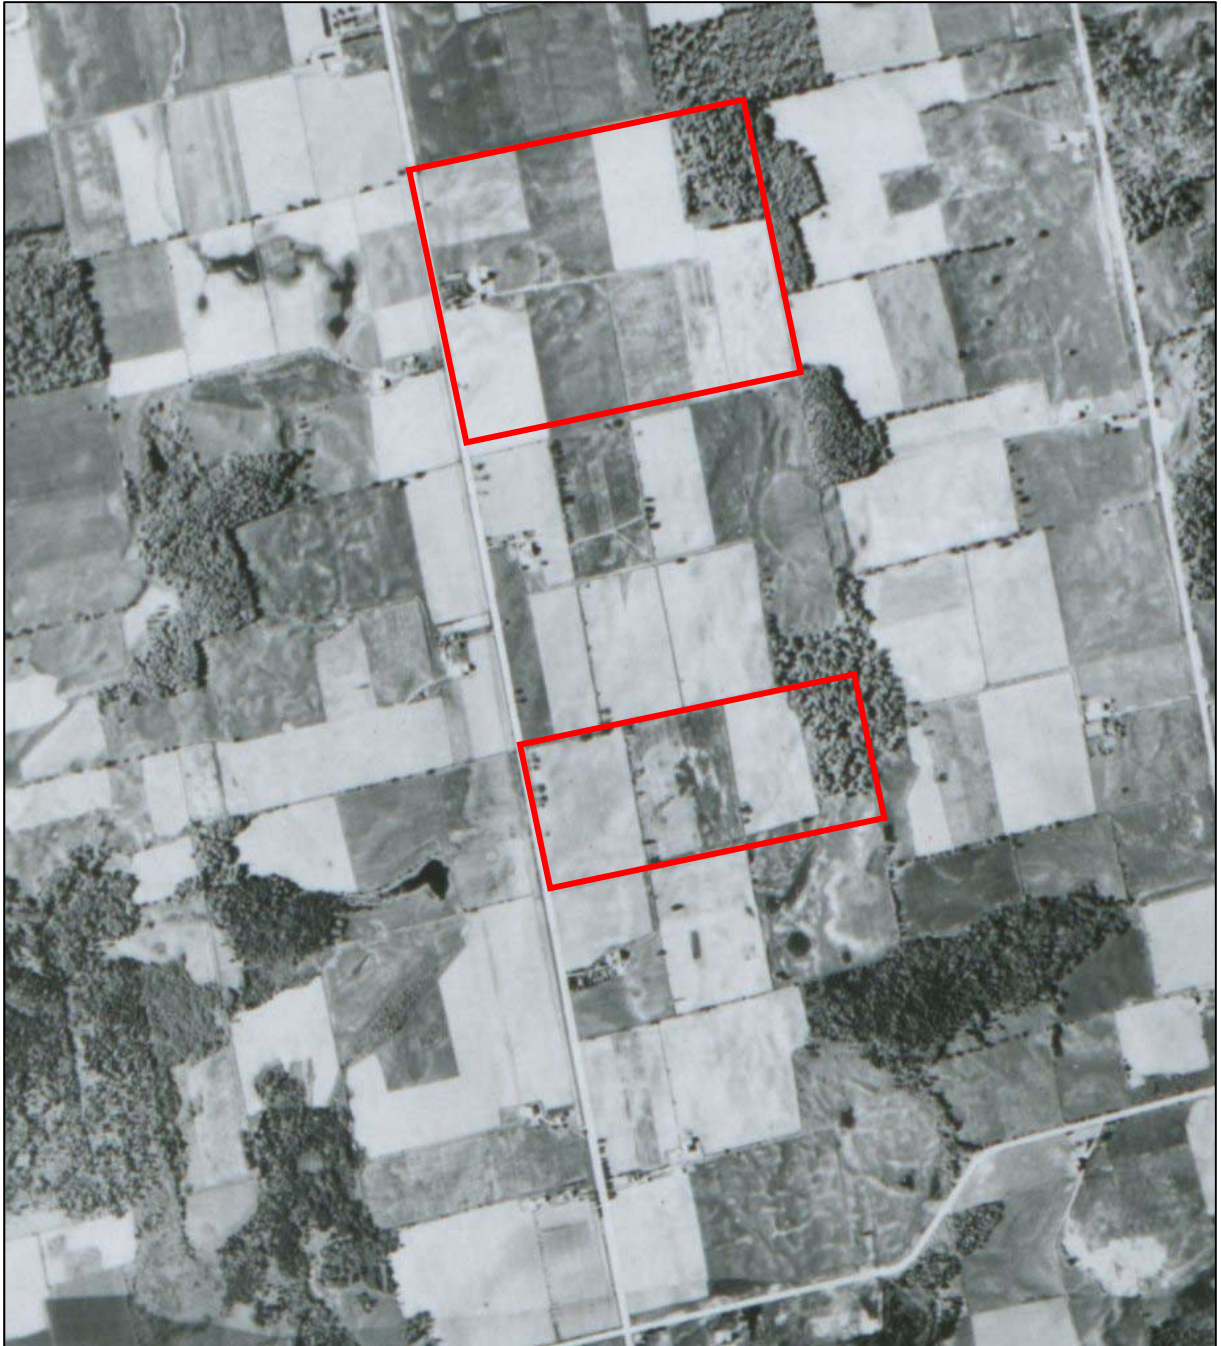
Figure 3 – Excerpt from 1954 aerial photograph

Based on a review of the information, it is apparent that there are no structures located on the southern (Bonfield) property which suggests that the property was used in conjunction with

the surrounding agricultural operations. Field divisions are also shown in a pattern similar to which exists today. Regarding the northern (Garner) property, a cluster of buildings is located amongst a group of trees in a similar location as found today. Field divisions are also evident. The plantation located at the rear of the property has not yet been planted.

A review of more recent aerial photographs was undertaken in order to determine the site features present in later decades on the subject lands. The 1954 set of aerial photographs undertaken by Hunting Survey Corporation on behalf of the Province of Ontario are of good quality and show the site features quite well. An excerpt from the compilation covering this portion of Melancthon Township is shown below as **Figure 3**.

The 1954 aerial photo (see **Figure 3**) shows that at that time, the property was cultivated with several different crops. There did not appear to be established fencerows between the fields, except at the borders of the property. Field divisions are quite different as compared to those which exist today (see **Figure __**). In the later 20th century, a plantation was established in the southeast corner of the property and it exists today.

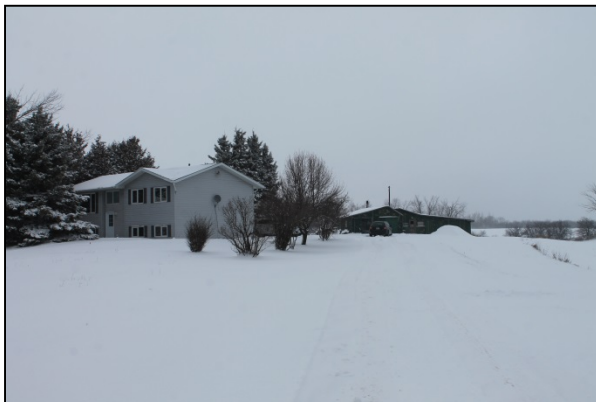
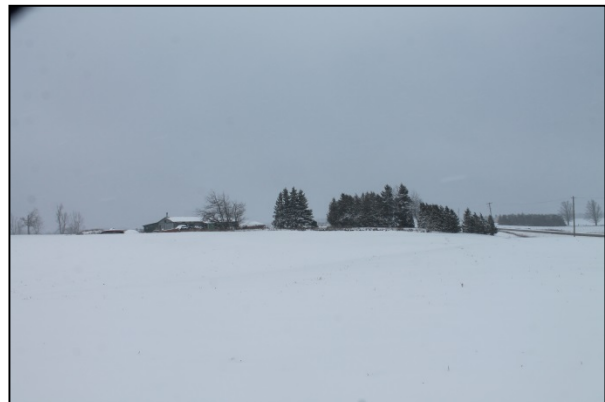
The southern (Bonneyfield) property contains a residential dwelling set back from 4th Line and accessed by a driveway located south of the dwelling. Several low rise outbuildings are located to the rear of the house. The majority of the property is utilized for agricultural purposes.

Photos 1 & 2 – Views of the building cluster from the south and north (MHBC, 2016).

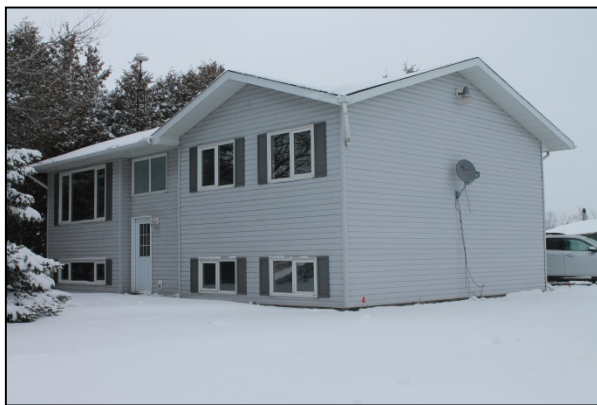
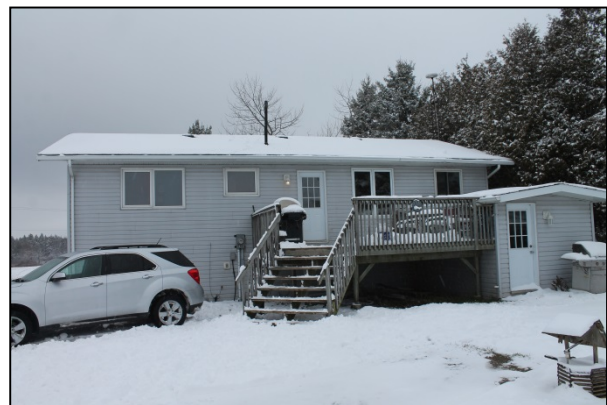
The residential dwelling on the subject property is a raised bungalow structure. The building features a cross gable roof and a dormer at the front of the building, facing 4th Line. The house appears to date from the mid-late 20th century.

The main elevation of the building addresses 4th Line, with the majority of windows also facing this direction. A door is located in the centre of the elevation, with windows on either side of the door and corresponding to the basement and main floor of the house.

The rear (easterly) elevation of the home also features a door that is accessed from a deck on the upper level of the home. Windows are located on either side of the door and only on the upper level of the building. The rear elevation also features a storage building located immediately adjacent to the main dwelling.

Photos 3 & 4 – Views of the front (west) and rear (east) elevations of the residential dwelling (MHBC, 2016).

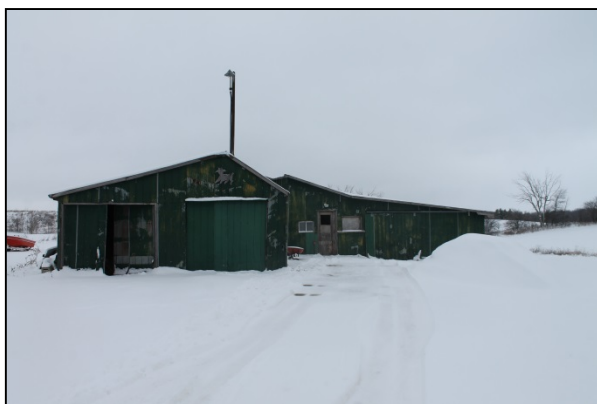
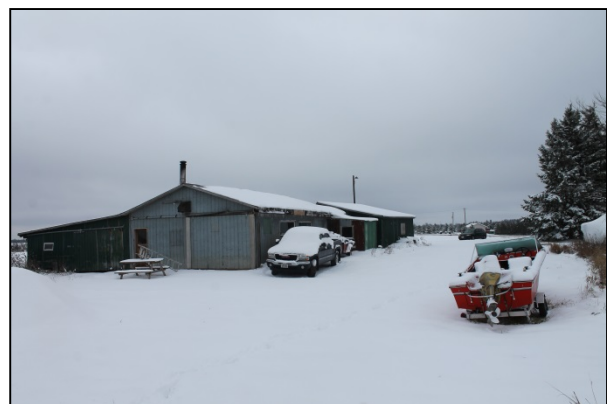
Northeast of the house is an assemblage of small single-storey outbuildings that are used for storage purposes. They are clad in wood and steel.

Photos 5 & 6 – Views of the outbuildings from the west and east (MHBC, 2016).

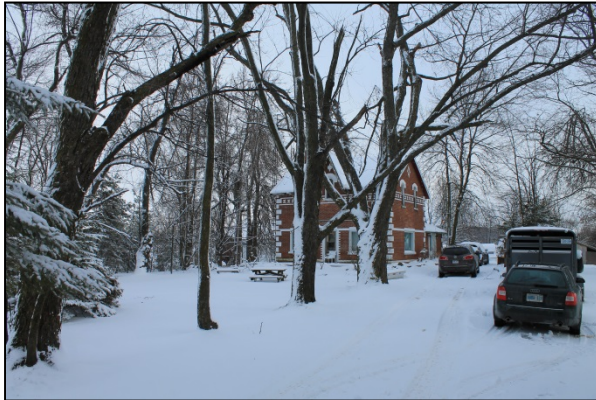
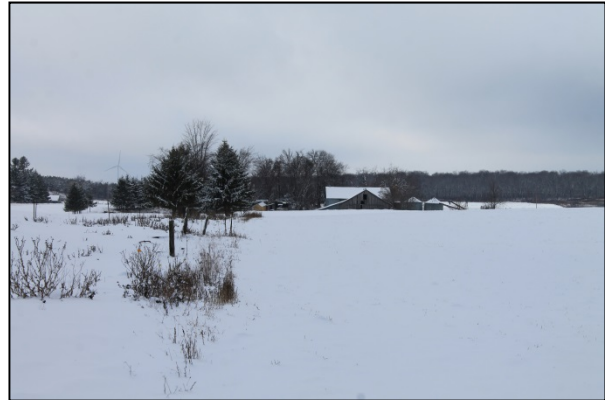
The northern (Prince) property contains a residential dwelling and related agricultural buildings set within a treed area located near 4th Line. The property is accessed by a looped driveway that encircles the house on three sides and passes between the house and outbuildings. The balance of the property is utilized for agricultural purposes, consisting of cropland and pasture areas.

Photos 7 & 8 – Views of the house from the west (4th Line) and of the building cluster from the south (MHBC, 2016).

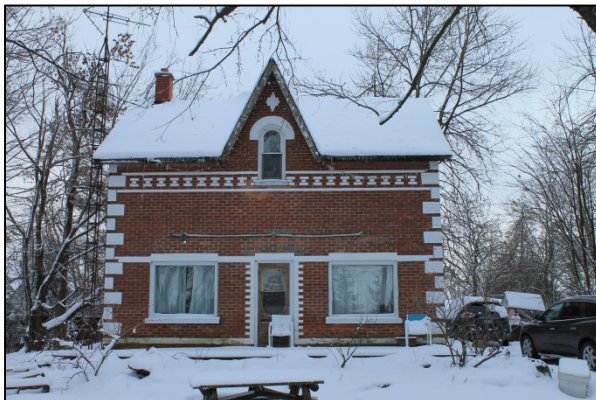
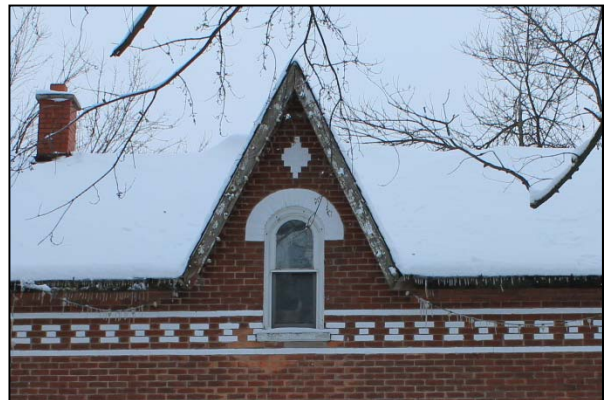
The residential dwelling on the subject property is a one-and-one-half storey structure with a cross gable roof. The original structure is T-shaped, and features an addition located on the east side. The house is representative of the Ontario Gothic Revival Cottage style of architecture, which was popular in the second half of the 19th century, particularly for rural dwellings.

The west elevation features a symmetrical façade with a central entrance door and windows on either side. Above the entrance is a steeply pitched centre gable with wooden bargeboard. A rounded arched window is located in the centre gable. Coloured brick detailing is found above the arched window, in the corners of the elevation, and in a band across the second storey. The windows and door are contemporary replacements.

Photos 7 & 8 – Front elevation and brick detail at upper level (MHBC, 2016).

The house has design or physical value because it is a representative example of an Ontario Gothic Revival Cottage style of architecture. This style of architecture was popular in rural areas in the 19th century, and there are many examples in the surrounding countryside. The house features several notable design features, including brick window hoods, rounded arch windows, brick quoins on the corners of the house, and a diamond-shaped decorative brick feature on several facades. The house is associated with the theme of early agricultural settlement in the Township of Melancthon. In addition, the house retains its historic and physical relationship to 4th Line, and is connected to the road via two driveways. The house appears to be in good condition and is proposed to be retained as part of the redevelopment of the property. Potential uses for the house include residential uses and/or a site office for the aggregate operation.

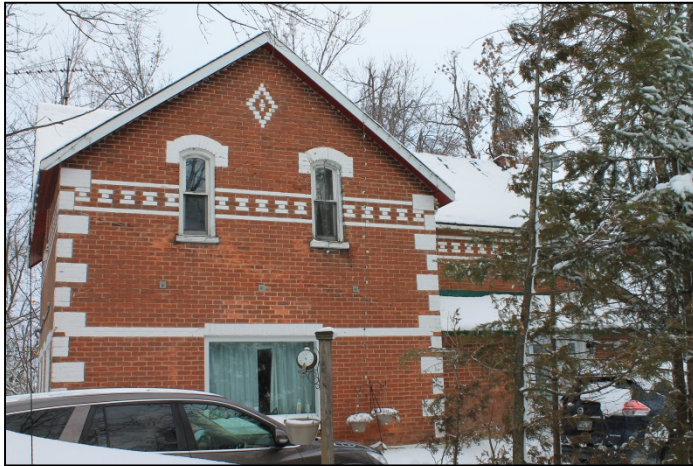
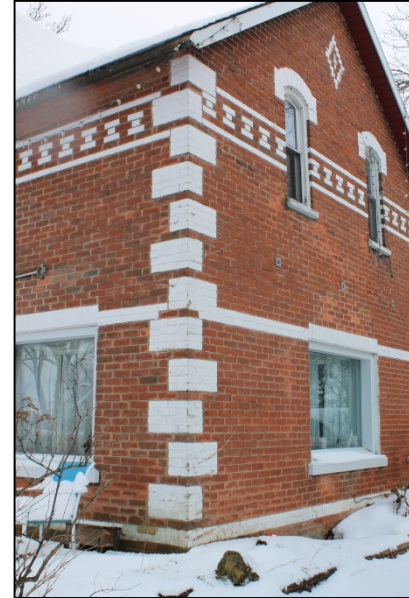
The south elevation includes a side gable section that features two arched windows on the upper storey. In the gable there is a decorative painted diamond brick pattern, painted striping, and painted brick hoods over the upper windows. The main floor has a replacement picture window. The rear wing of the house features a side entrance from a single storey addition.

Photos 9 & 10 – Photos of the south elevation of the house (MHBC, 2016).

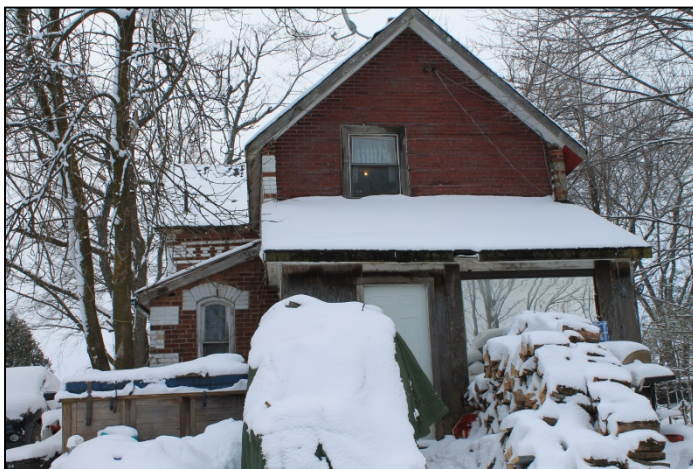
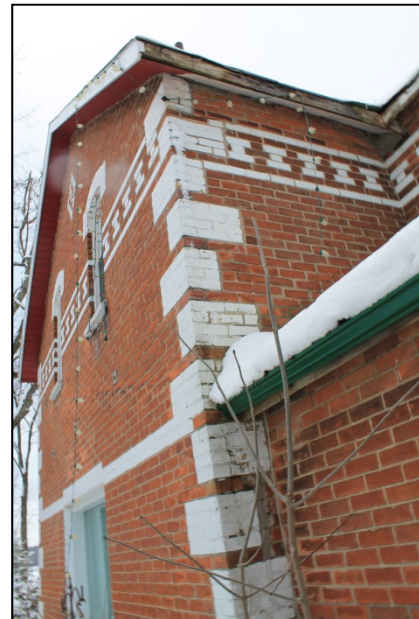
The east (rear) elevation of the house features an east-facing gable with a window on the half storey. There is a single storey lean-to addition at the rear of the house, with a woodpile along the east wall. The one storey east elevation projects beyond this section. Decorative brickwork is contained along the rear portion of the main house.

Photos 11 & 12 – Photos of the east elevation of the house (MHBC, 2016).

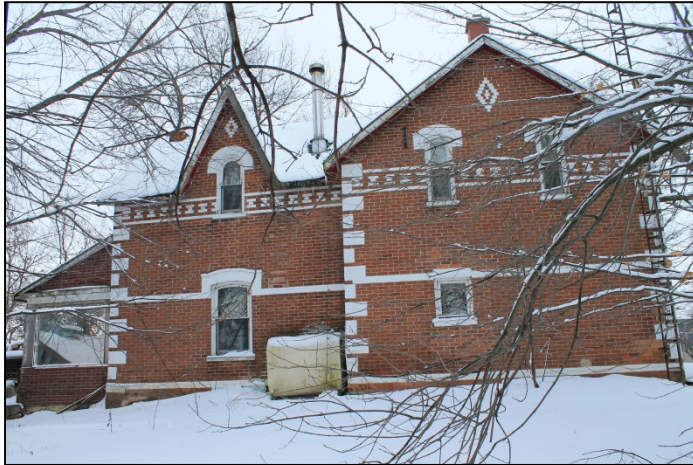
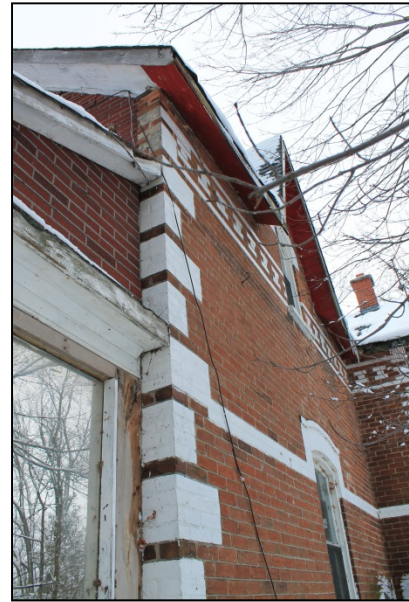
The north elevation features an arch window and a small square window on the first storey, and three rounded arched windows in the upper storey. Two windows are located on the main house and one in the gable of the rear wing. An interior brick chimney is located in the centre of the gable, and a newer metal chimney is located on the rear wing. The lean-to brick addition at the rear features one rectangular window. The same painted brick quoins, window hoods and diamond pattern in the gable are found on this elevation.

Photos 13 & 14 – Photos of the north elevation of the house (MHBC, 2016).

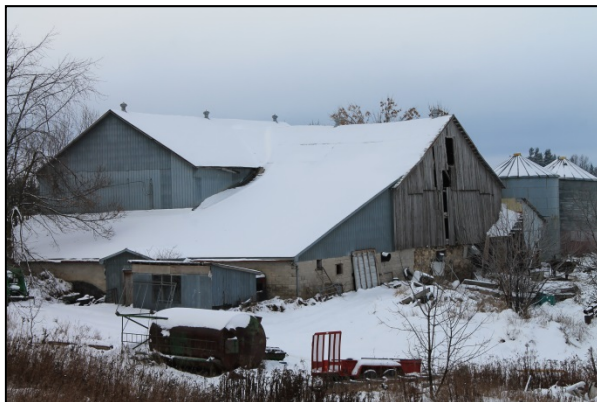
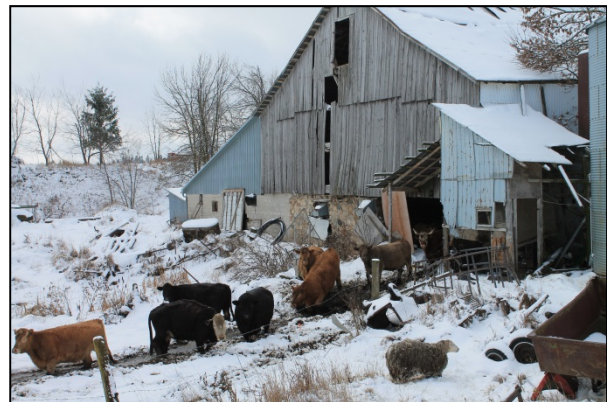
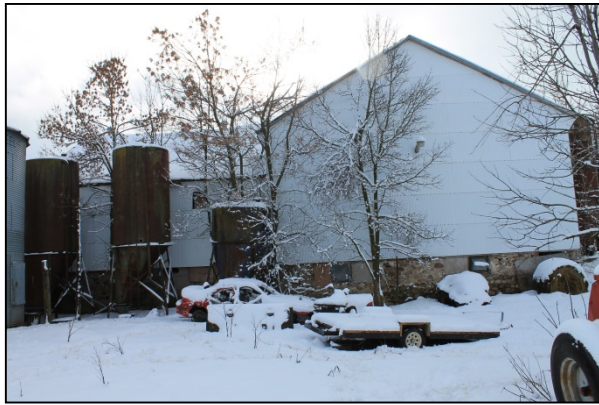
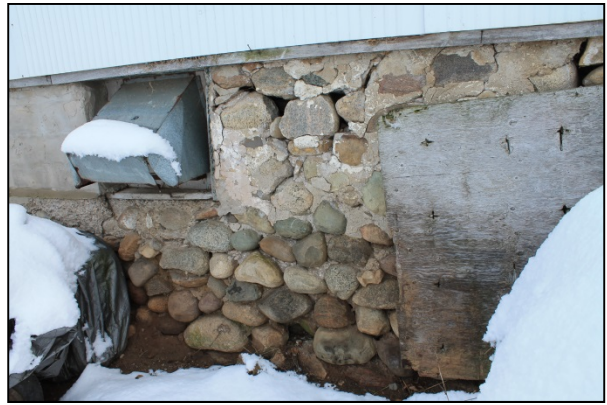
Northeast of the house is a barn complex that has continued to evolve over the years as evident from the various additions and lean-to structures. Portions of the barn feature rubble stone foundation and other portions are concrete block. Wall cladding is a mixture of ribbed steel siding and wood planks. The barn has several window and door openings on all sides. Clapboard siding is missing in several locations. Portions of the barn complex appear to be used for storage and also for livestock. Some of the area around the barn complex is also used by livestock.

Photos 15 - 18 – Photos of the barn exterior (MHBC, 2016).

The barn complex has some design value because it is representative of an early agricultural building within the Township of Melancthon. However, the barn does not feature any notable architectural features that would distinguish it from other buildings in the area, and it has been modified significantly through more recent additions and repurposing. The barn has some associative value because it, like the house is associated with the early agricultural settlement of the area. The barn retains some context to the house and surrounding lands. The condition of the barn complex is generally poor, and it is proposed to be removed as part of the redevelopment of the property.

The barn complex and outbuildings are proposed to be removed through the aggregate extraction operation. The barn complex and outbuildings are considered to have low cultural heritage value and is in generally poor condition.

- The potential for the use of the barn and outbuildings as salvage materials should be explored. This could occur as part of onsite activities or through other means.
- A conservation plan for the house is recommended to be prepared in order to ensure that the heritage attributes of the house are retained. It is recommended that this occur at the commencement of site operations on the Prince property.
- Site rehabilitation as shown in **Figure 6** is recommended in order to provide additional context and yard area surrounding the house. This will assist in a viable long-term after-use for the house.

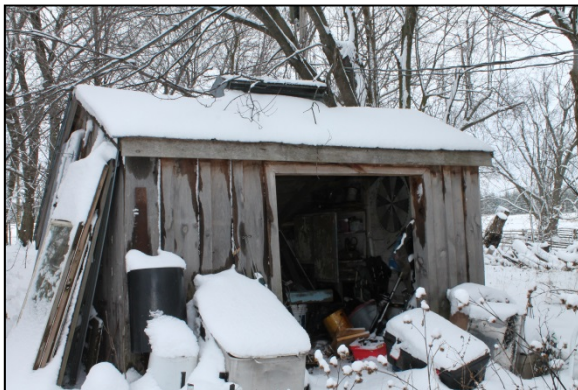
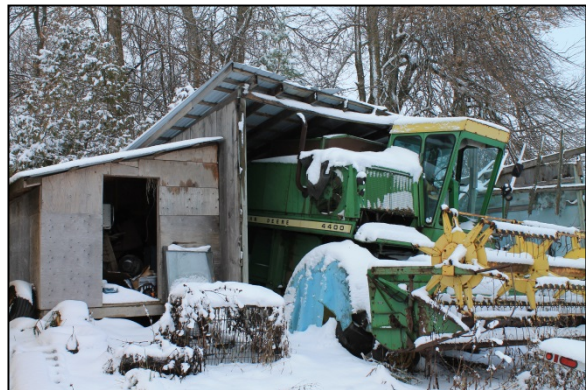
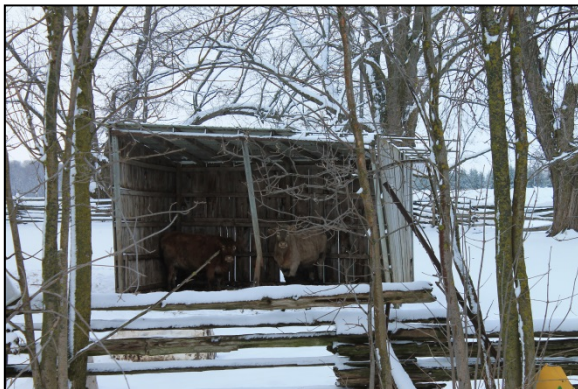
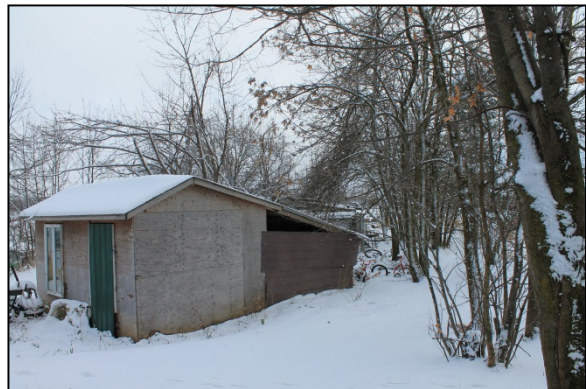
The property contains several other outbuildings from various eras, including silos, storage buildings and a small shed within a pasture. The buildings are generally in poor condition.

Photos 19 – 22 – Photos of the recent workshop and two vehicle garage (MHBC, 2016).

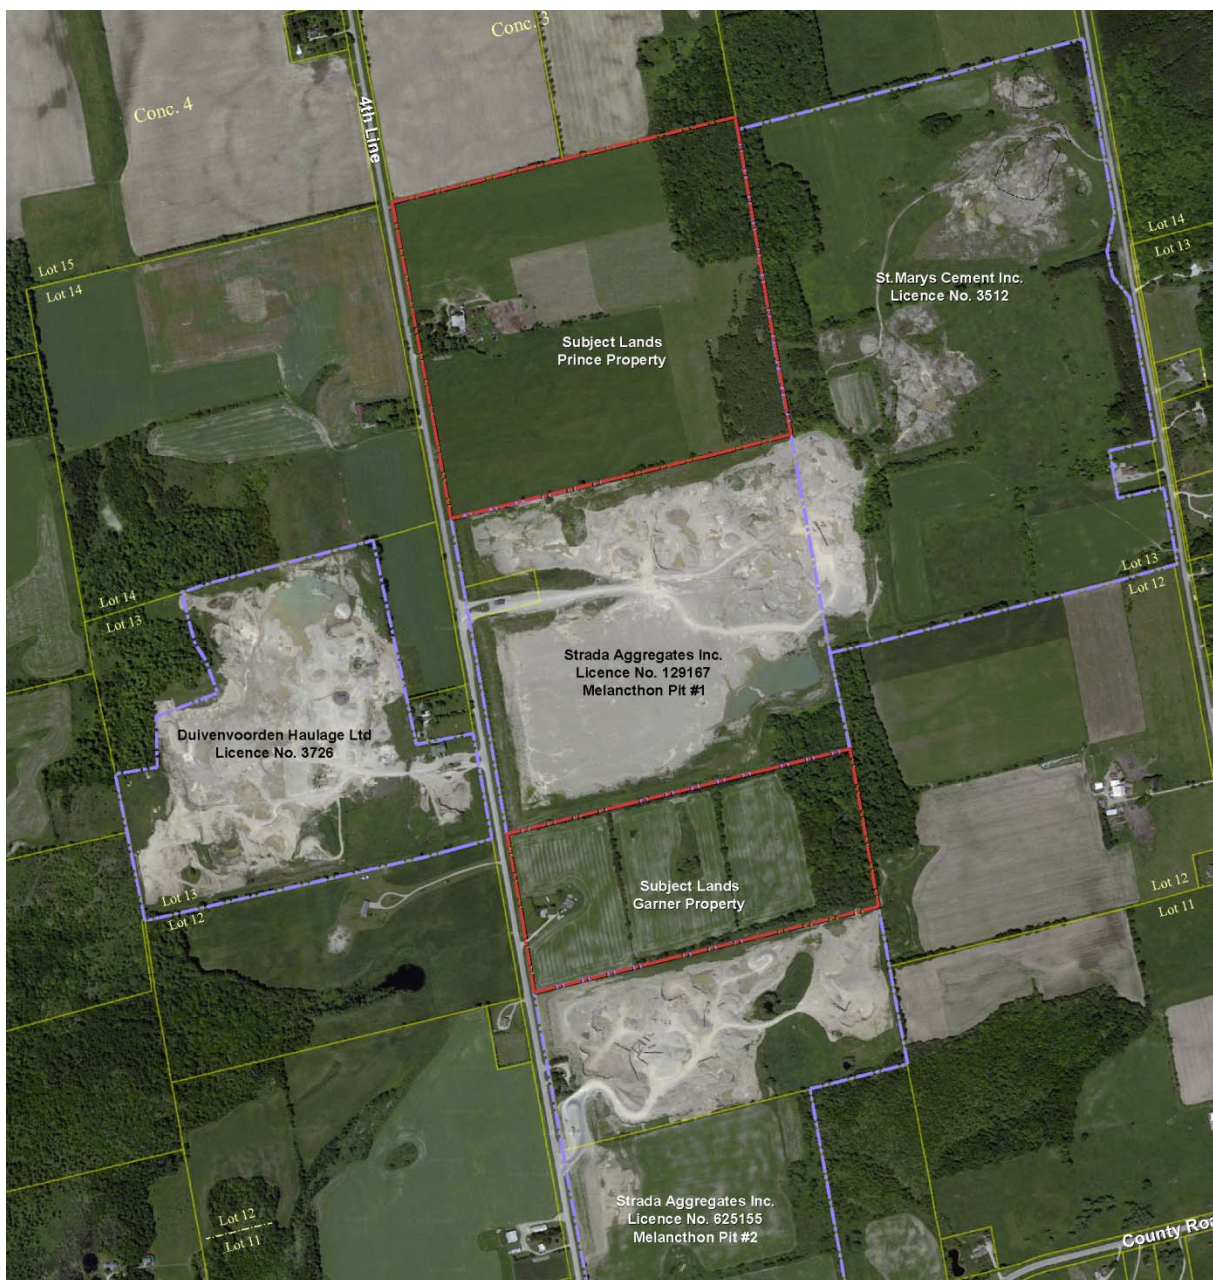
Figure 4 – 2015 aerial photograph showing subject sites and surrounding context (source: MHBC)

The subject lands are situated in an agricultural area that has continued to evolve in the decades since this portion of Melancthon Township was originally settled. The surrounding area is characterized by farm-related and non-farm-related dwellings, agricultural buildings, and aggregate extraction operations. **Figure 4** (below) provides the current site context.

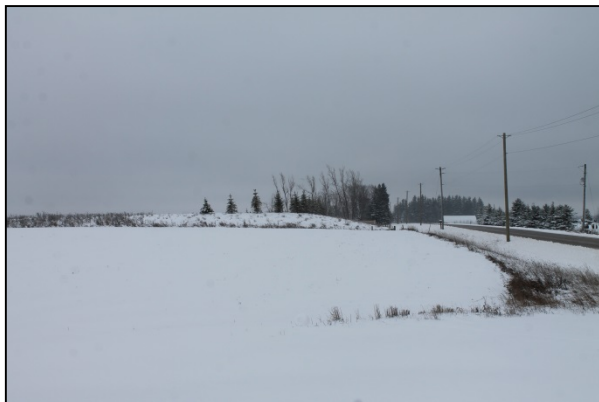
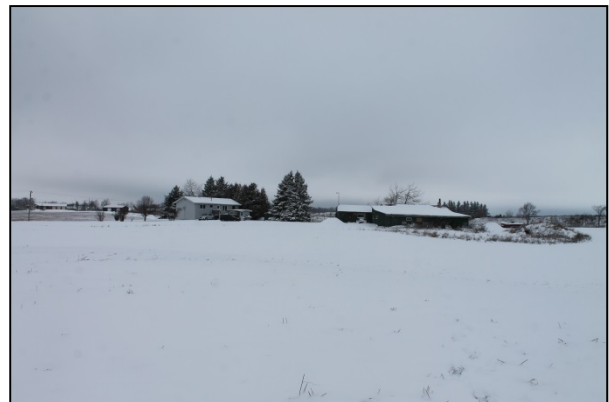
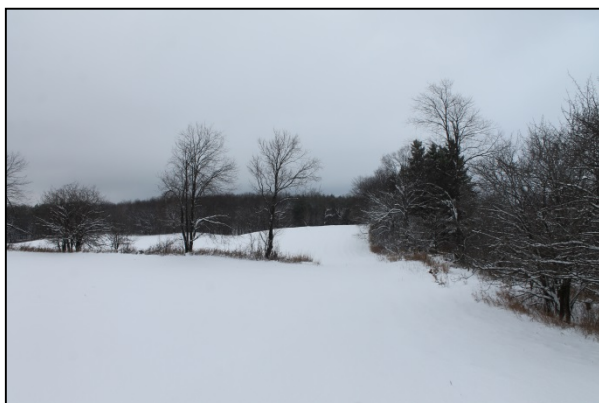
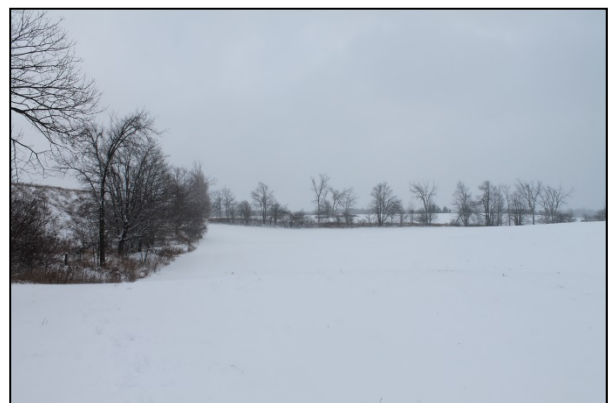
The field pattern surrounding the buildings has remained similar to that which existed in the mid-20th century. There are hedgerows between the field divisions. Fencing is located around the perimeter of the property, and berms are provided adjacent to the abutting aggregate operation.

Photos 23 - 26 – Photos of the agricultural field pattern and plantation areas (MHBC, 2016).

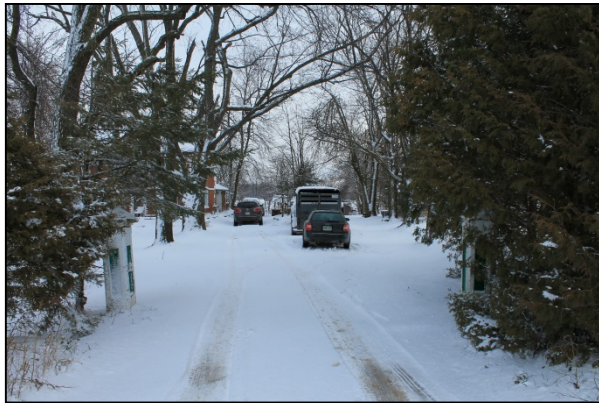
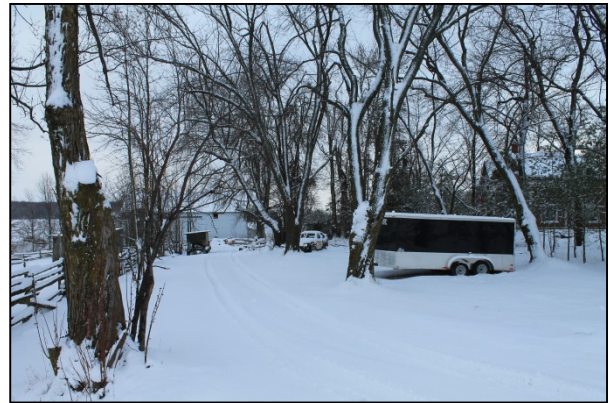
The house is situated along a tree-lined driveway with entrance posts, and is surrounded by trees that are a mix of coniferous and deciduous varieties. In addition to the house previously described, the property contains a barn complex and several smaller outbuildings. There are two lanes that enter the property north and south of the house, and they connect together to form a loop connecting the buildings. It appears that the driveway configuration has been modified over

Photos 27 & 28 – Photos of the two driveway access points to 4th Line (MHBC, 2016)

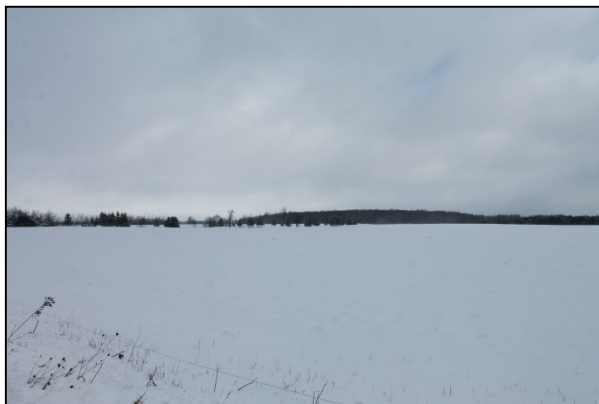
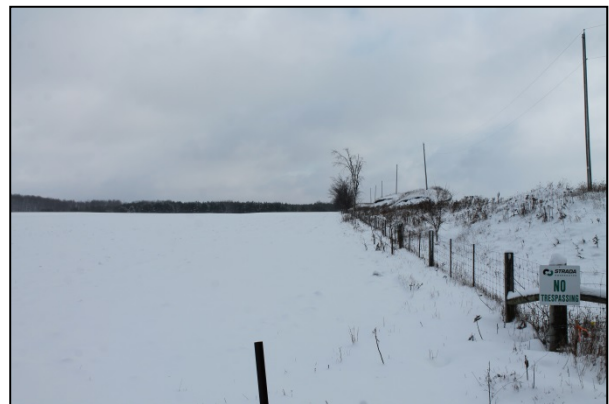
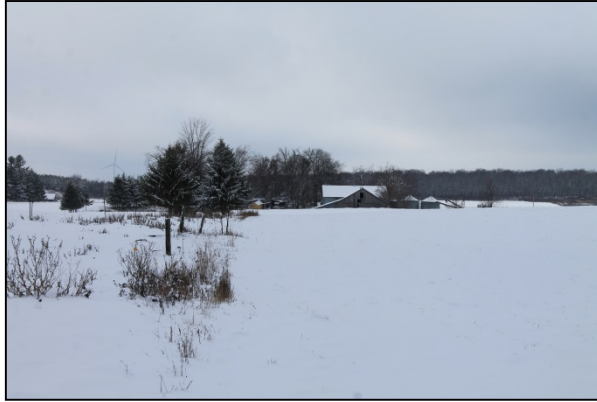
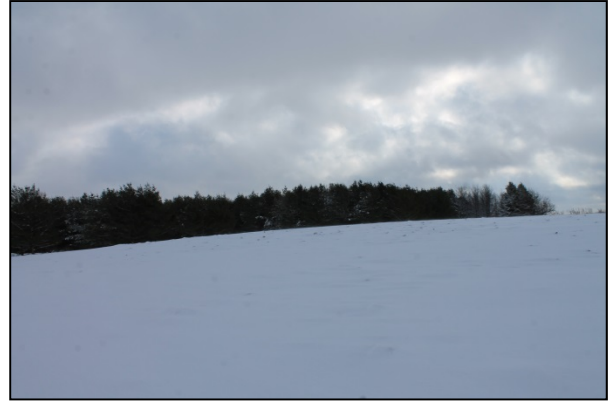
The field pattern surrounding the farm buildings has been modified in the past, and the agricultural lands have mostly been consolidated into one large field. Fences exist along the perimeter of the lands, and a hedgerow extends east from the barn complex. Berms are located along the property line adjacent to the abutting aggregate operation.

Photos 29 - 32 – Photos of the agricultural field pattern and plantation areas (MHBC, 2016).

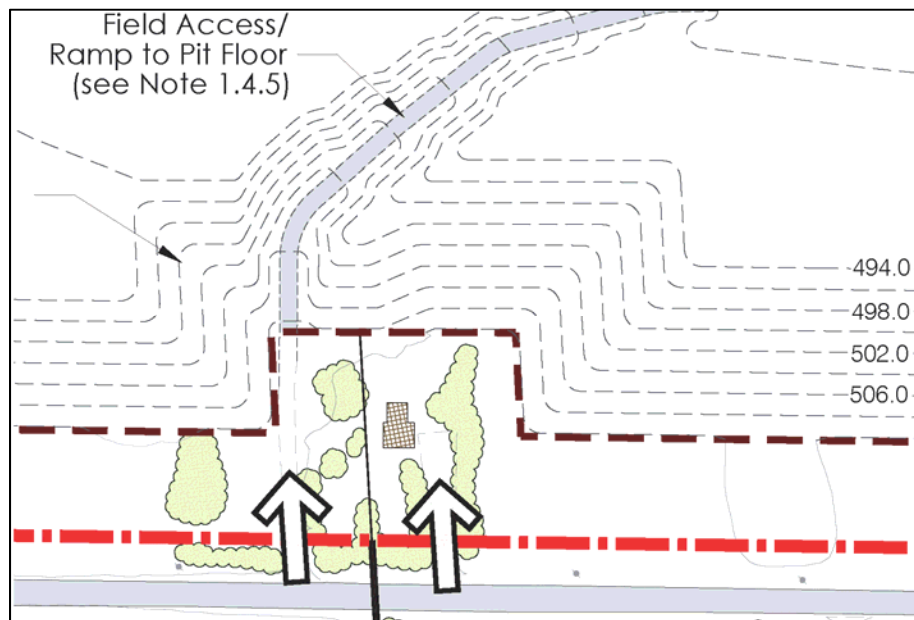
In order to provide additional context for the house, the rehabilitation of the site will create an expanded yard area on the three sides of the house adjacent to extraction operations. The increased setback will provide approximately 20 m from the rear of the house to the start of the slope down to the agricultural lands. The additional space around the house will provide an increased yard area, and assist in ensuring a viable after-use for the dwelling post-extraction.

Figure 6 – Final site rehabilitation and house / yard context.
