**RE: VISUAL IMPACT ASSESSMENT STUDY for HORNING'S MILL'S DEVELOPMENT
RESULTS OF LEAF OFF STUDY (STAGE 2, REVISION 1)**

VM1 HORNING'S MILLS VISUAL IMPACT ASSESSMENT VIEWSHED MAP

S.1 HORNING'S MILLS VISUAL IMPACT ASSESSMENT

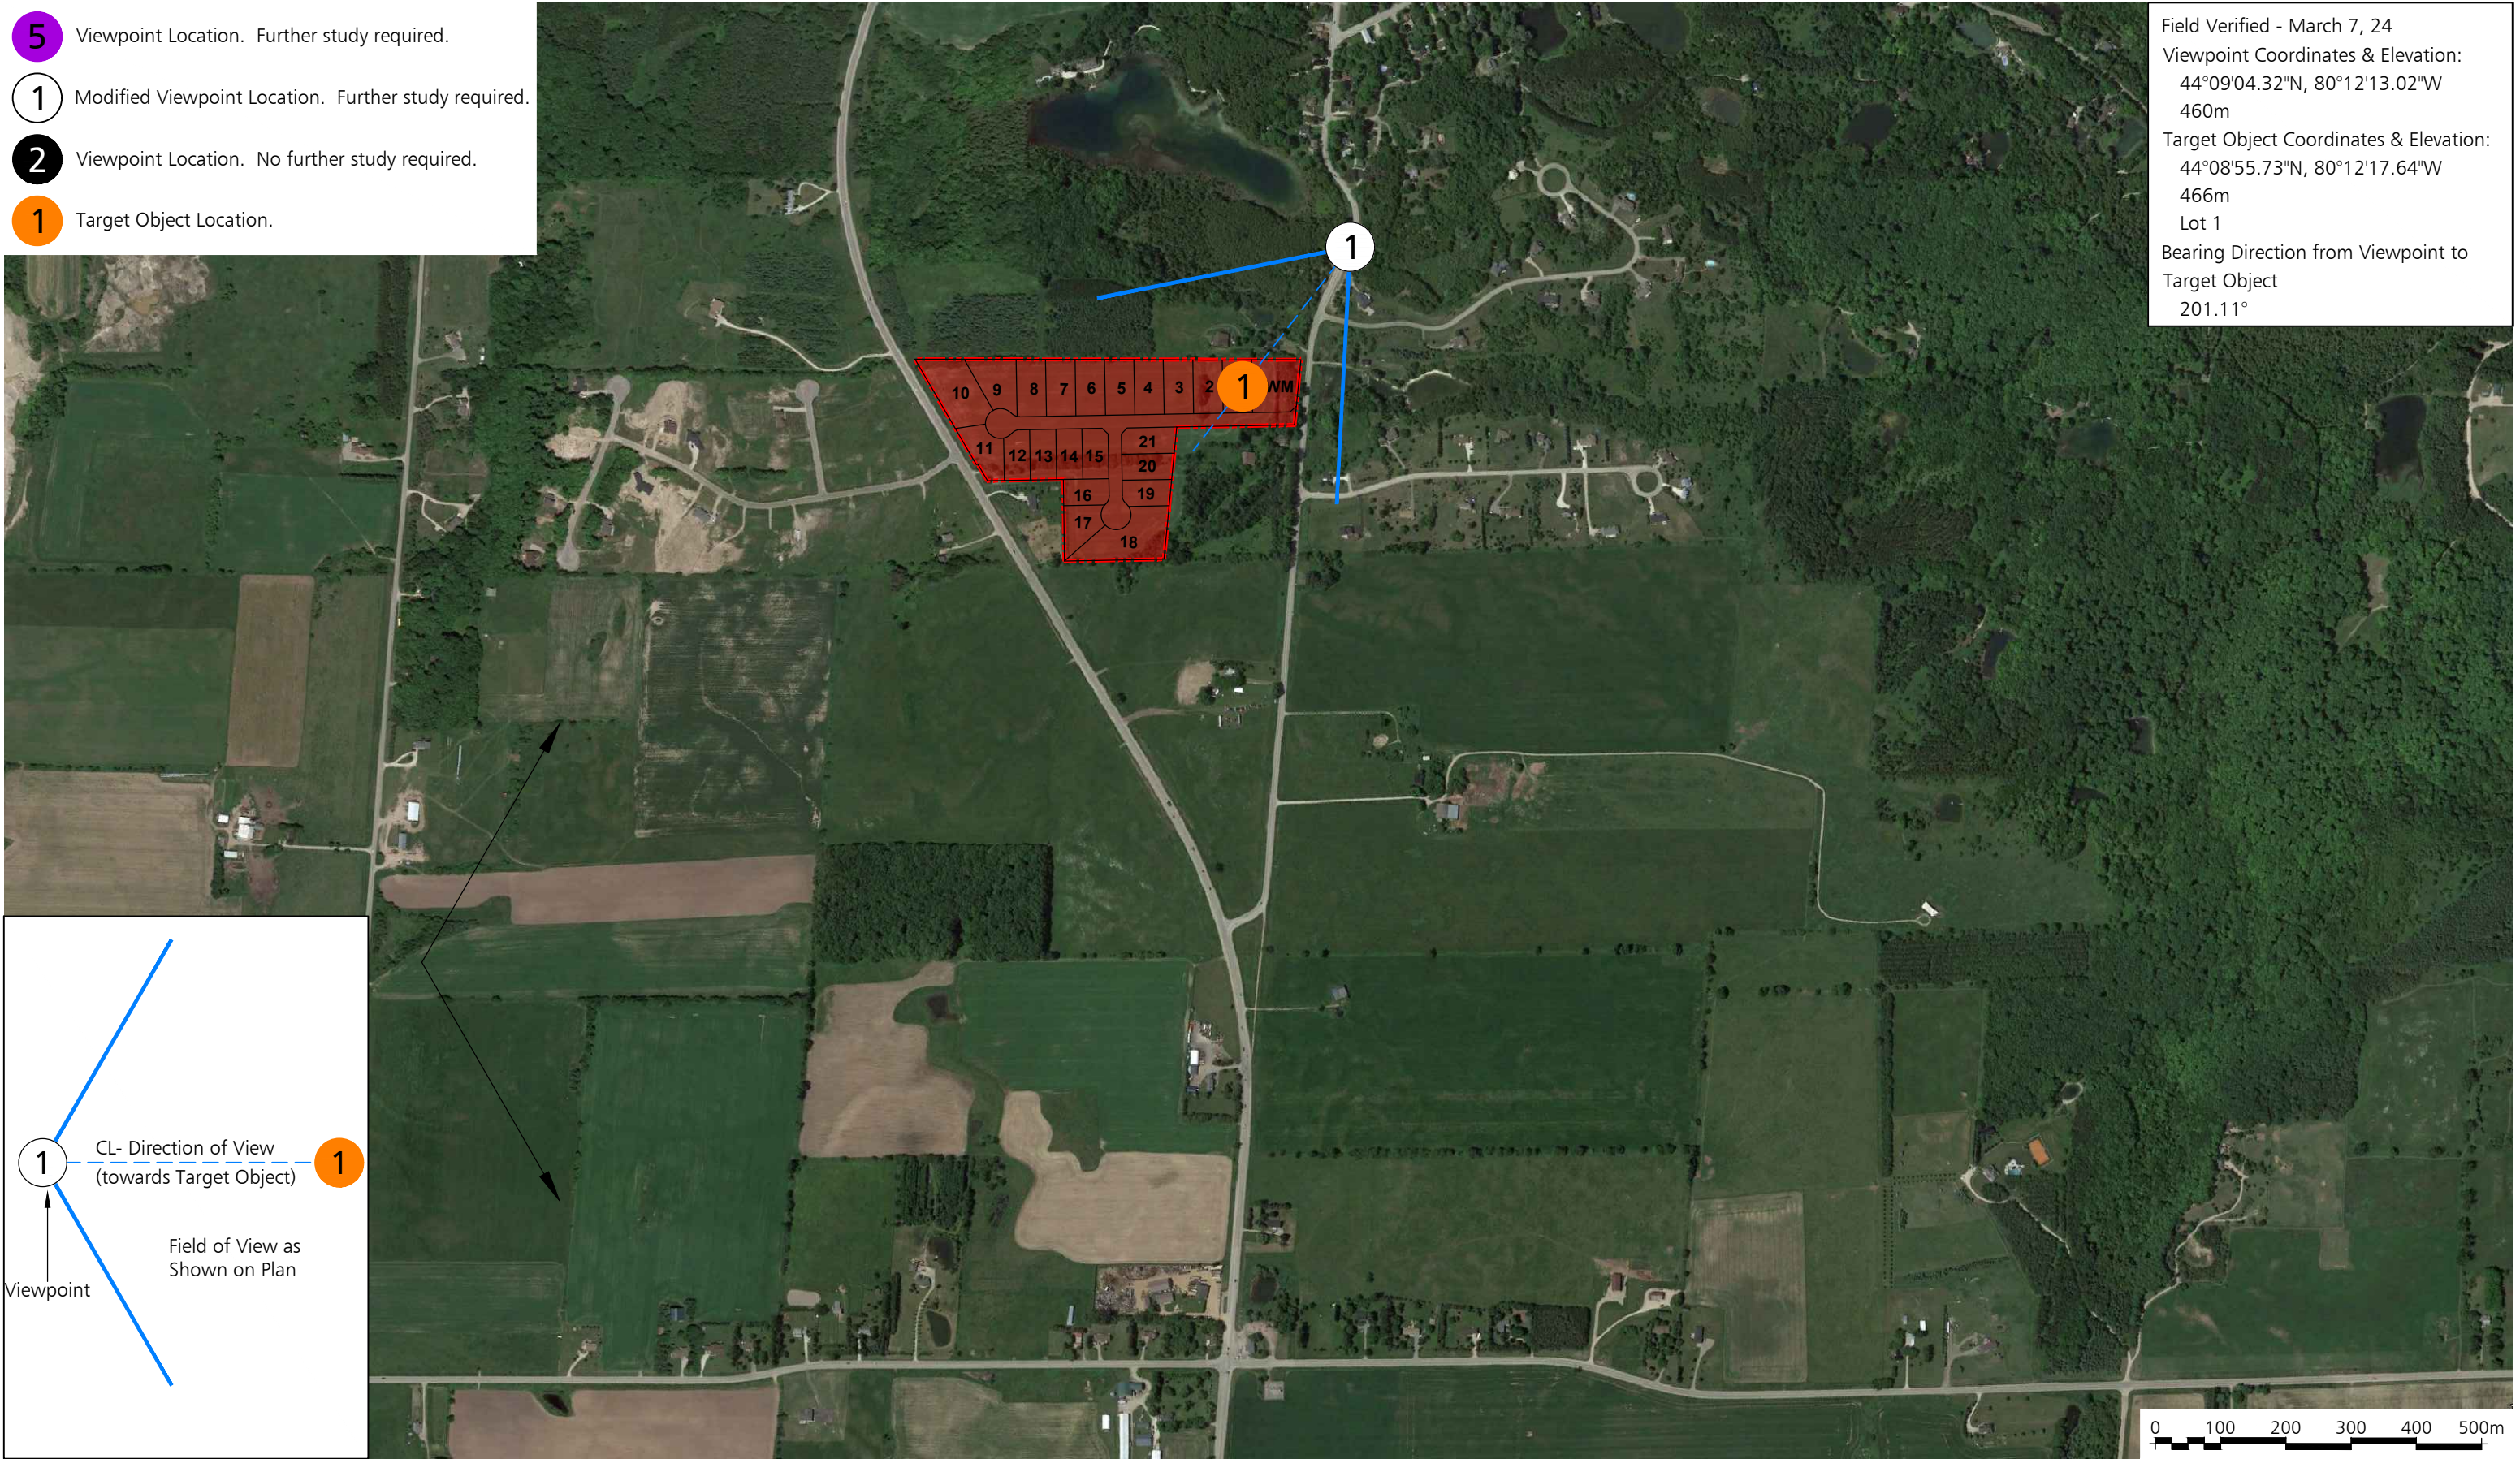
VP1

Field Verified - March 7, 24
 Viewpoint Coordinates & Elevation:
 44°09'04.32"N, 80°12'13.02"W
 460m
 Target Object Coordinates & Elevation:
 44°08'55.73"N, 80°12'17.64"W
 466m
 Lot 1
 Bearing Direction from Viewpoint to
 Target Object
 201.11°

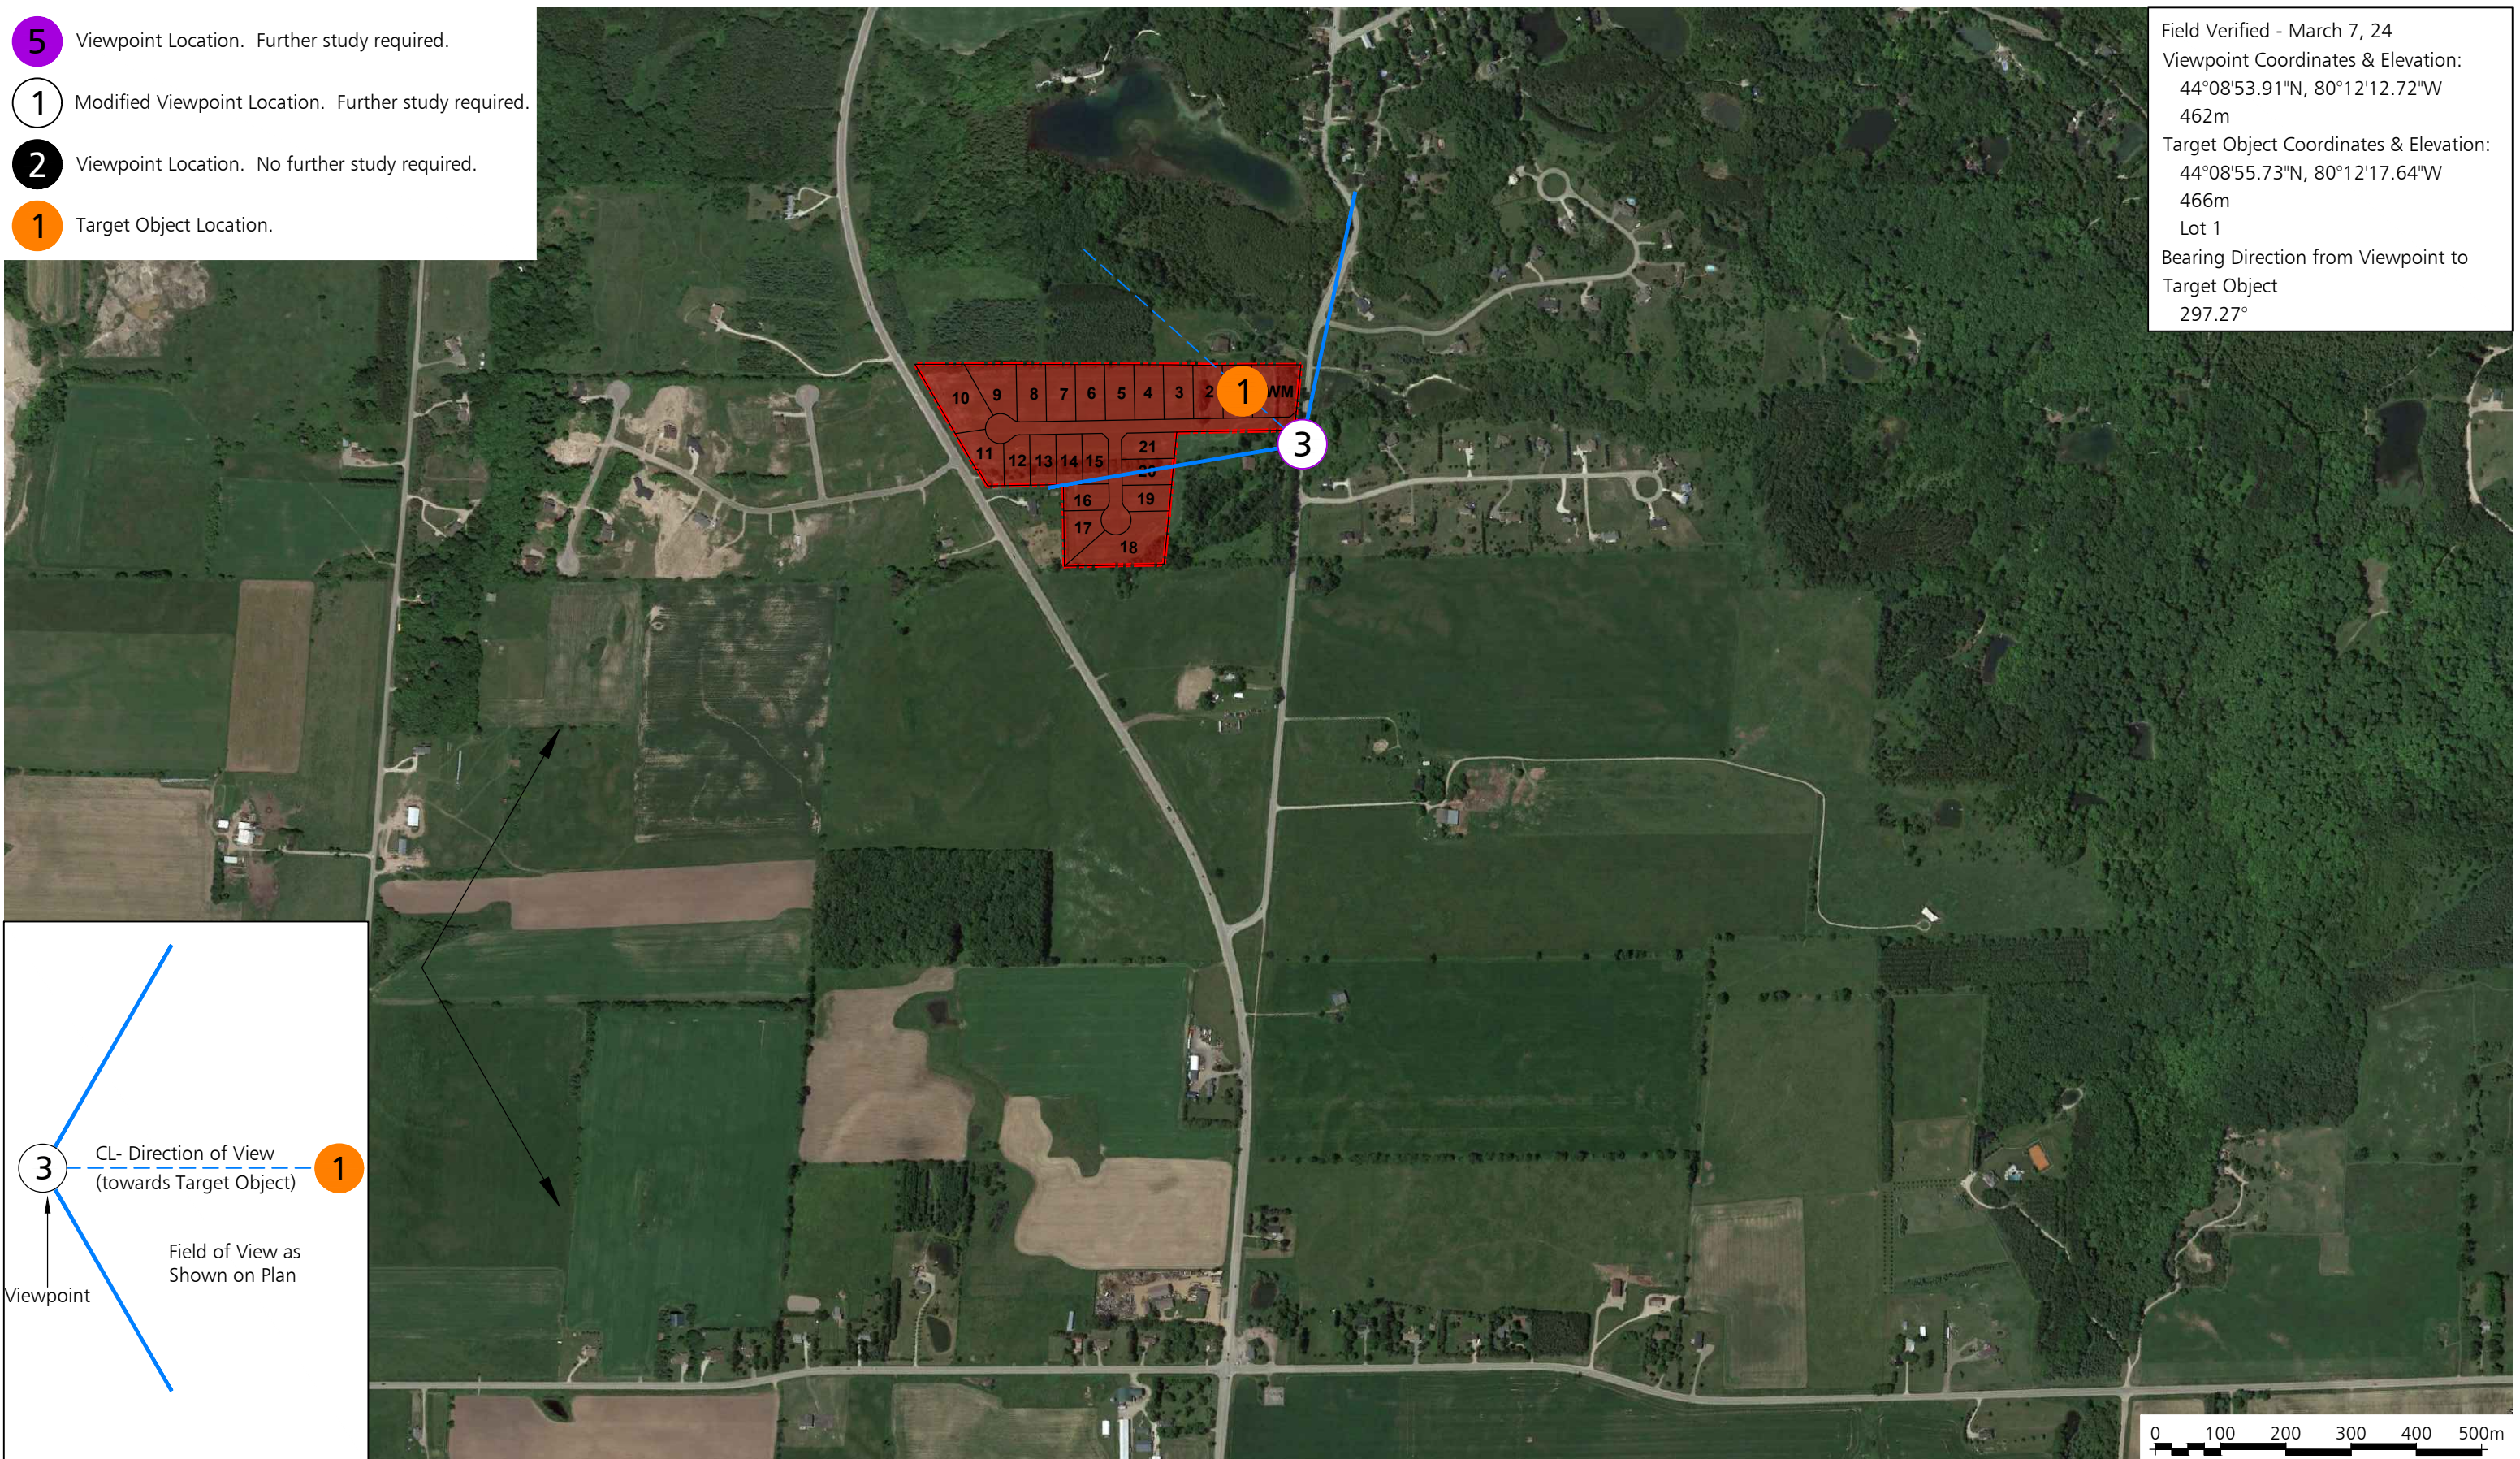
VP3

Field Verified - March 7, 24
 Viewpoint Coordinates & Elevation:
 44°08'53.91"N, 80°12'12.72"W
 462m
 Target Object Coordinates & Elevation:
 44°08'55.73"N, 80°12'17.64"W
 466m
 Lot 1
 Bearing Direction from Viewpoint to
 Target Object
 297.27°

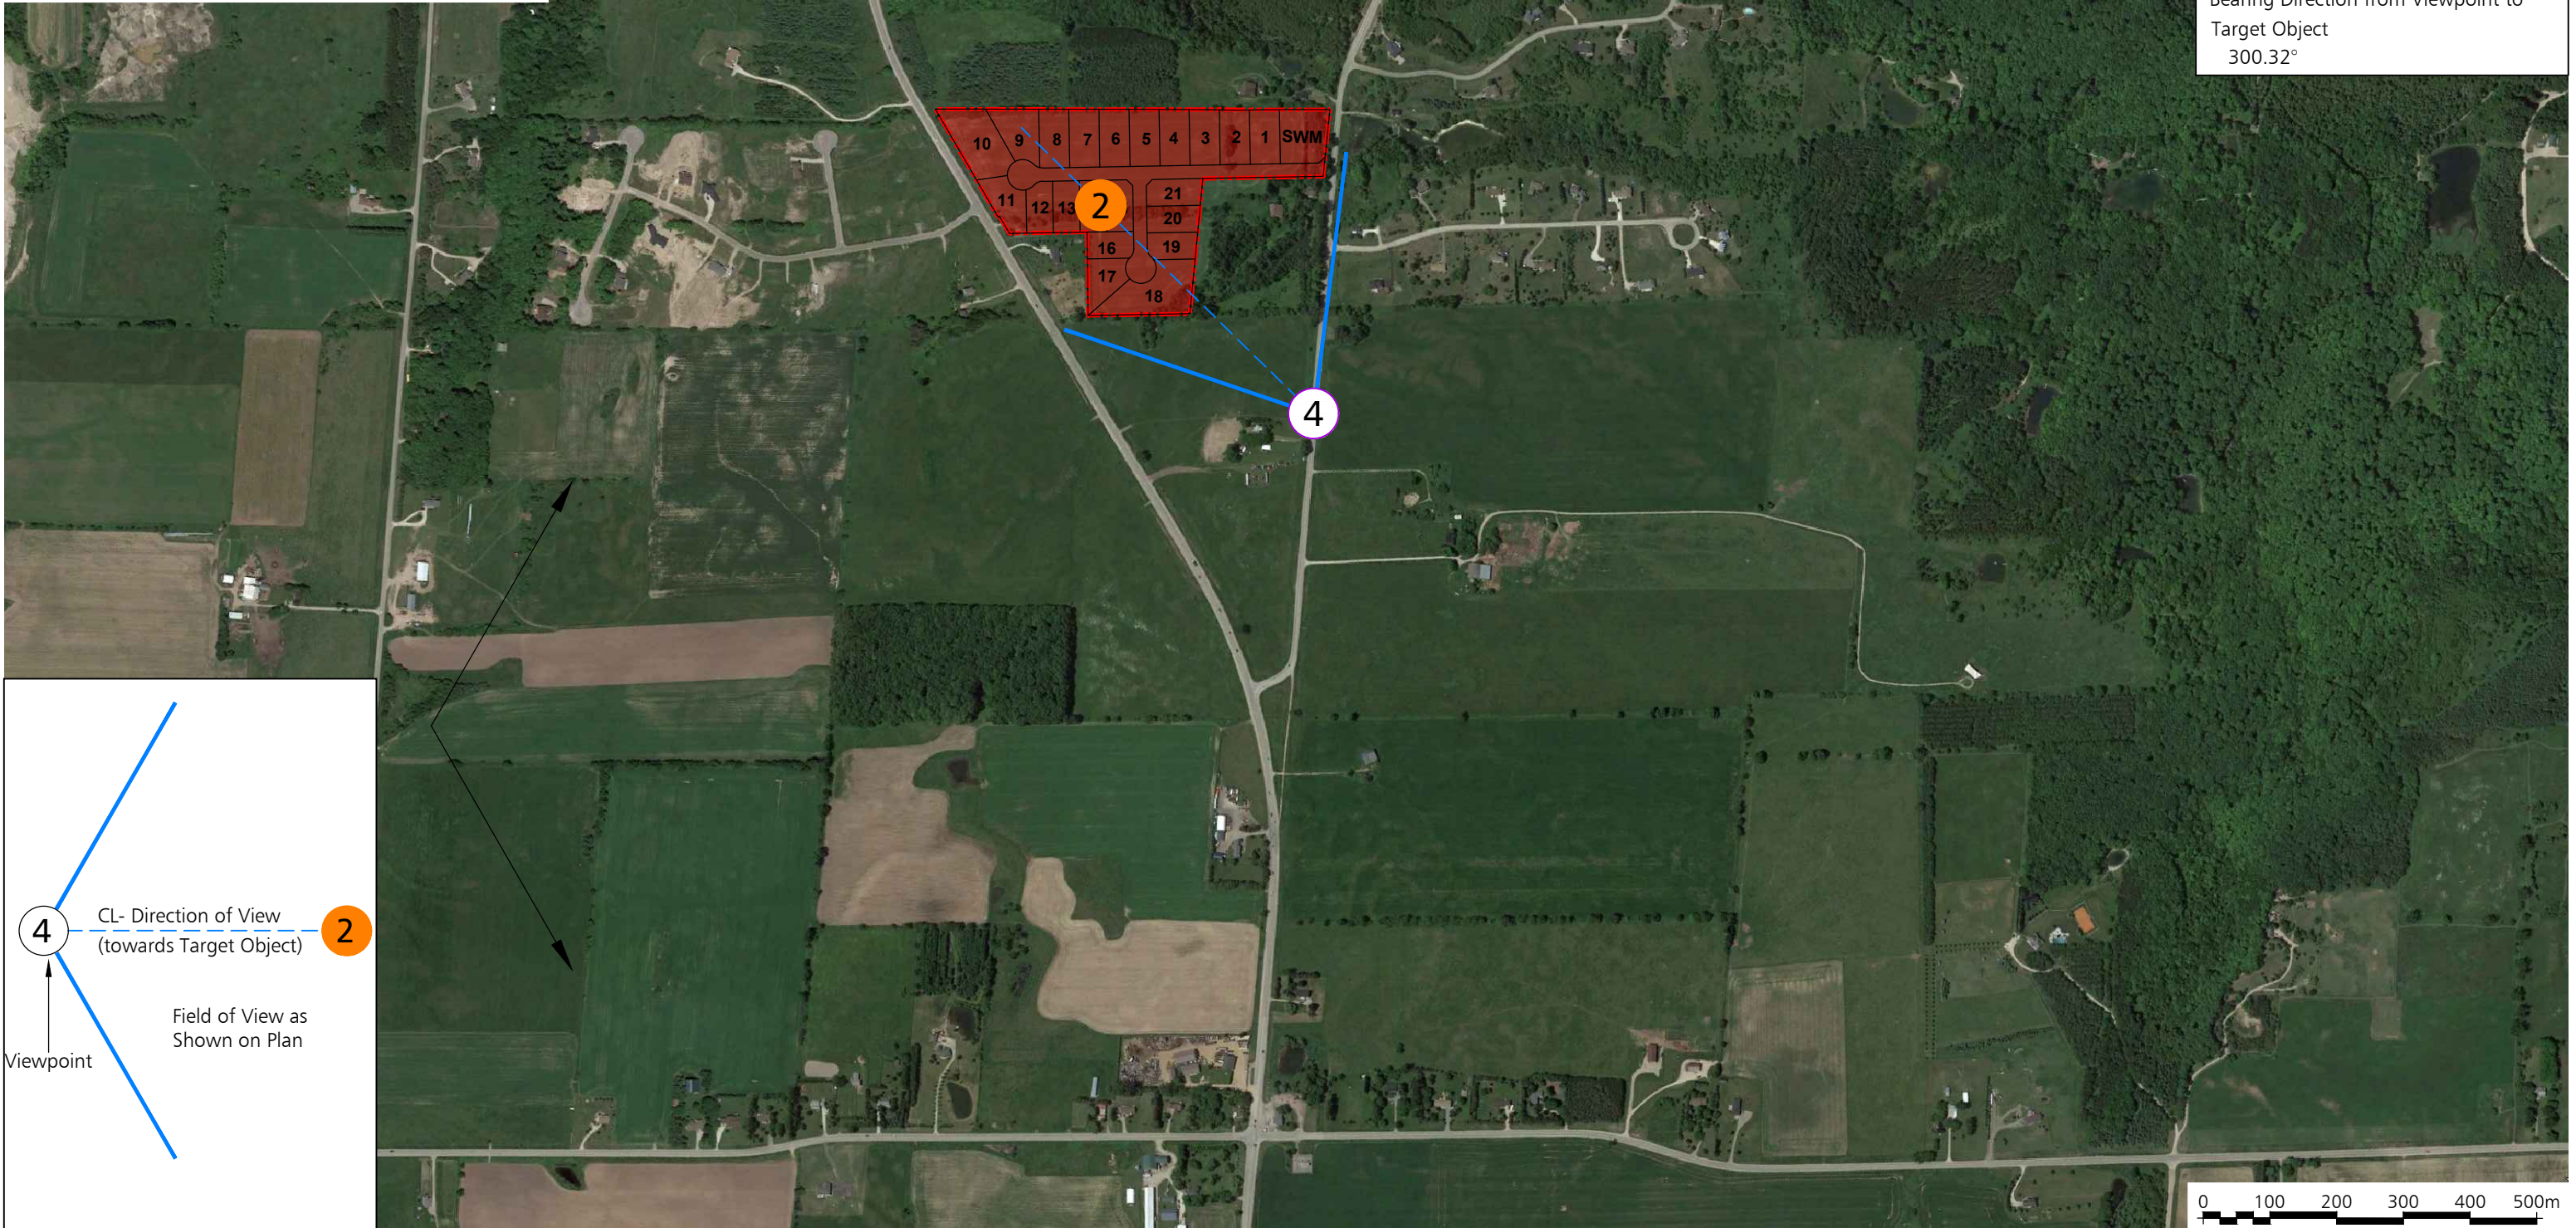
VP4

Field Verified - March 7, 24
 Viewpoint Coordinates & Elevation:
 44°08'43.47"N, 80°12'10.09"W
 475m
 Target Object Coordinates & Elevation:
 44°08'50.81"N, 80°12'27.58"W
 480m
 Lot 14
 Bearing Direction from Viewpoint to
 Target Object
 300.32°

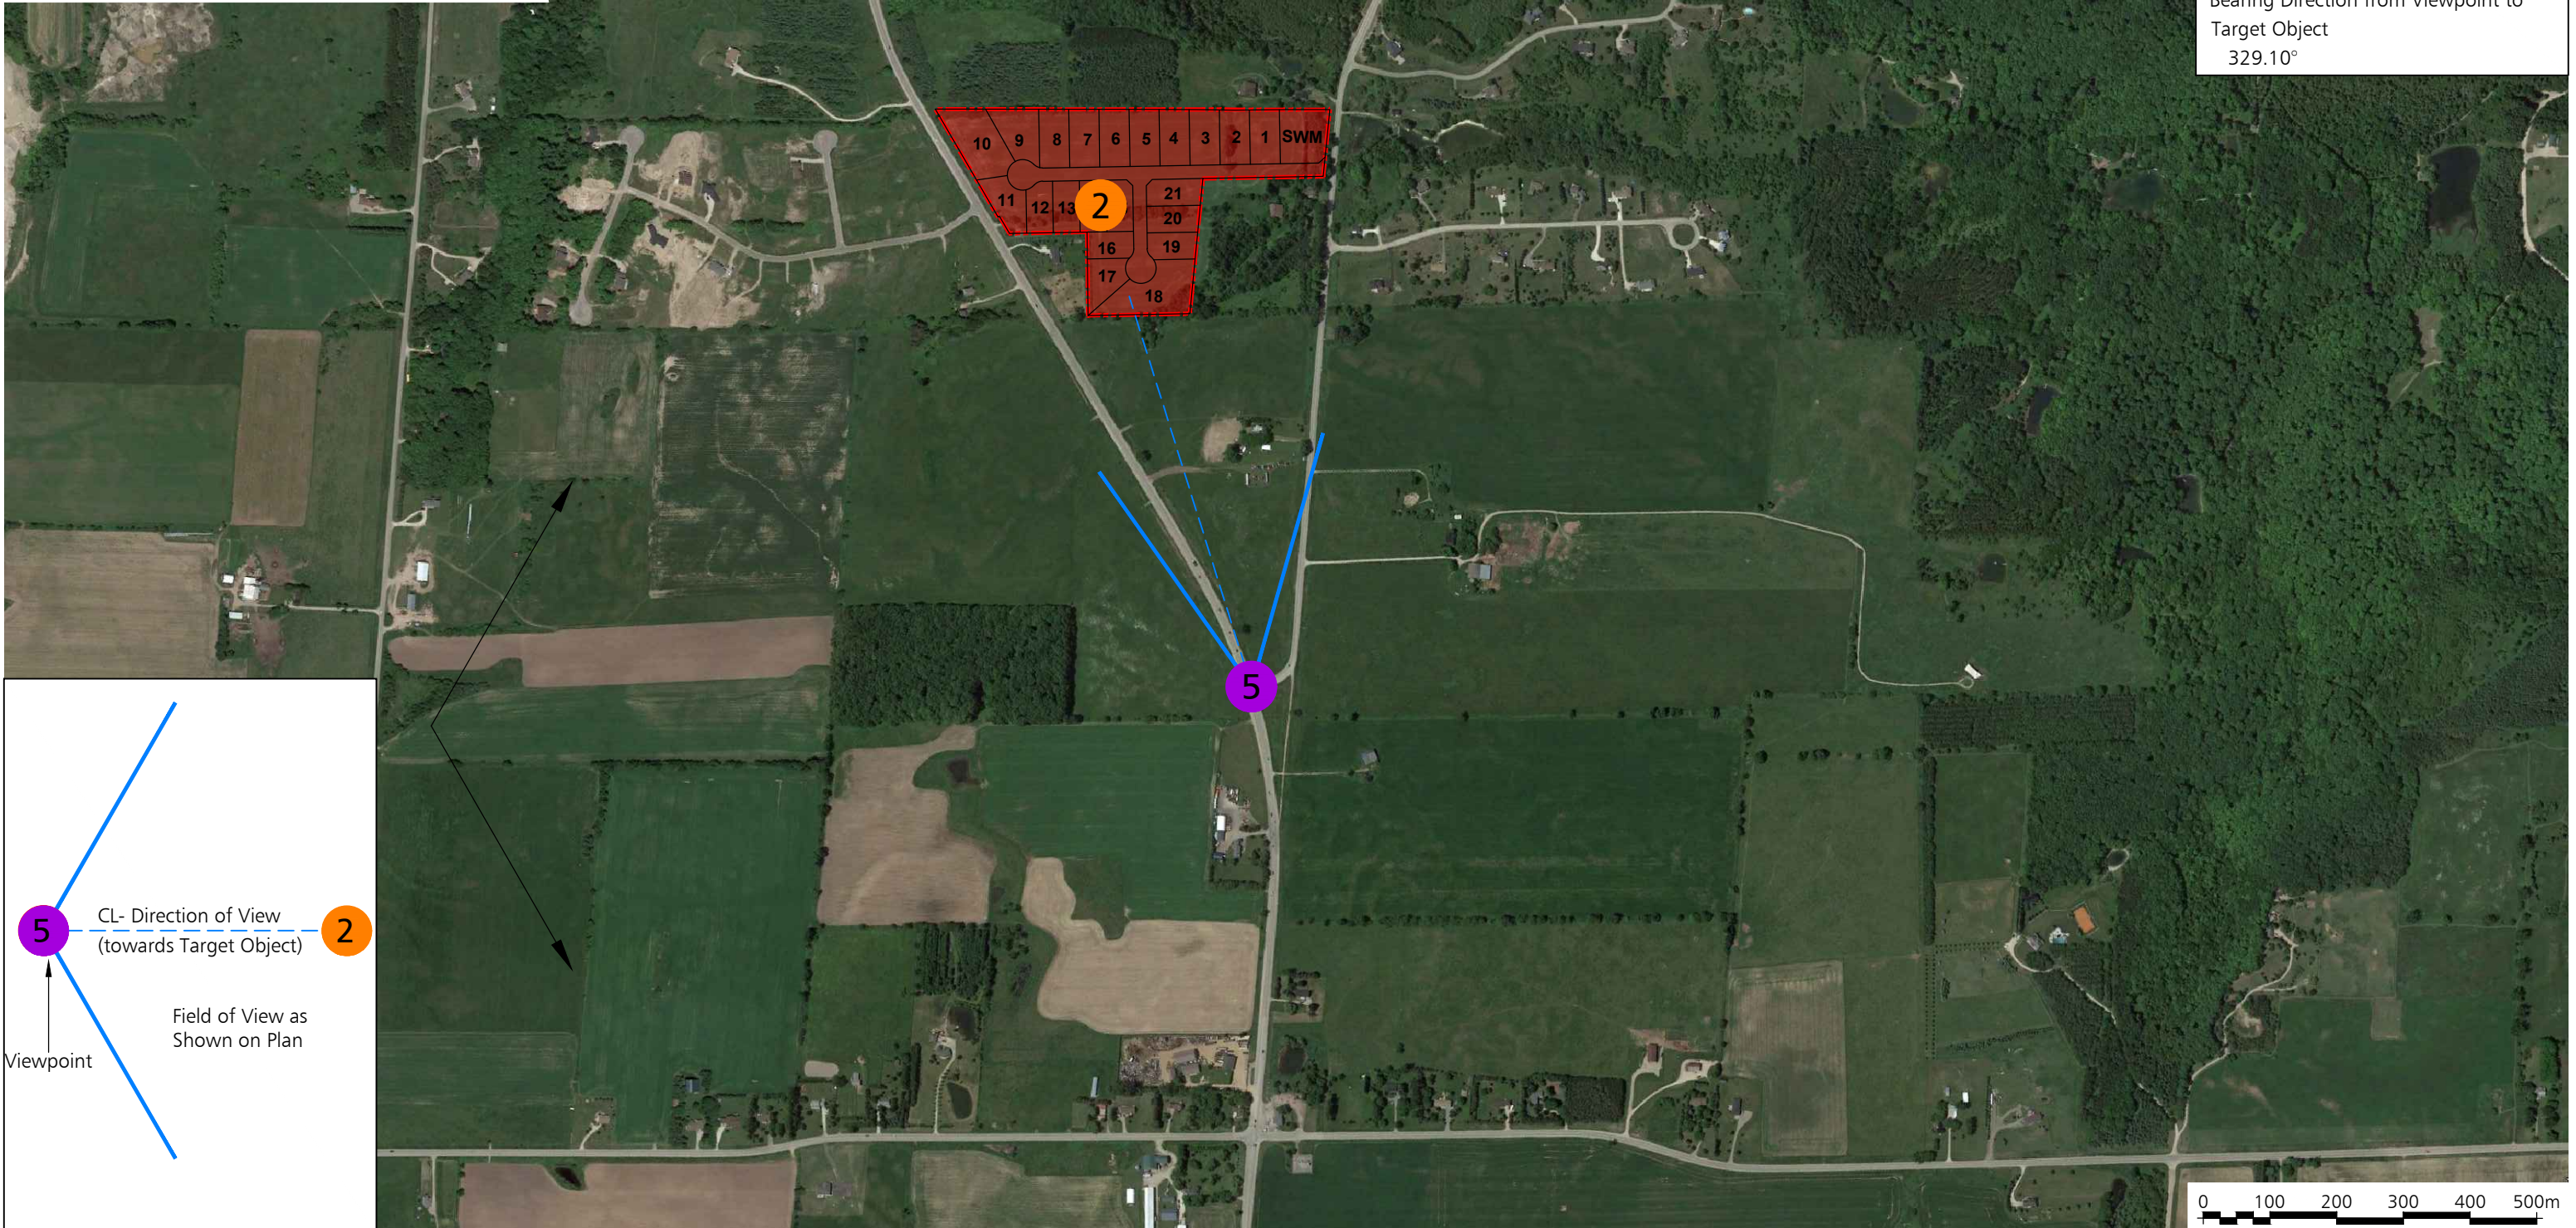
VP5

Field Verified - March 7, 24
 Viewpoint Coordinates & Elevation:
 44°08'29.77"N, 80°12'10.02"W
 480m
 Target Object Coordinates & Elevation:
 44°08'50.81"N, 80°12'27.58"W
 480m
 Lot 14
 Bearing Direction from Viewpoint to
 Target Object
 329.10°

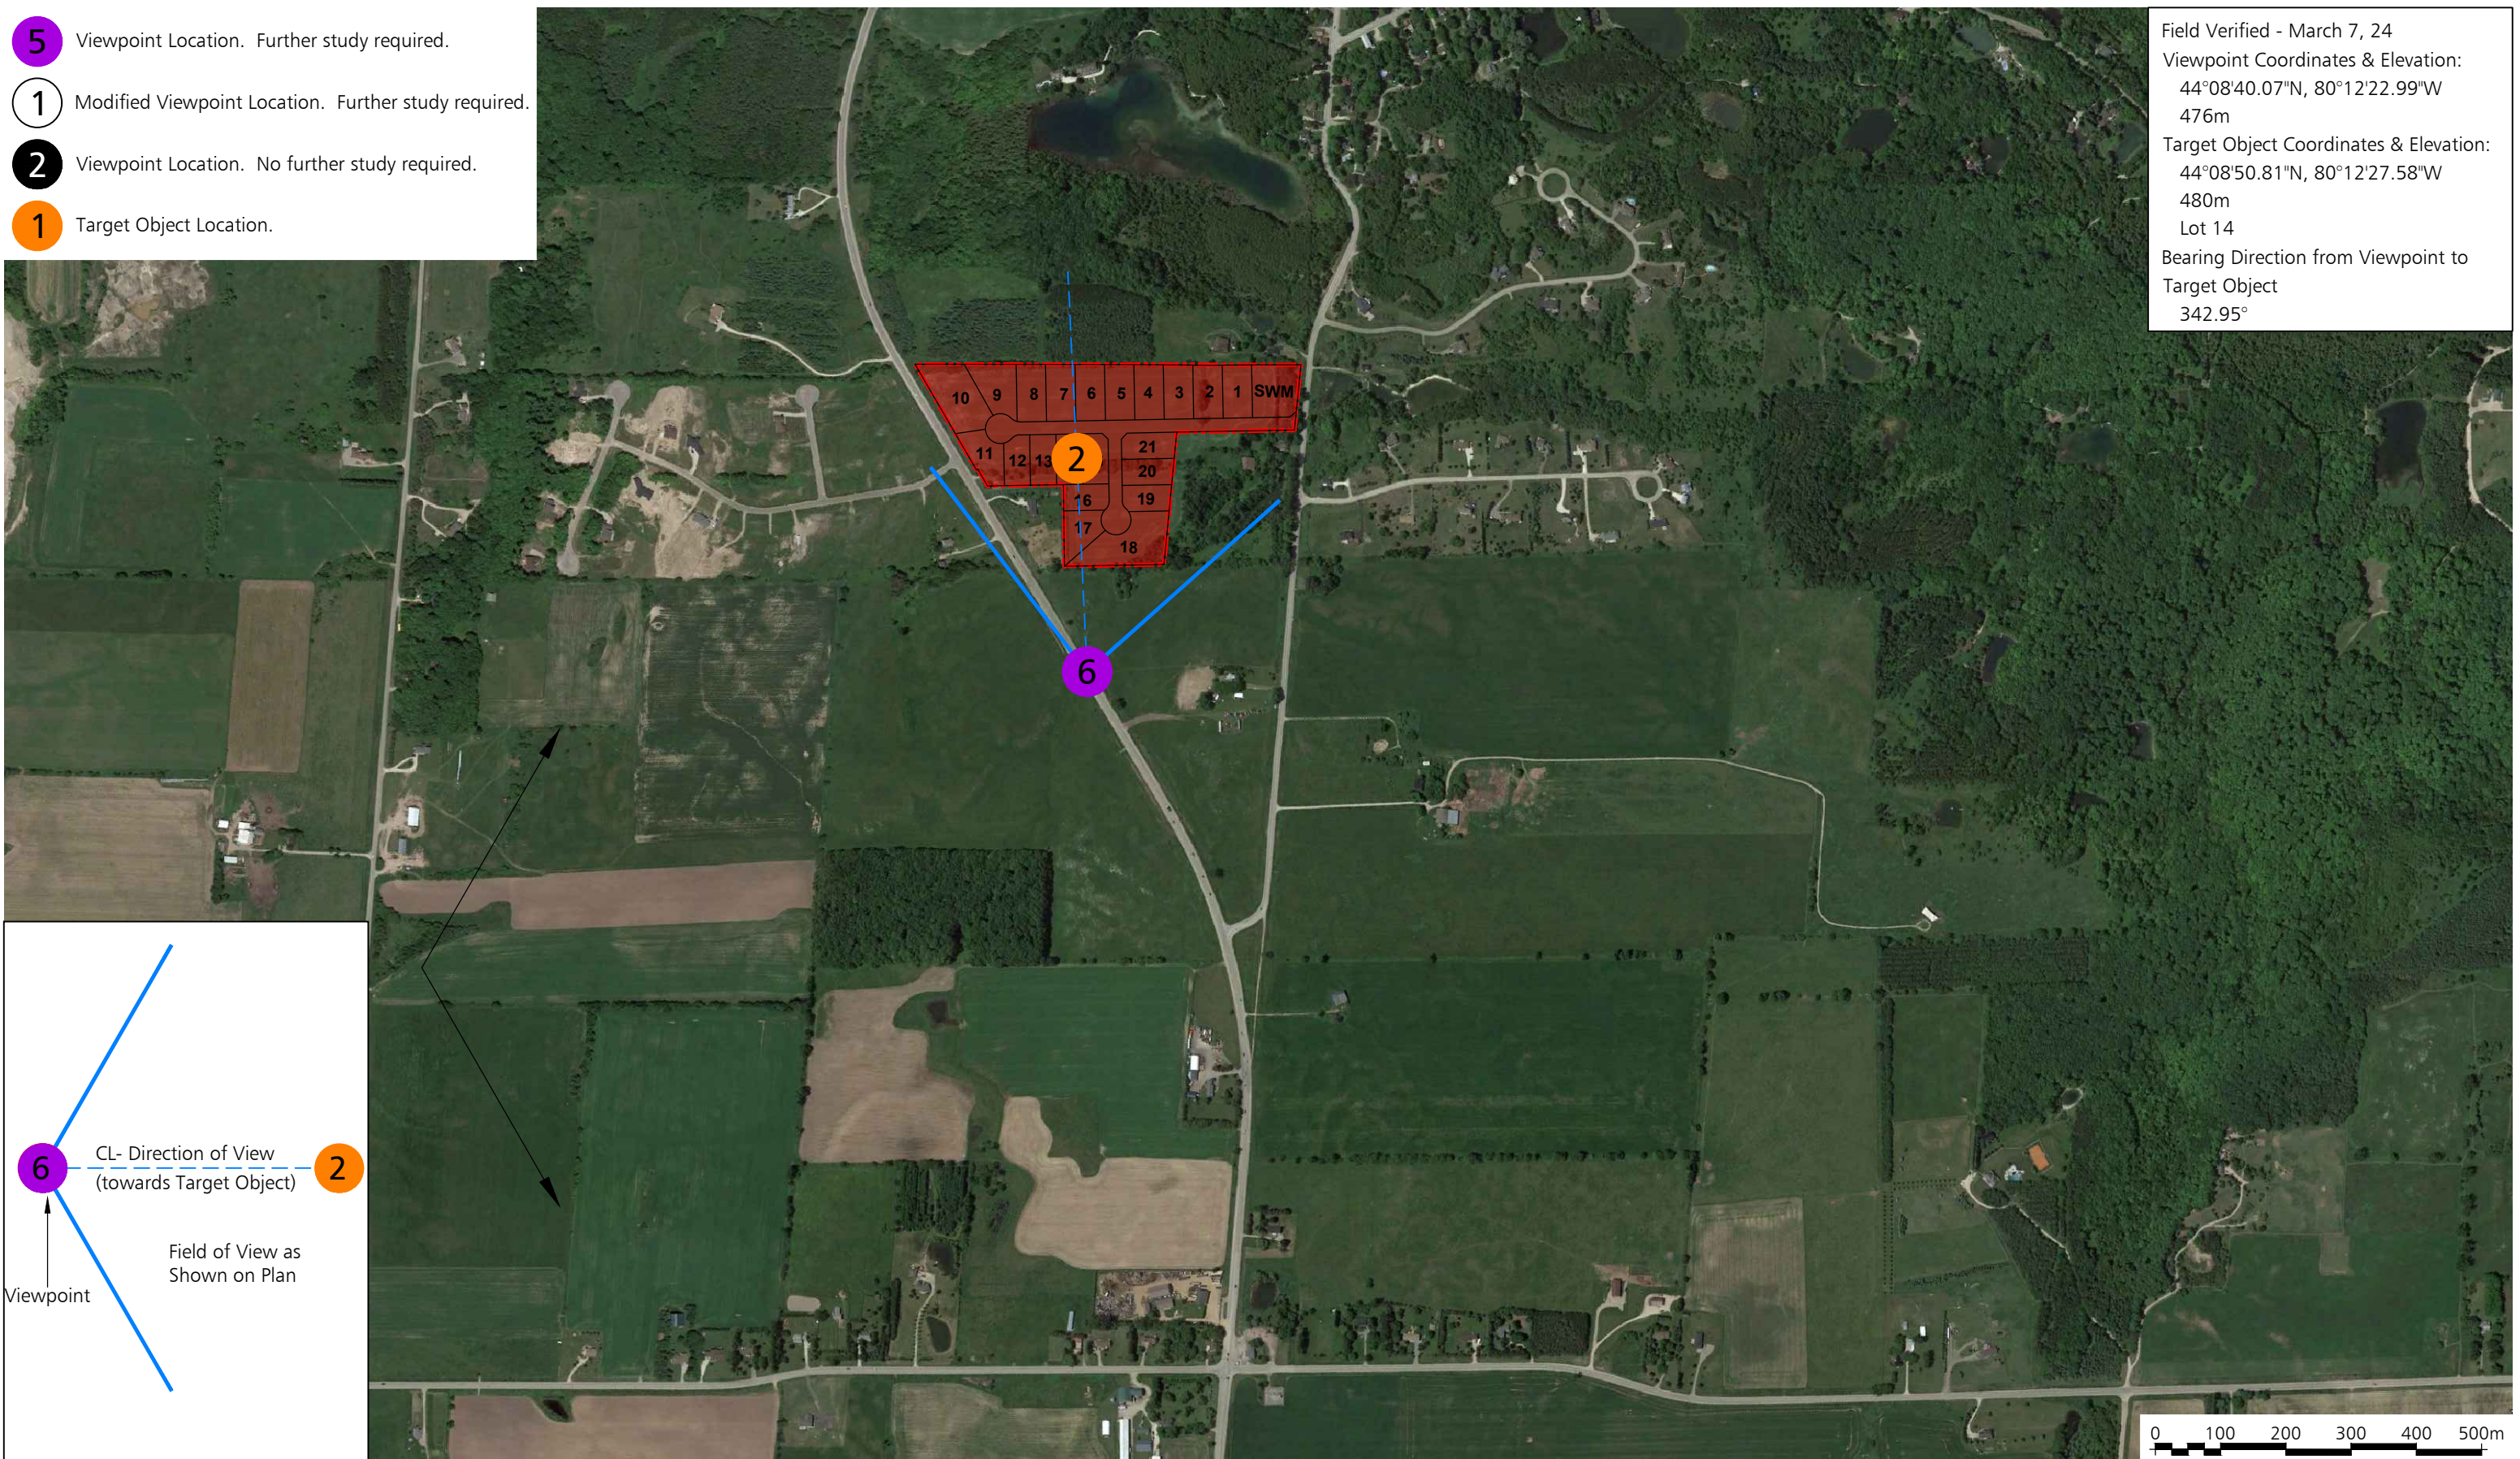
VP6

Field Verified - March 7, 24
 Viewpoint Coordinates & Elevation:
 44°08'40.07"N, 80°12'22.99"W
 476m
 Target Object Coordinates & Elevation:
 44°08'50.81"N, 80°12'27.58"W
 480m
 Lot 14
 Bearing Direction from Viewpoint to
 Target Object
 342.95°

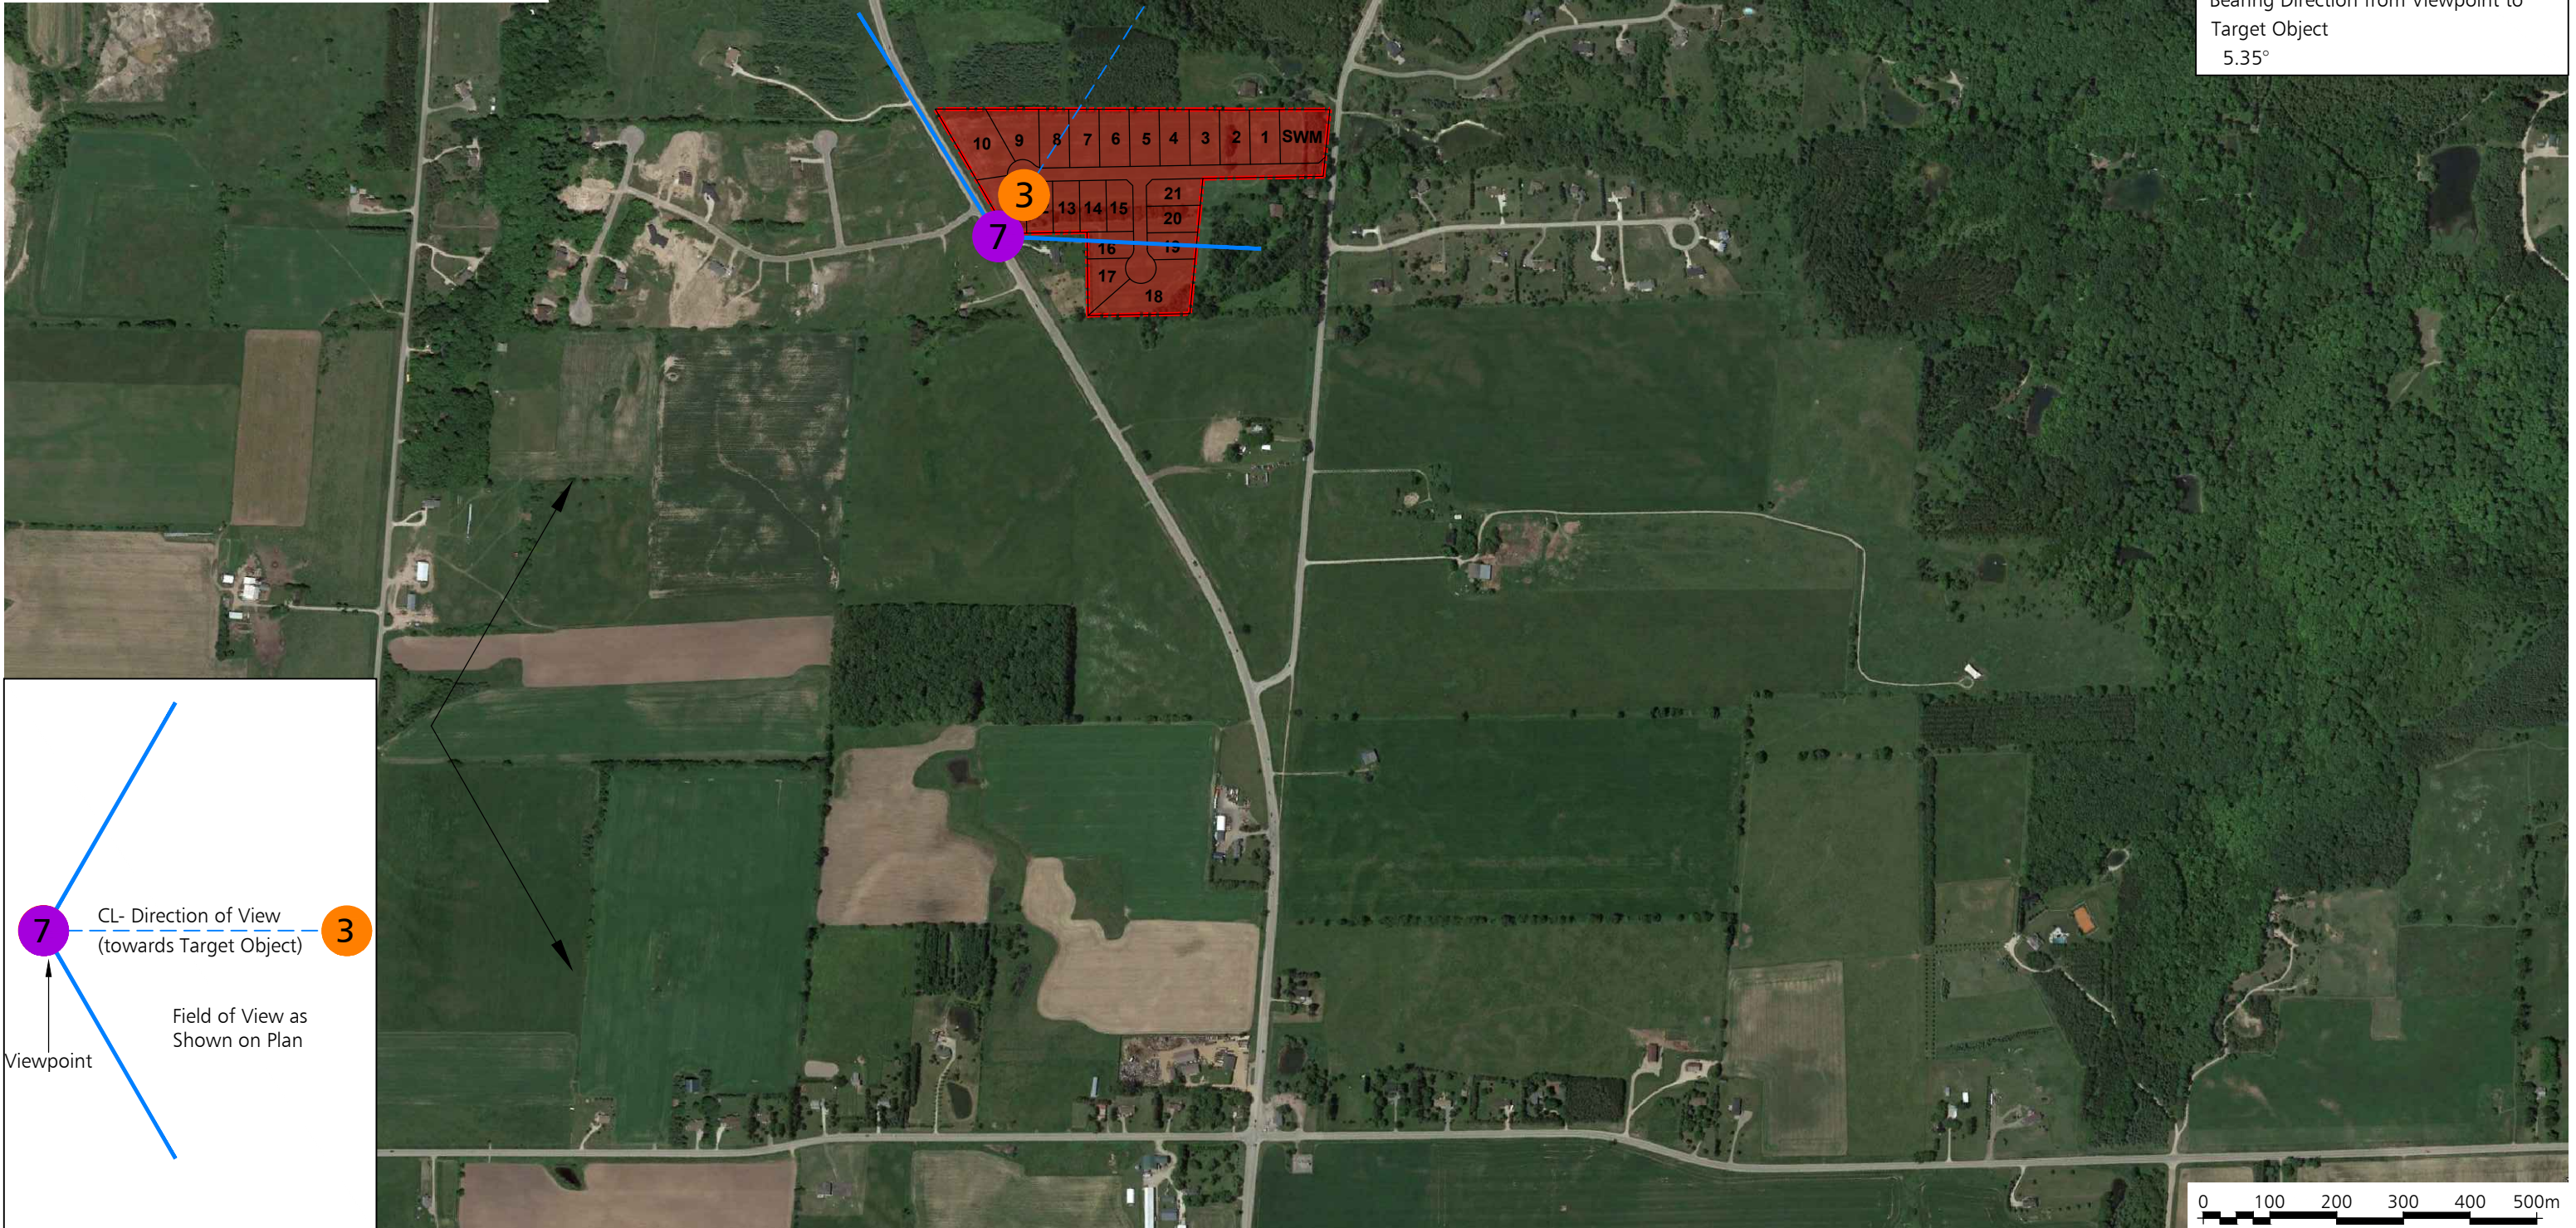
VP7

Field Verified - March 7, 24
 Viewpoint Coordinates & Elevation:
 44°08'47.16"N, 80°12'33.14"W
 482m
 Target Object Coordinates & Elevation:
 44°08'49.75"N, 80°12'33.192"W
 482m
 Lot 11
 Bearing Direction from Viewpoint to
 Target Object
 5.35°
