**RE: VISUAL IMPACT ASSESSMENT STUDY for HORNING'S MILL'S DEVELOPMENT
RESULTS OF LEAF OFF STUDY (STAGE 2, REVISION 1)**

VM1 HORNING'S MILLS VISUAL IMPACT ASSESSMENT VIEWSHED MAP

S.1 HORNING'S MILLS VISUAL IMPACT ASSESSMENT

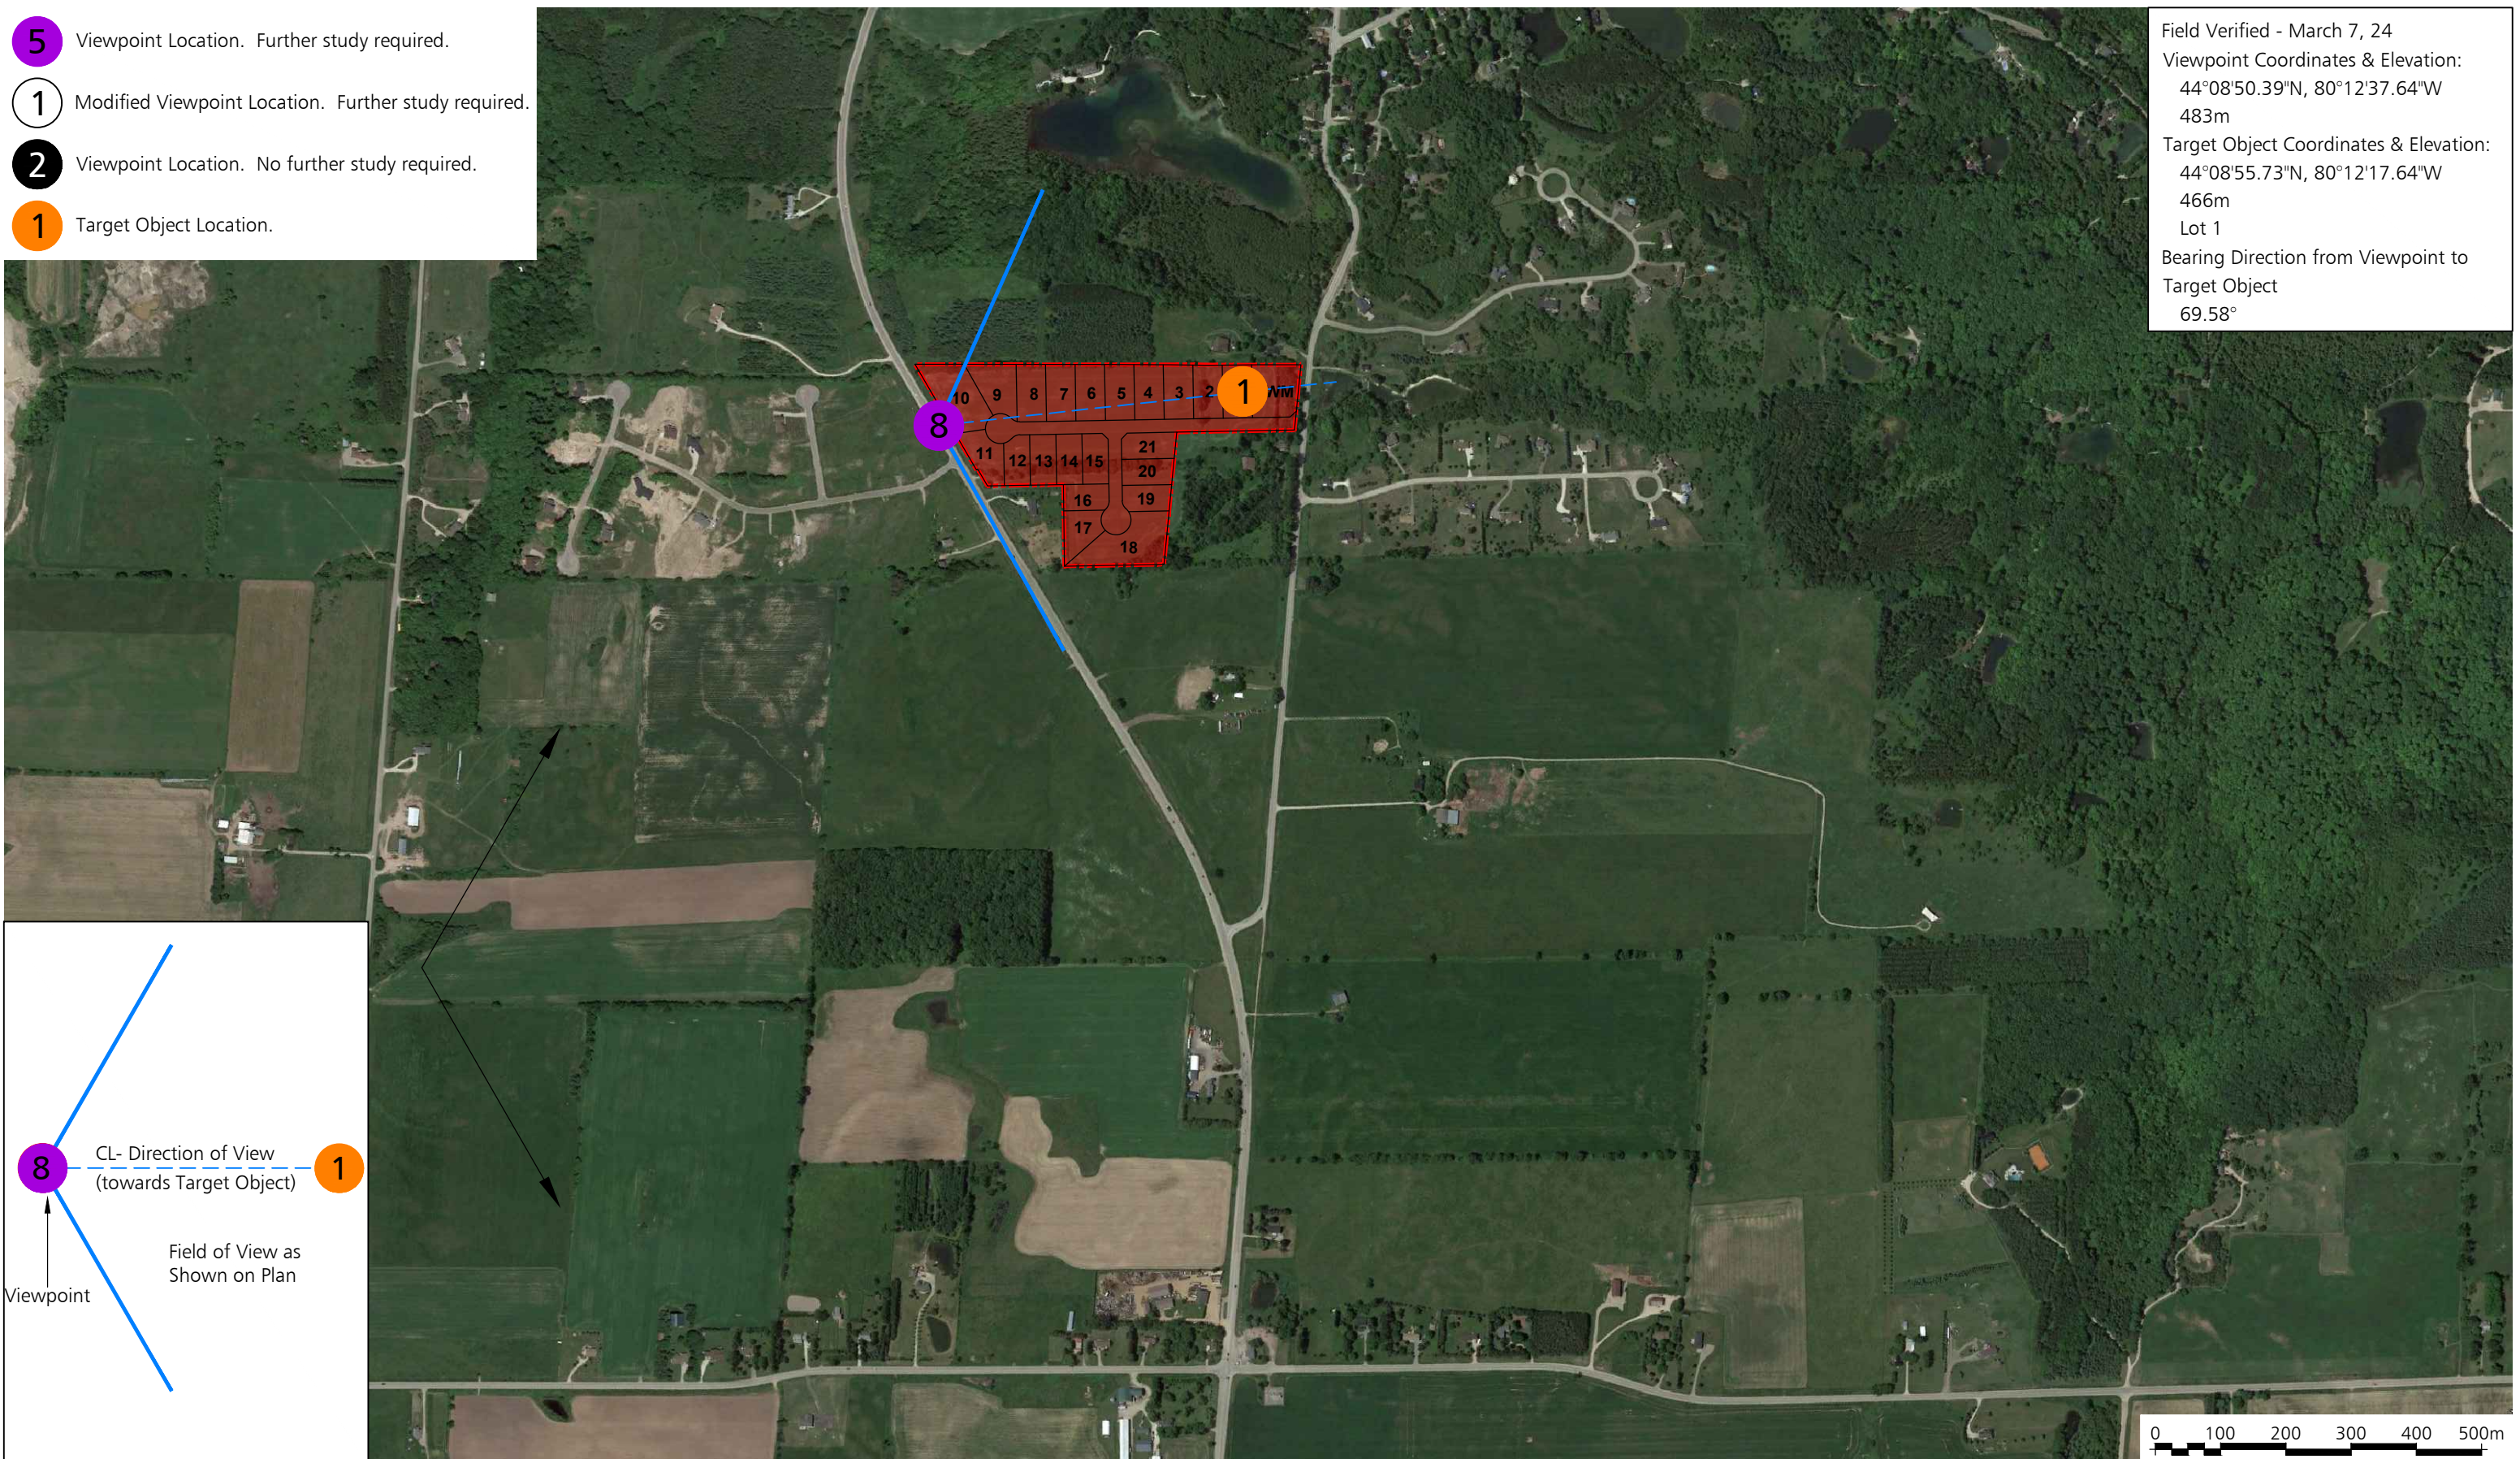
VP8

Field Verified - March 7, 24
 Viewpoint Coordinates & Elevation:
 44°08'50.39"N, 80°12'37.64"W
 483m
 Target Object Coordinates & Elevation:
 44°08'55.73"N, 80°12'17.64"W
 466m
 Lot 1
 Bearing Direction from Viewpoint to
 Target Object
 69.58°

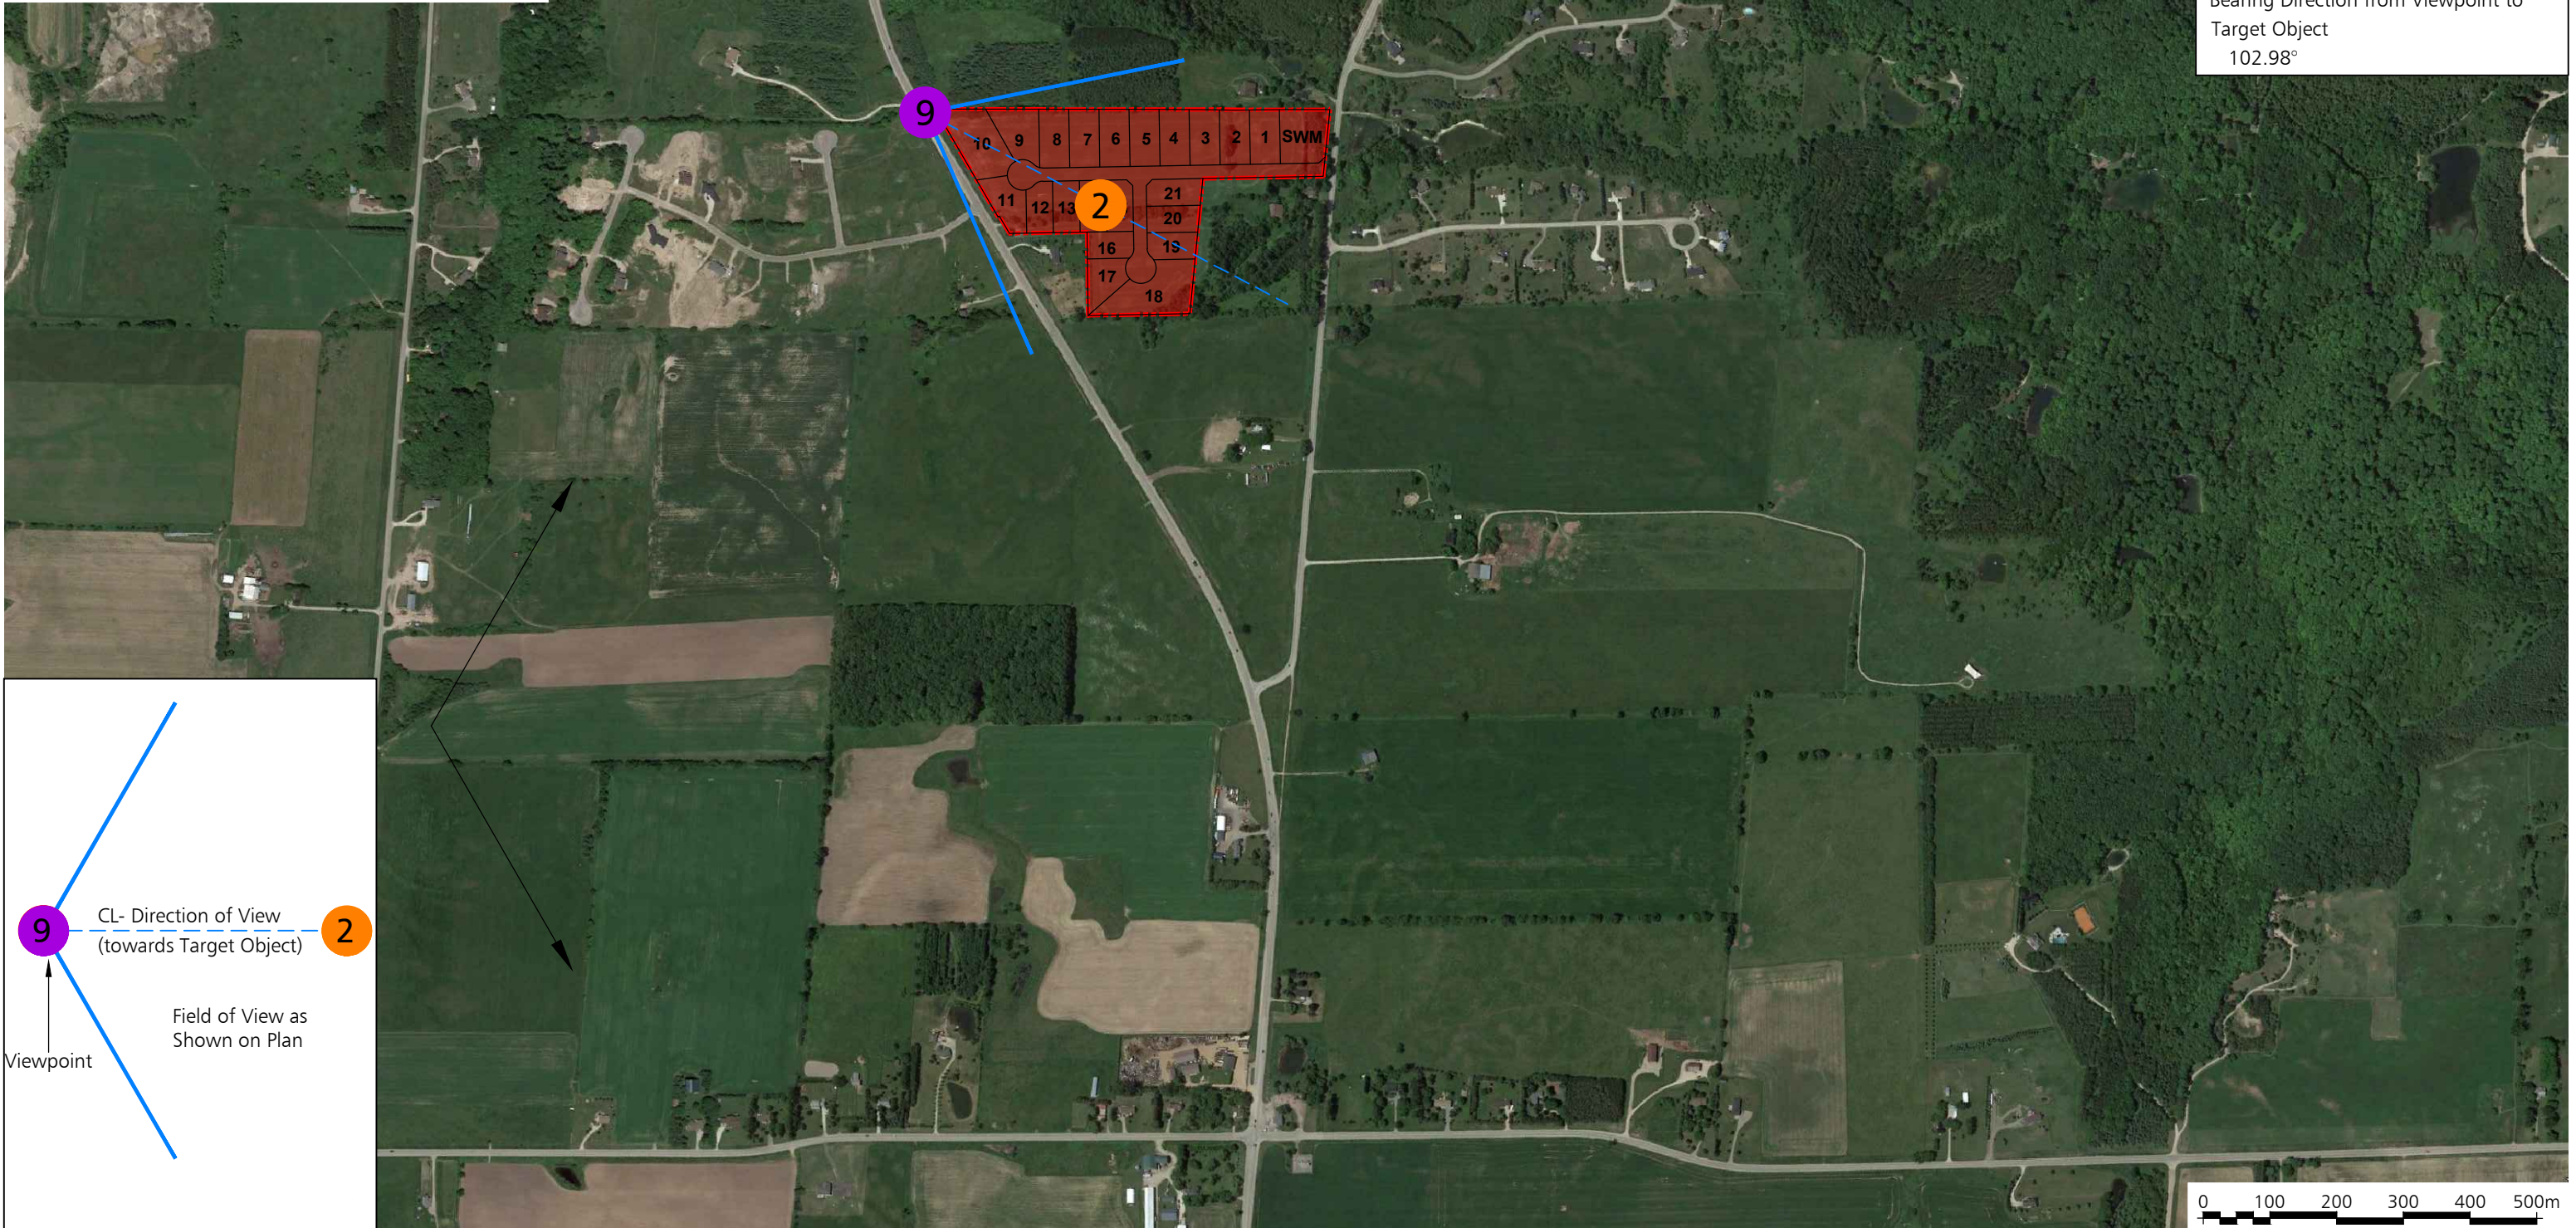
VP9

Field Verified - March 7, 24
 Viewpoint Coordinates & Elevation:
 44°08'53.16"N, 80°12'41.79"W
 481m
 Target Object Coordinates & Elevation:
 44°08'50.81"N, 80°12'27.58"W
 480m
 Lot 14
 Bearing Direction from Viewpoint to
 Target Object
 102.98°

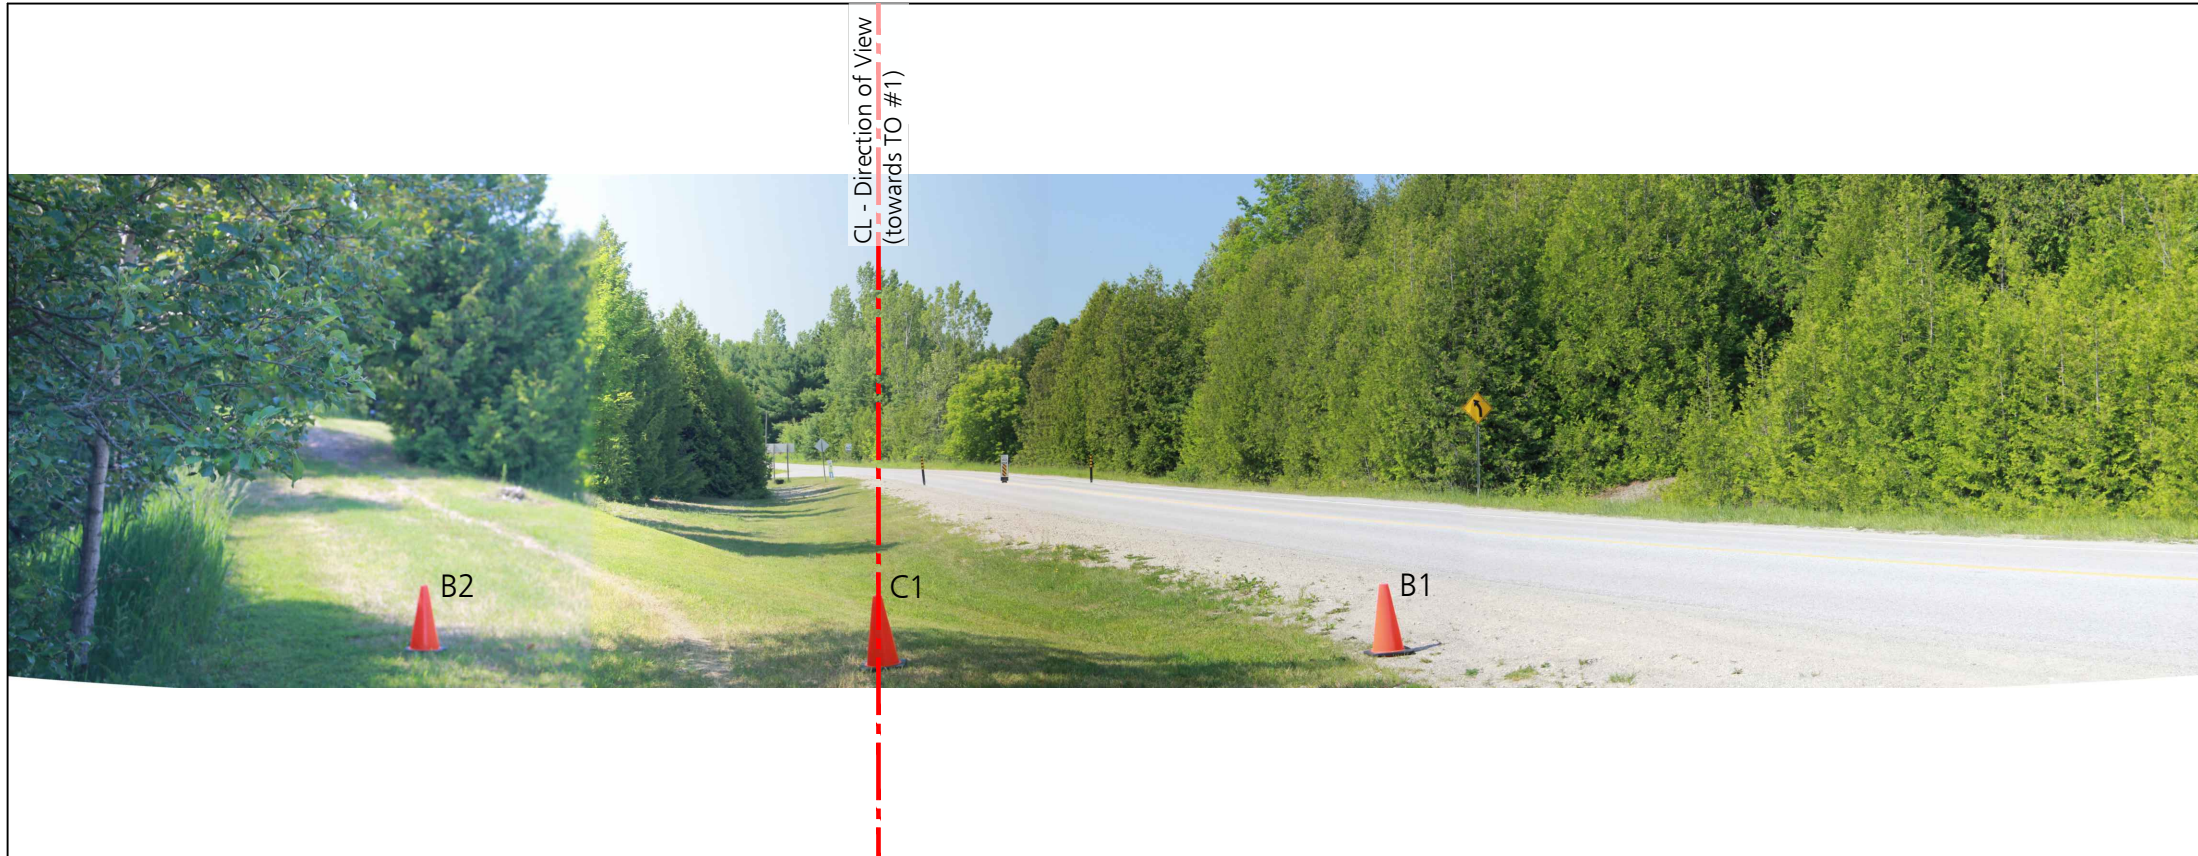
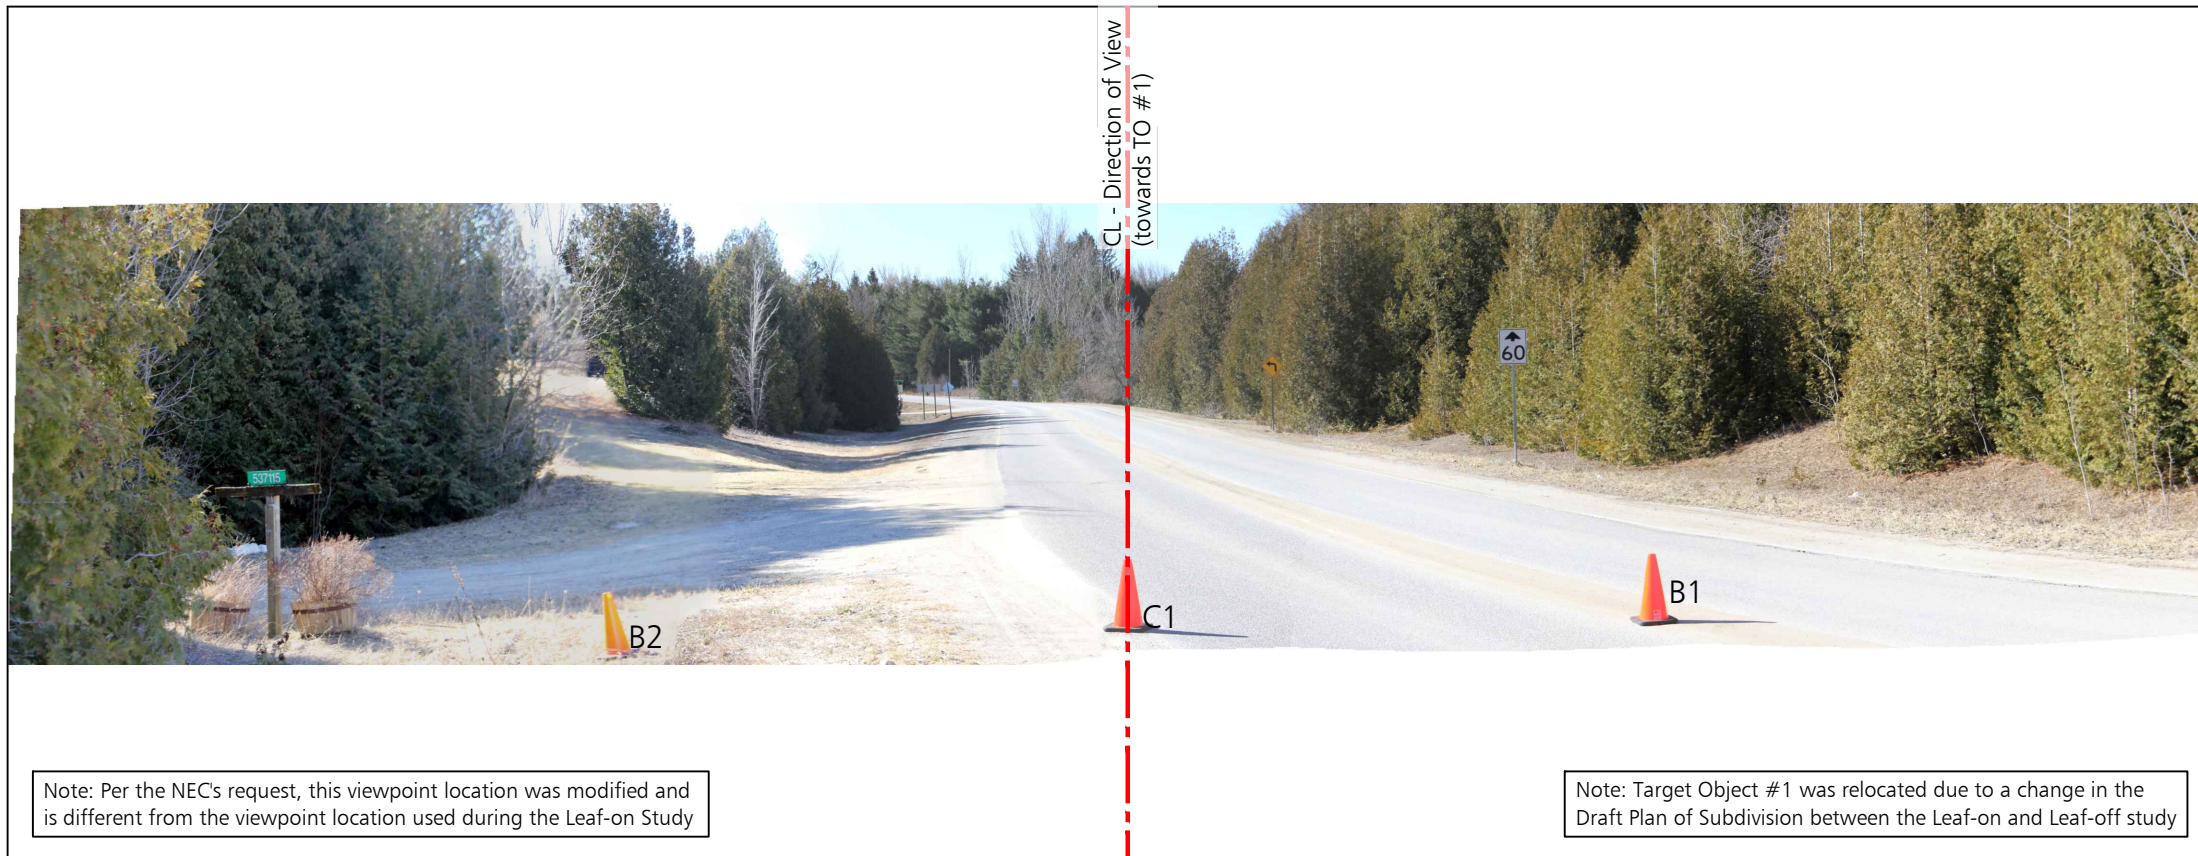
Existing Conditions Photograph (On Leaf Conditions - June 21, 2023)

Note: Per the NEC's request, this viewpoint location was modified and is different from the viewpoint location used during the Leaf-on Study

Note: Target Object #1 was relocated due to a change in the Draft Plan of Subdivision between the Leaf-on and Leaf-off study

Existing Conditions Photograph (Off Leaf Conditions - March 7, 2024)

- Because of the coniferous nature of the existing woodlot, and the change in elevation between this viewpoint and the subject property, further study not required from this viewpoint
- No mitigation required on Subject Property to provide a visual buffer from this viewpoint

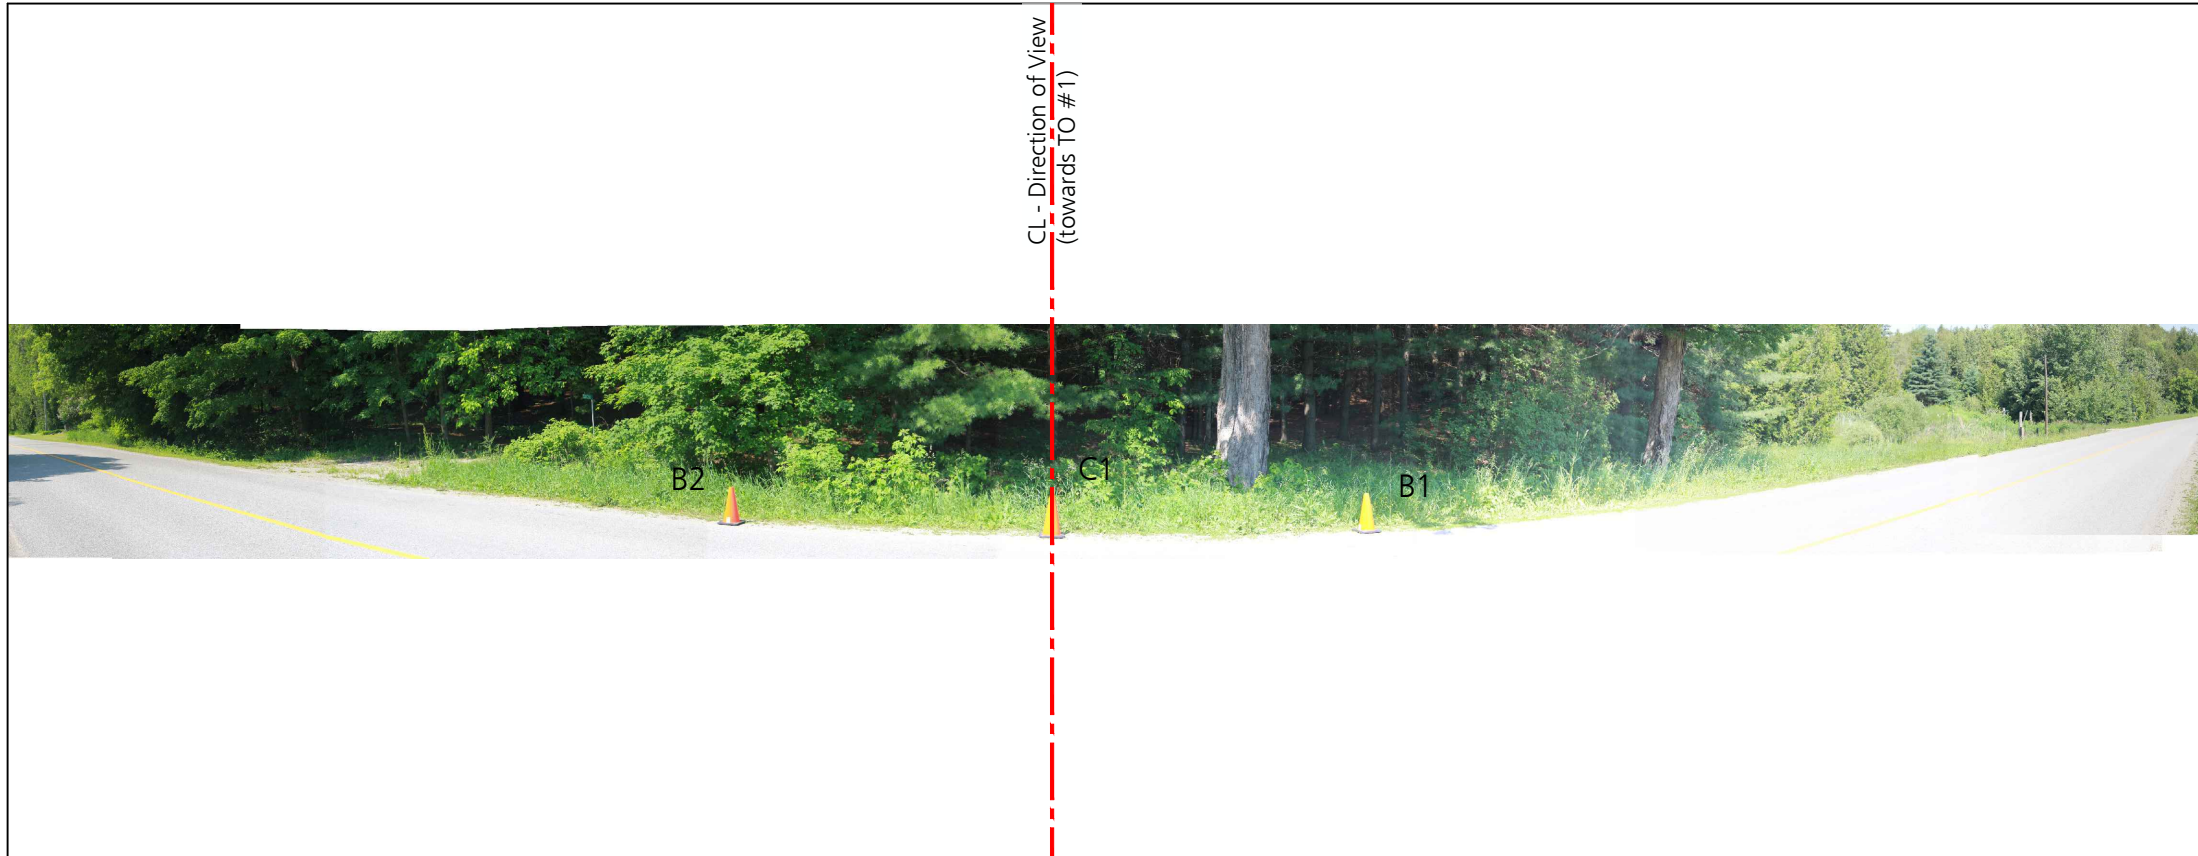
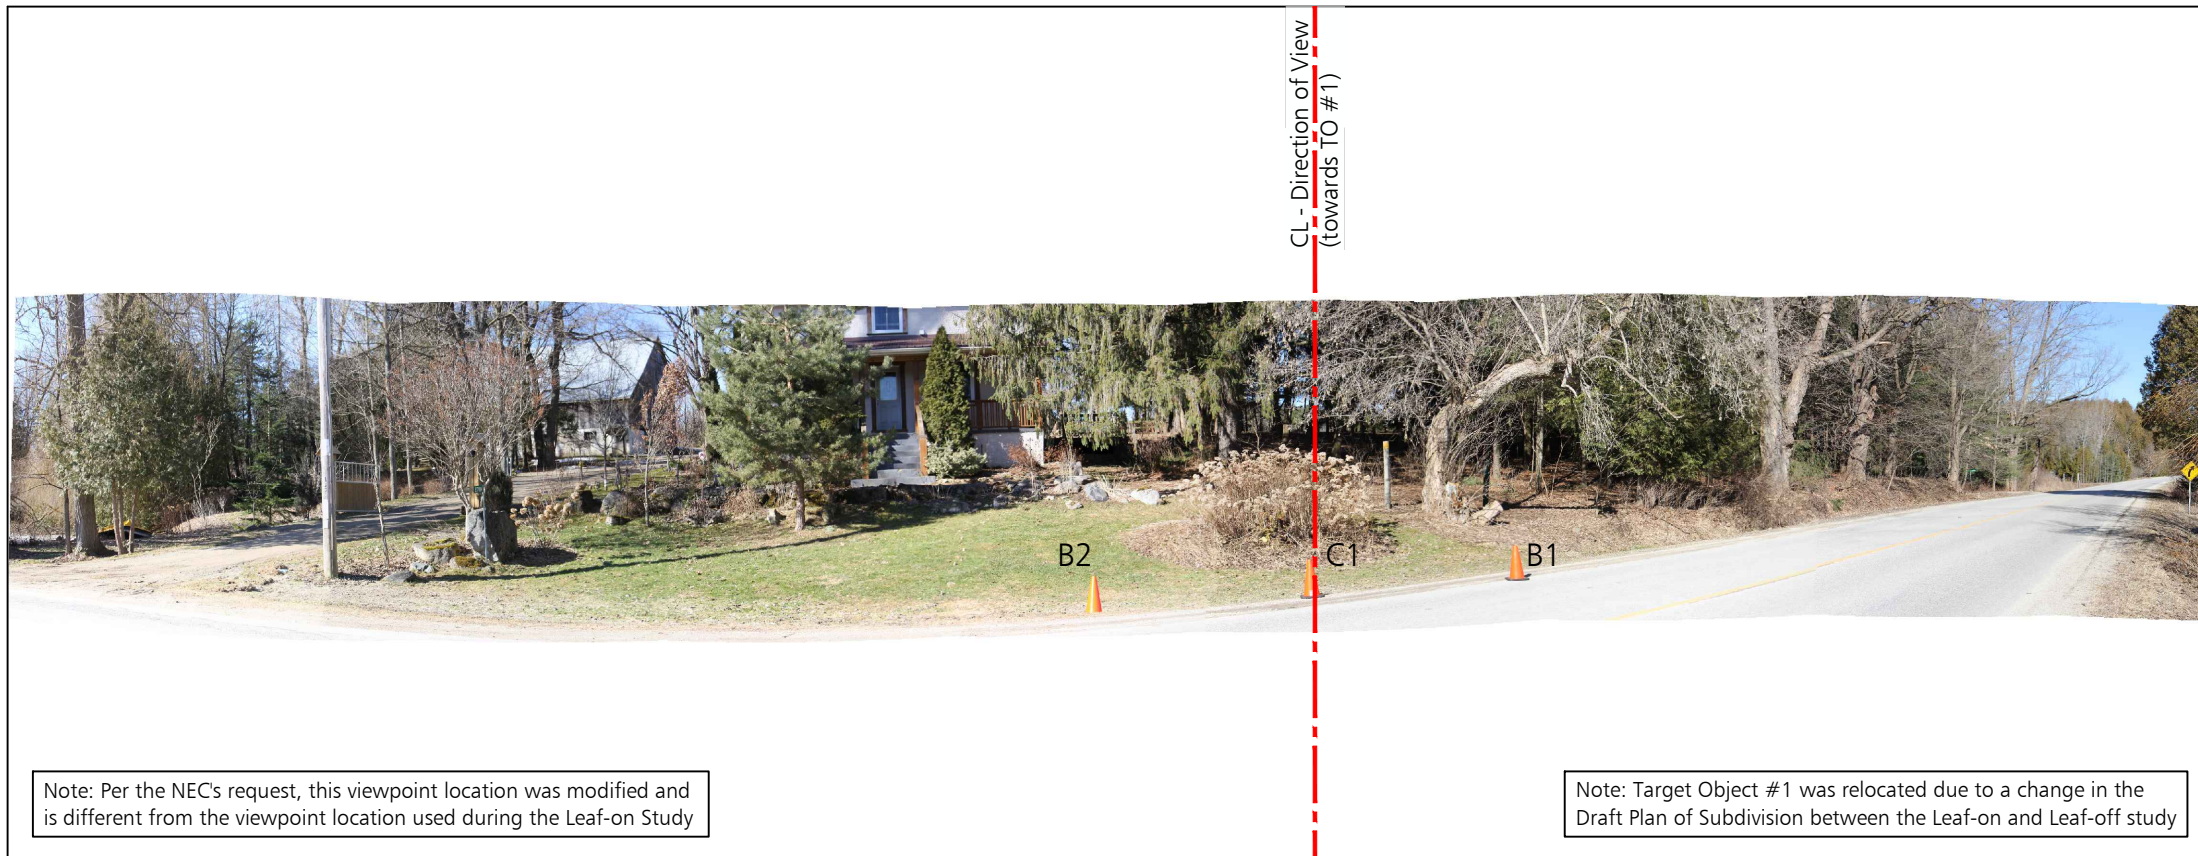
Existing Conditions Photograph (On Leaf Conditions - June 21, 2023)

Note: Per the NEC's request, this viewpoint location was modified and is different from the viewpoint location used during the Leaf-on Study

Note: Target Object #1 was relocated due to a change in the Draft Plan of Subdivision between the Leaf-on and Leaf-off study

Existing Conditions Photograph (Off Leaf Conditions - March 7, 2024)

- Because of the dense nature of the existing woodlot between the subject property and this viewpoint further study not required from this viewpoint
- No mitigation required on Subject Property to provide a visual buffer from this viewpoint

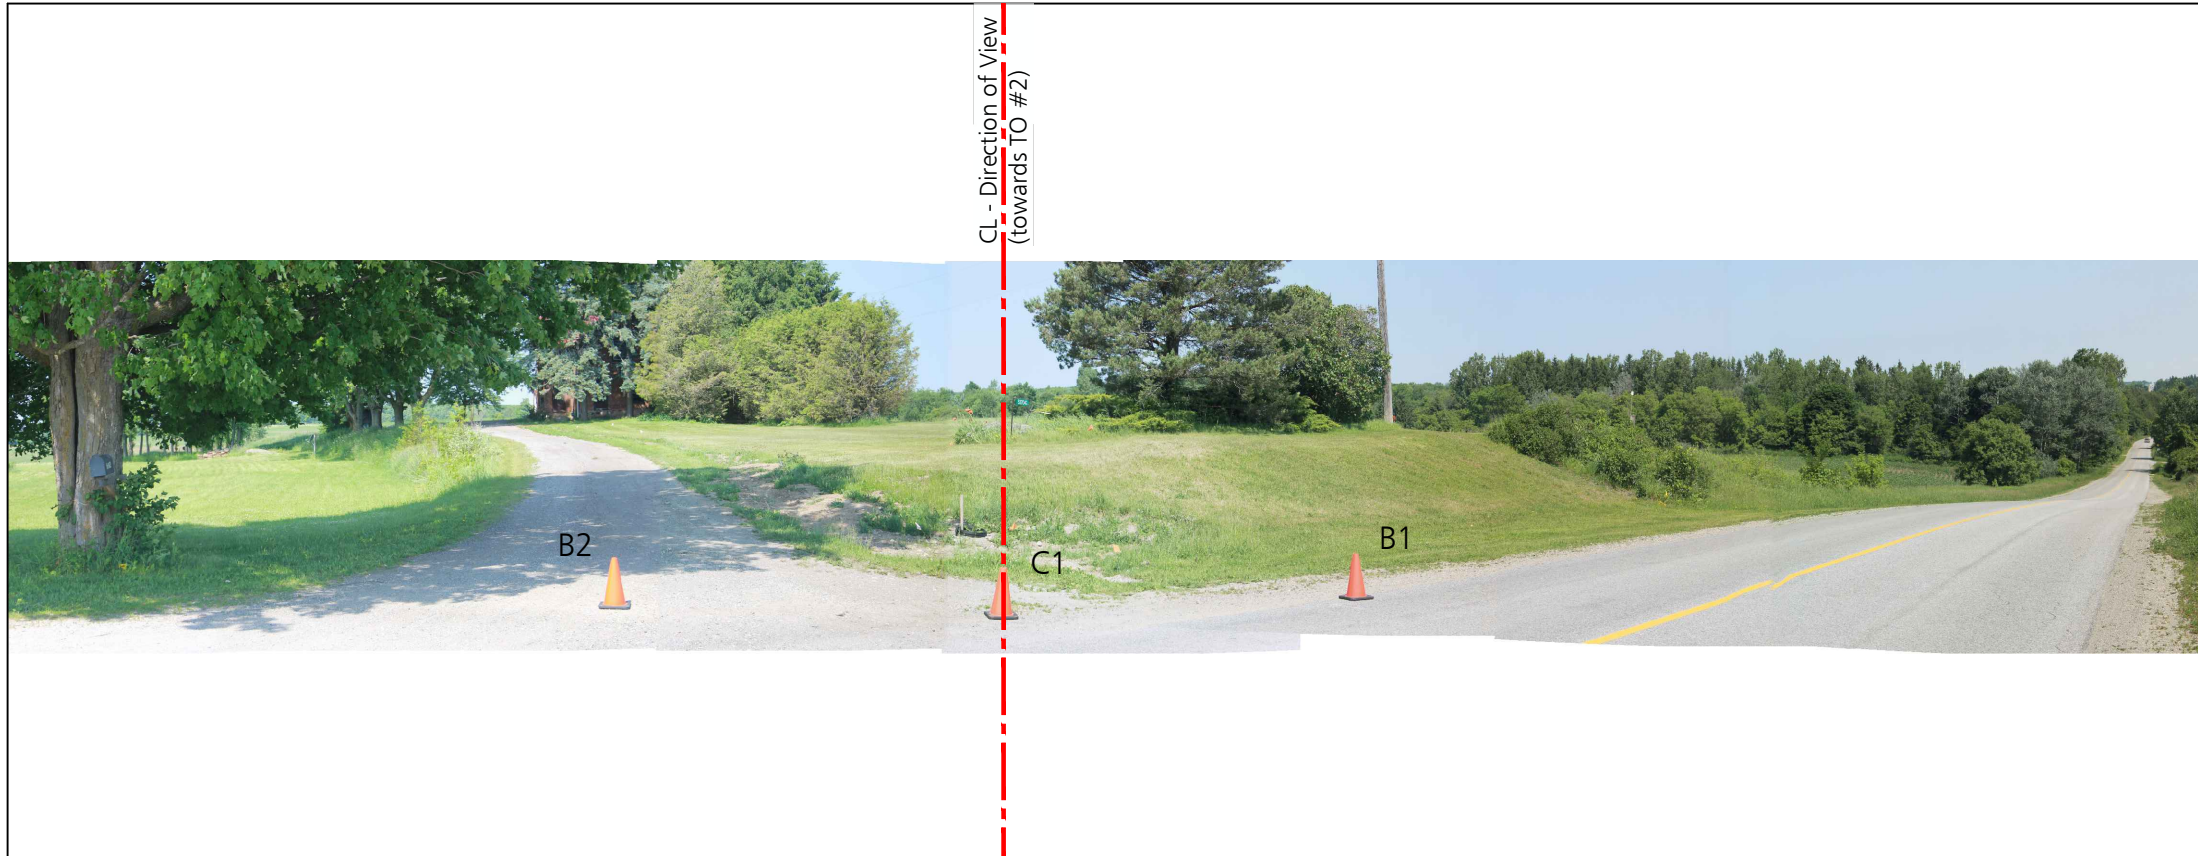
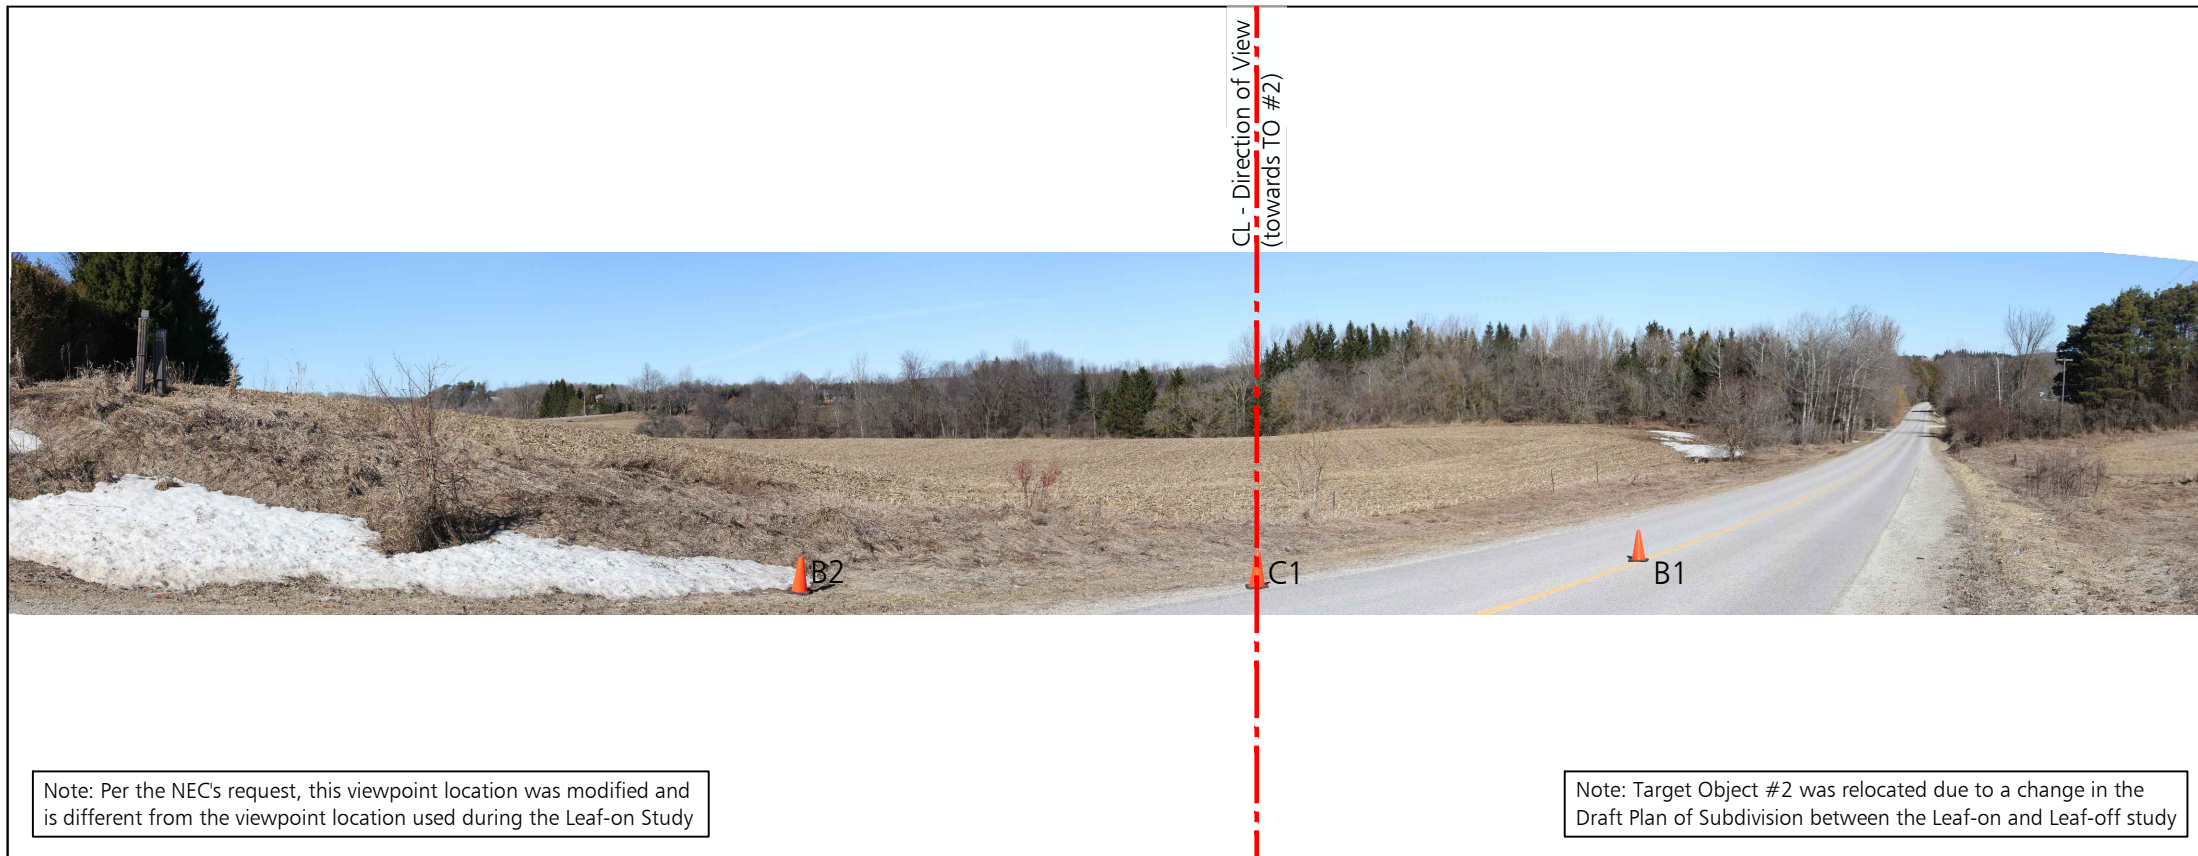
Existing Conditions Photograph (On Leaf Conditions - June 21, 2023)

Note: Per the NEC's request, this viewpoint location was modified and is different from the viewpoint location used during the Leaf-on Study

Note: Target Object #2 was relocated due to a change in the Draft Plan of Subdivision between the Leaf-on and Leaf-off study

Existing Conditions Photograph (Off Leaf Conditions - March 7, 2024)

- Because of the dense nature of the existing woodlot between the subject property and this viewpoint further study not required from this viewpoint
- No mitigation required on Subject Property to provide a visual buffer from this viewpoint

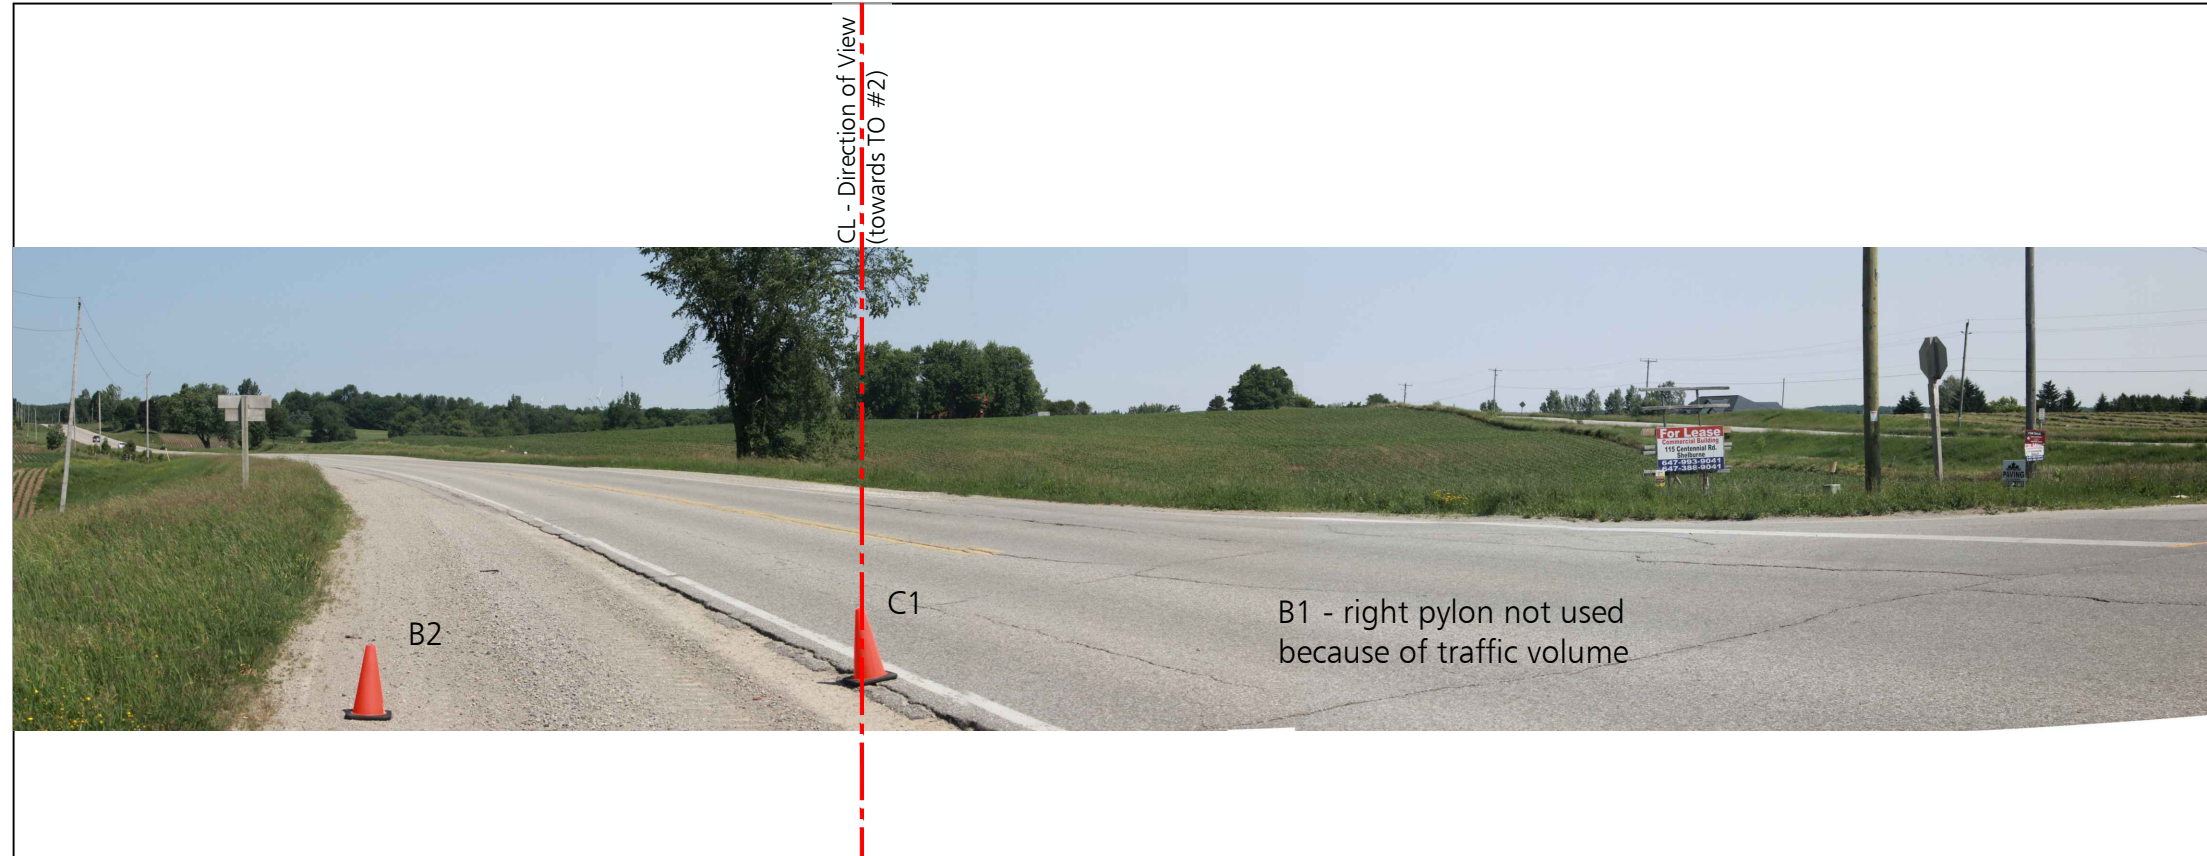
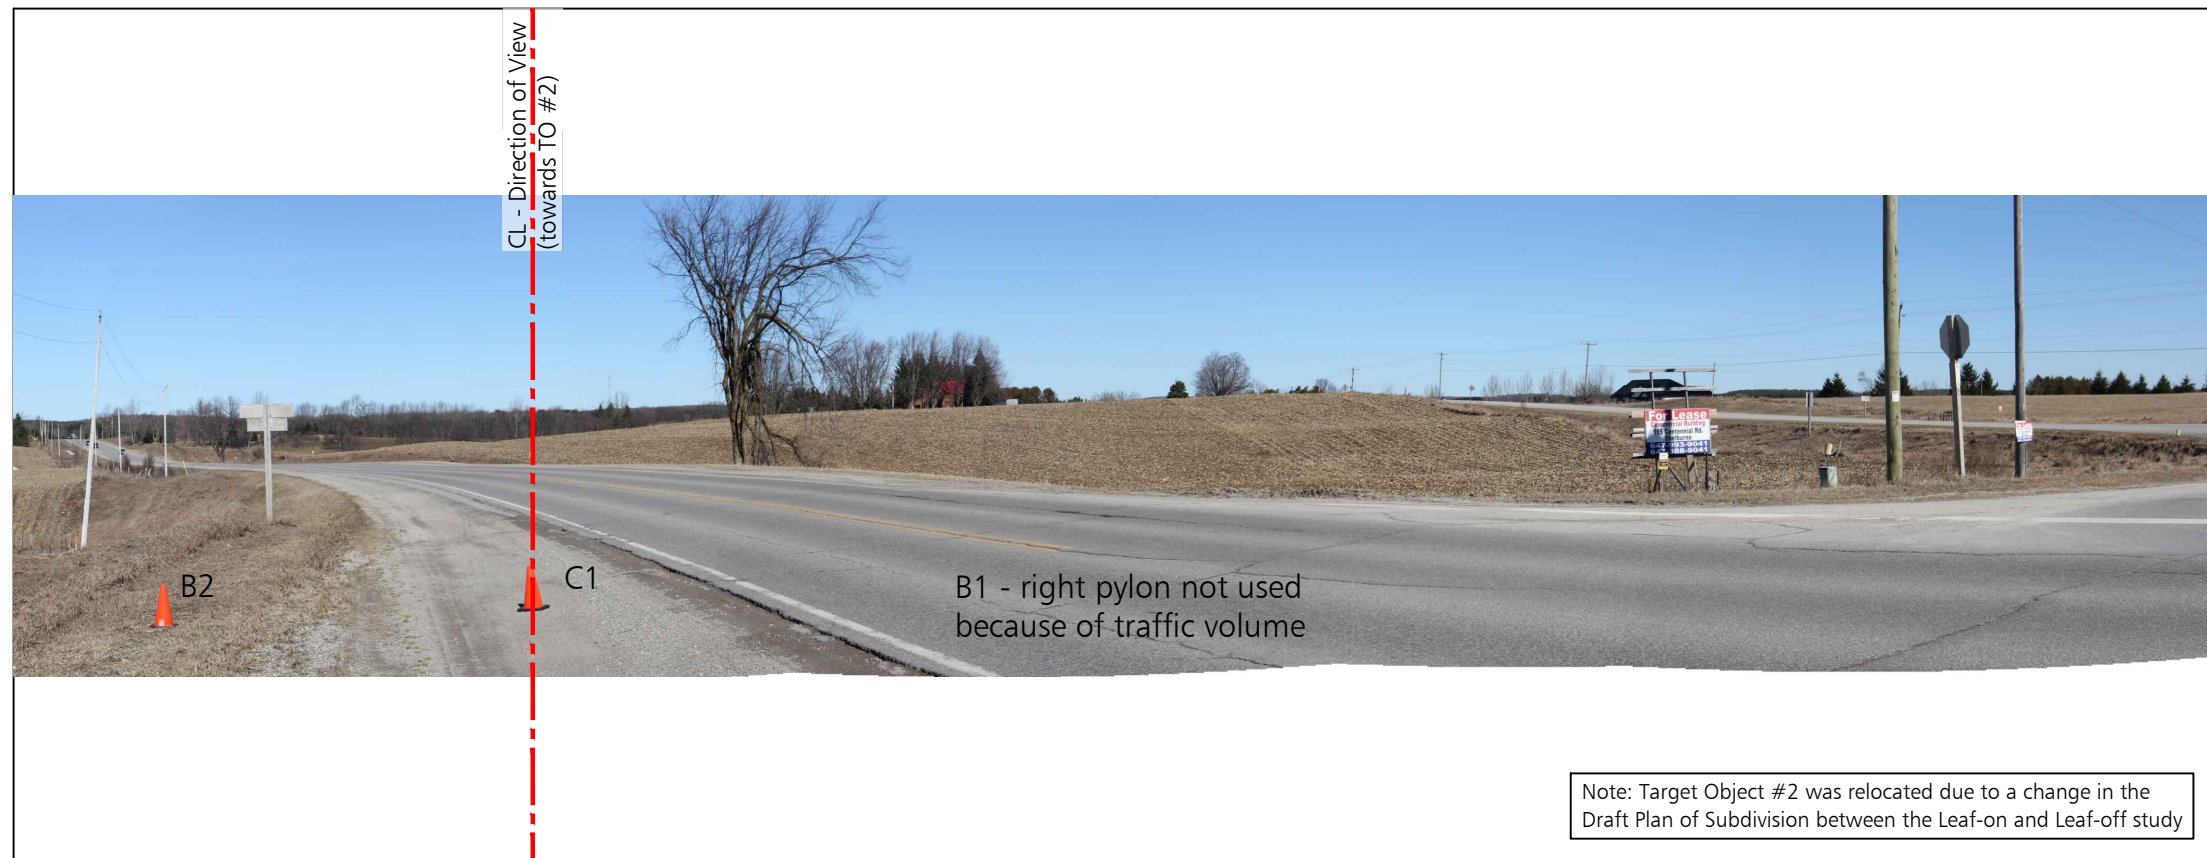
VIEWPOINT #6

Existing Conditions Photograph (On Leaf Conditions - June 21, 2023)

Existing Conditions Photograph (Off Leaf Conditions - March 7, 2024)

- We recommend introducing a hedgerow along the southern property line by adding both deciduous and evergreen trees with deciduous shrubs. The additional plantings will provide additional visual buffering thereby reducing visibility into the subject property.
- Recommended planting:
 - deciduous trees @7.0m o/c
 - evergreen trees @4.0m o/c
 - deciduous shrubs @1.0m o/c
