**RE: VISUAL IMPACT ASSESSMENT STUDY for HORNING'S MILL'S DEVELOPMENT
RESULTS OF LEAF OFF STUDY (STAGE 2, REVISION 1)**

VM1 HORNING'S MILLS VISUAL IMPACT ASSESSMENT VIEWSHED MAP

S.1 HORNING'S MILLS VISUAL IMPACT ASSESSMENT

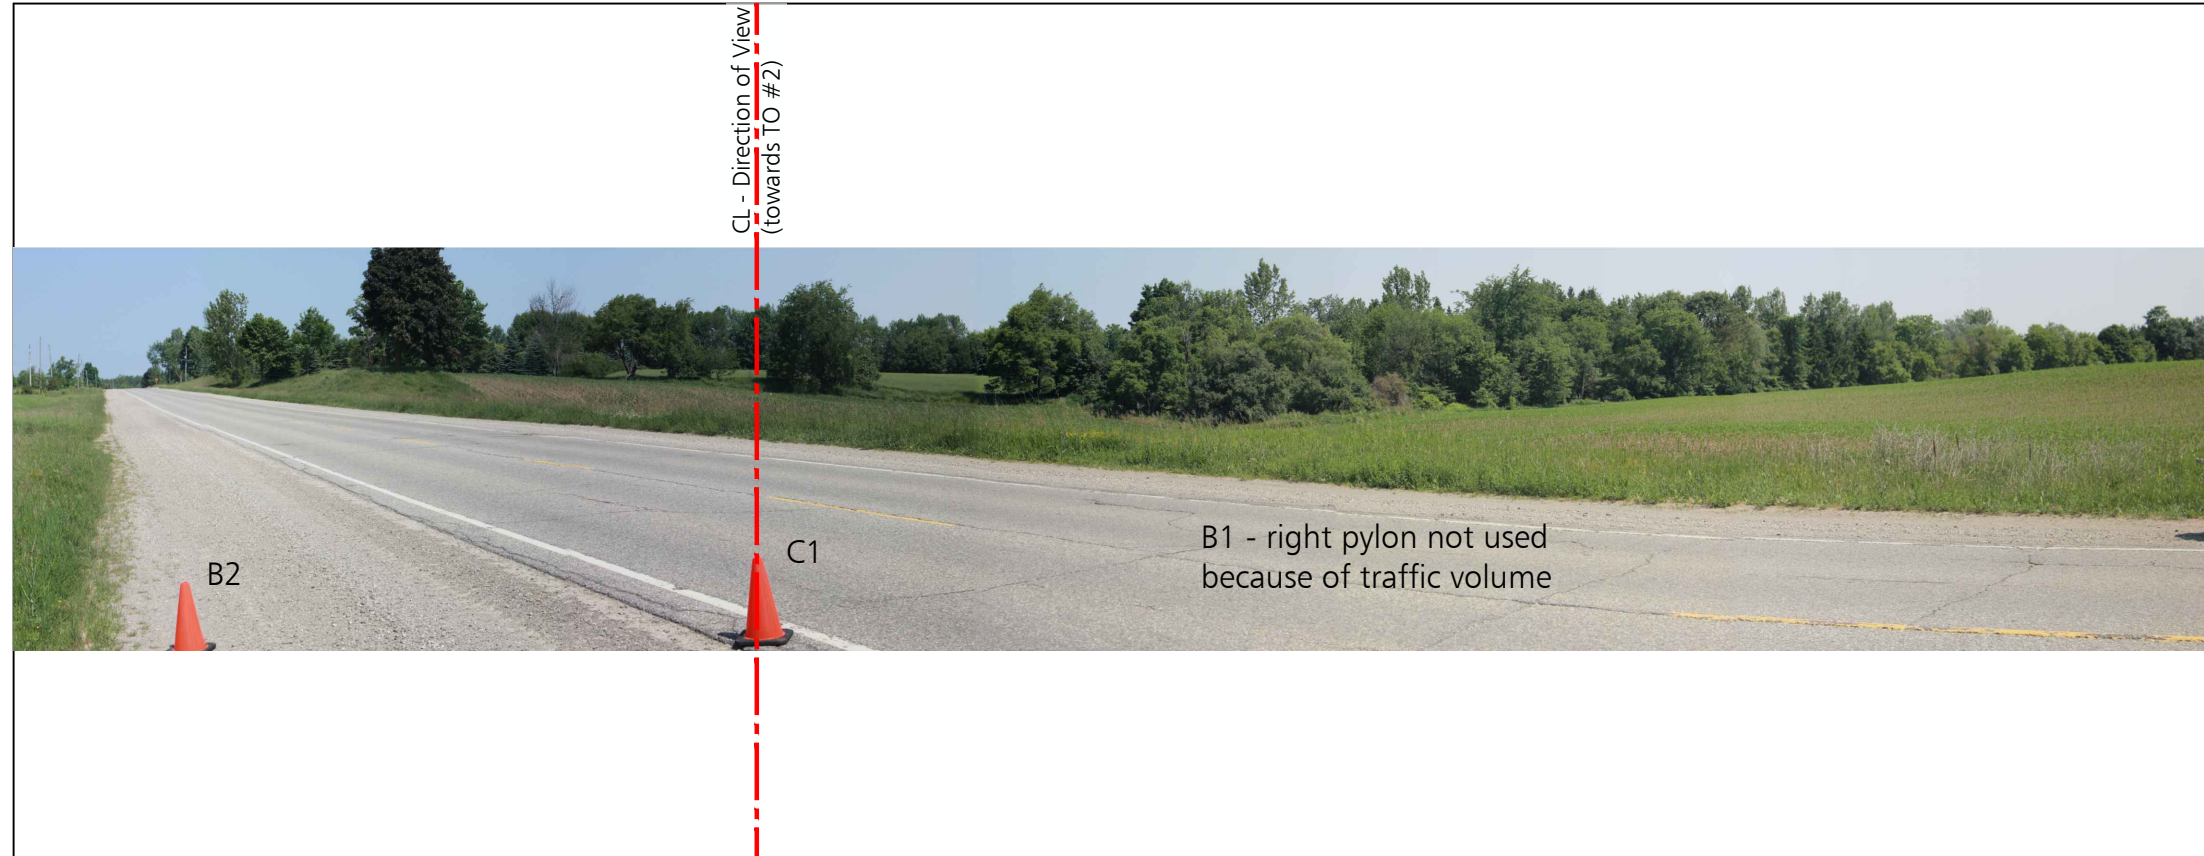
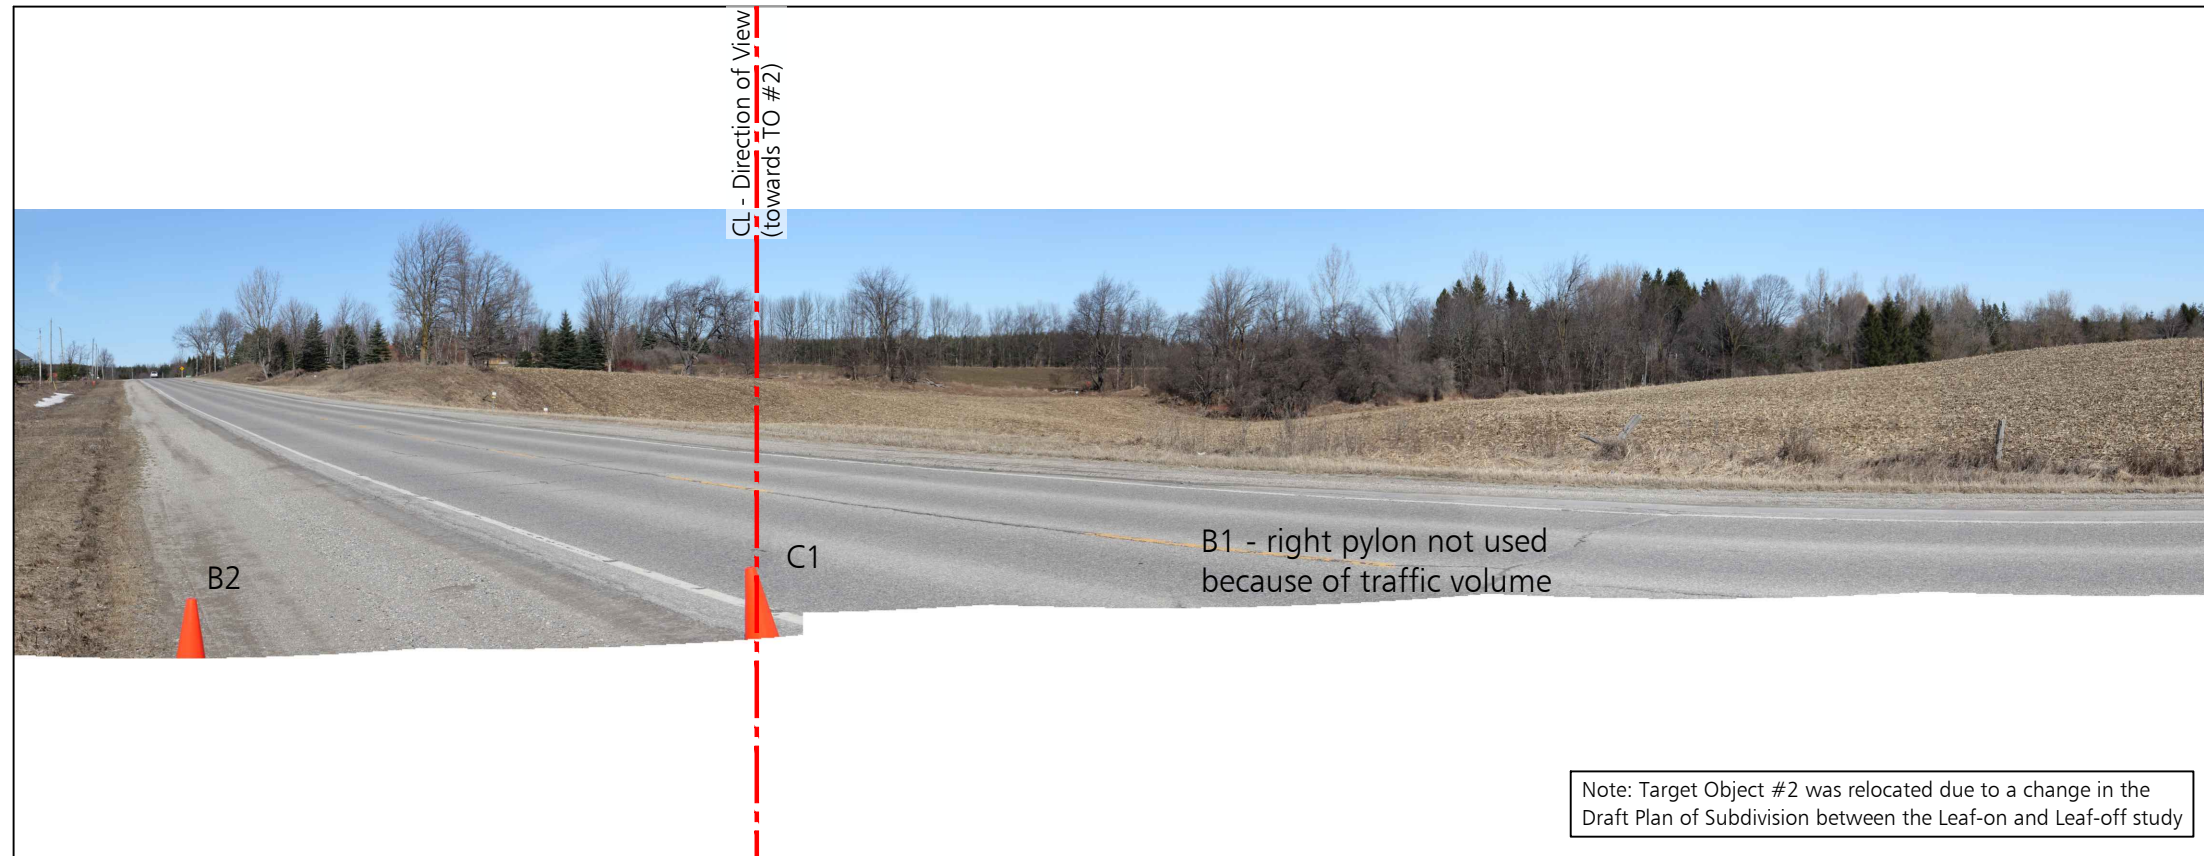
Existing Conditions Photograph (On Leaf Conditions - June 21, 2023)

Note: Target Object #2 was relocated due to a change in the Draft Plan of Subdivision between the Leaf-on and Leaf-off study

Existing Conditions Photograph (Off Leaf Conditions - March 7, 2024)

- We recommend introducing a hedgerow along the southern property line by adding both deciduous and evergreen trees with deciduous shrubs. The additional plantings will provide additional visual buffering thereby reducing visibility into the subject property.
- Recommended planting:
 - deciduous trees @7.0m o/c
 - evergreen trees @4.0m o/c
 - deciduous shrubs @1.0m o/c

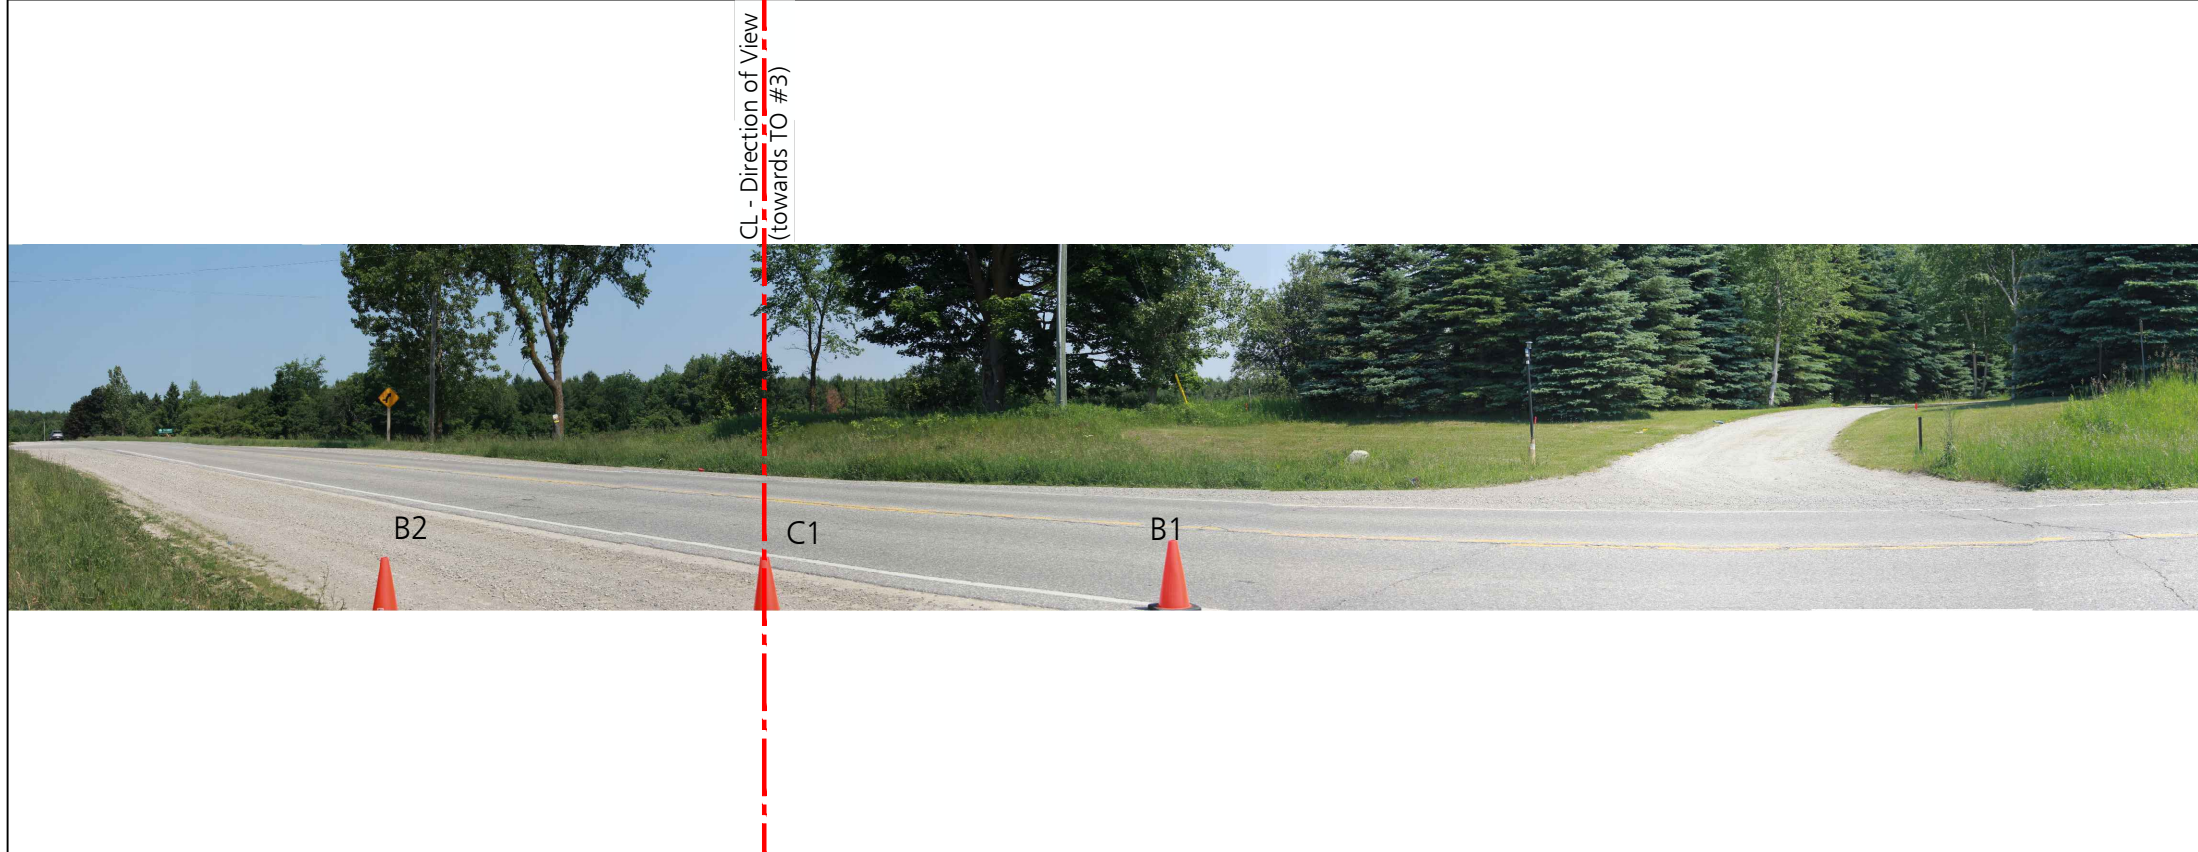
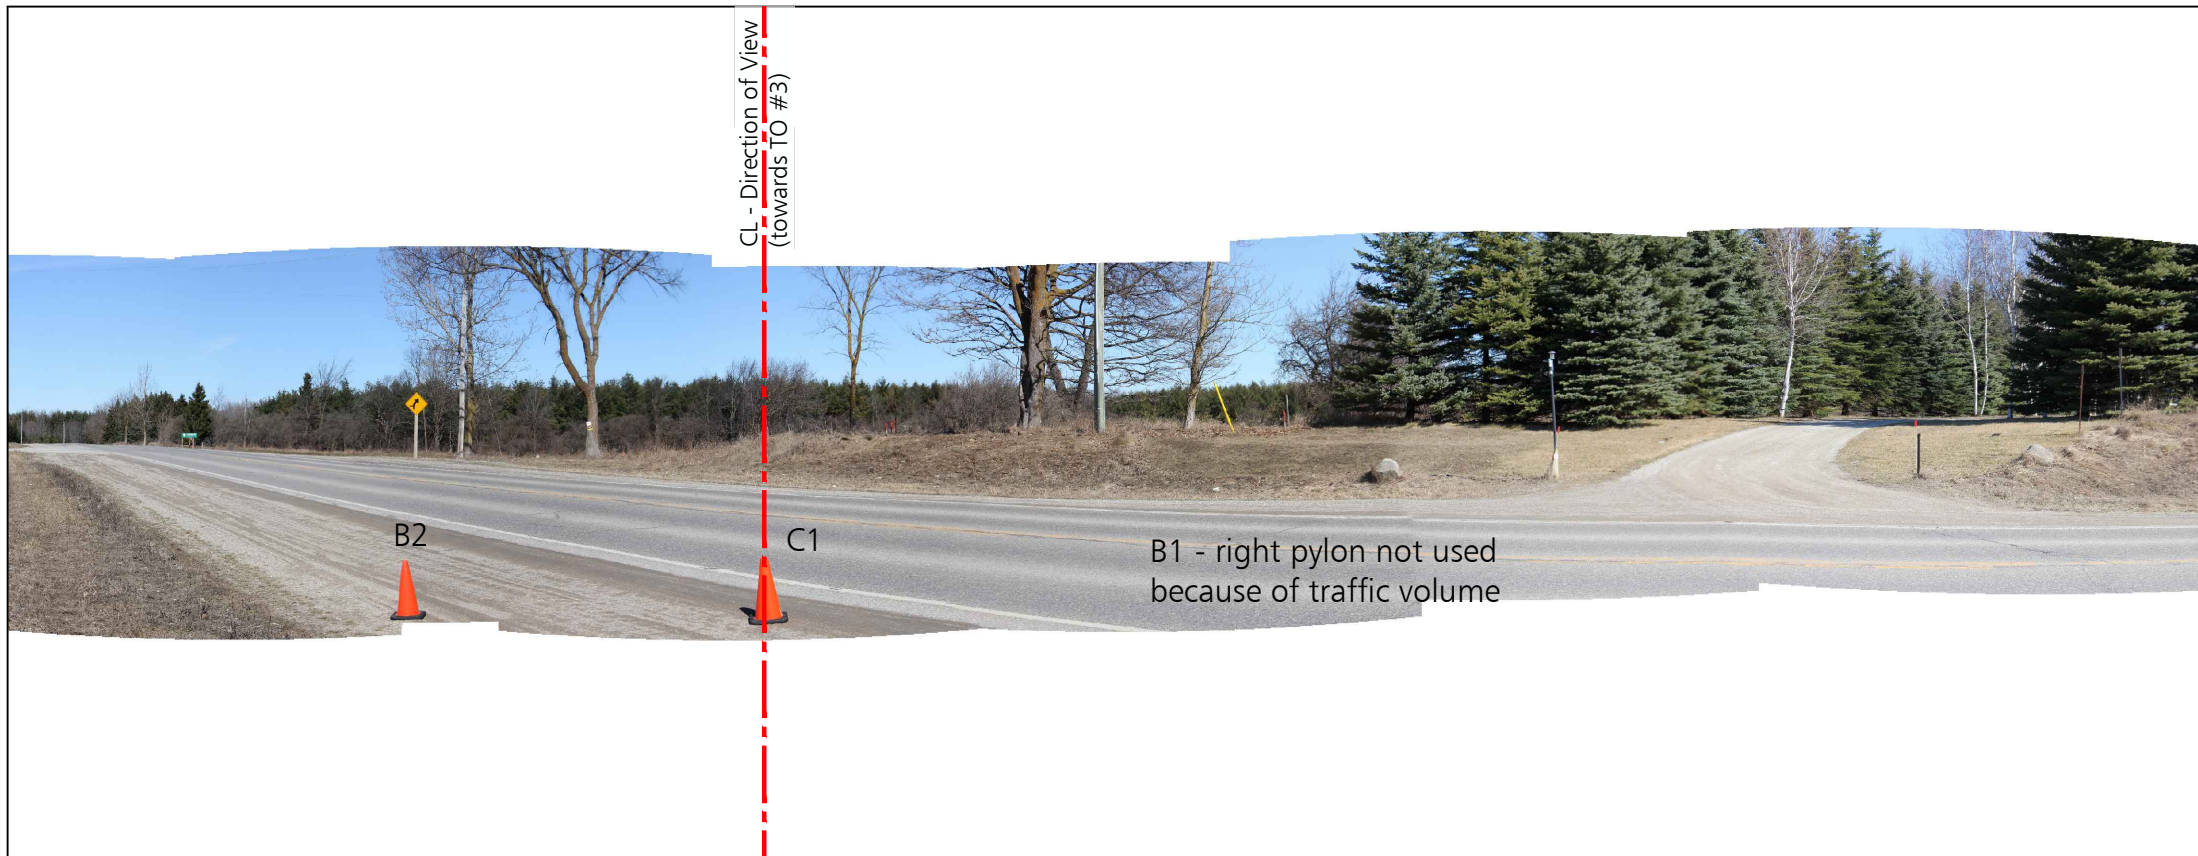
Existing Conditions Photograph (On Leaf Conditions - June 21, 2023)

Existing Conditions Photograph (Off Leaf Conditions - March 7, 2024)

- We recommend introducing a hedgerow along the western and southern property lines by adding both deciduous and evergreen trees with deciduous shrubs. The additional plantings will provide additional visual buffering thereby reducing visibility into the subject property.
- Recommended planting:
 - deciduous trees @7.0m o/c
 - evergreen trees @4.0m o/c
 - deciduous shrubs @1.0m o/c

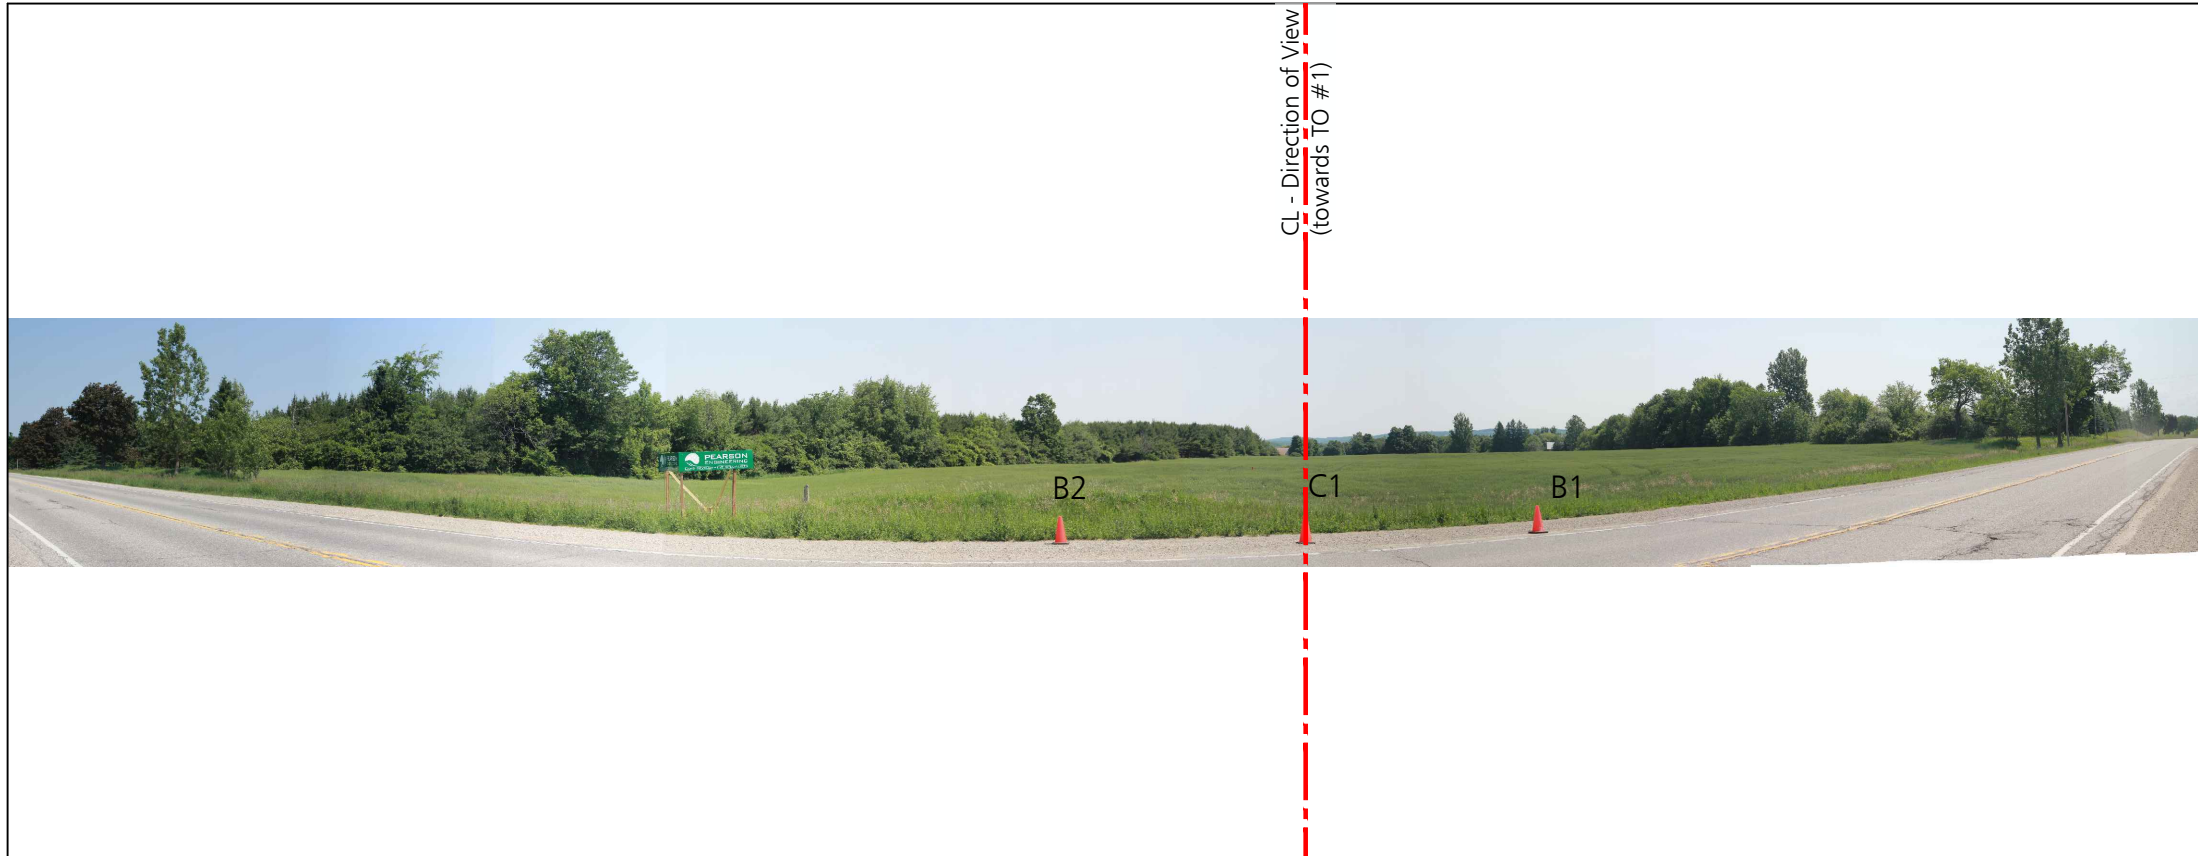
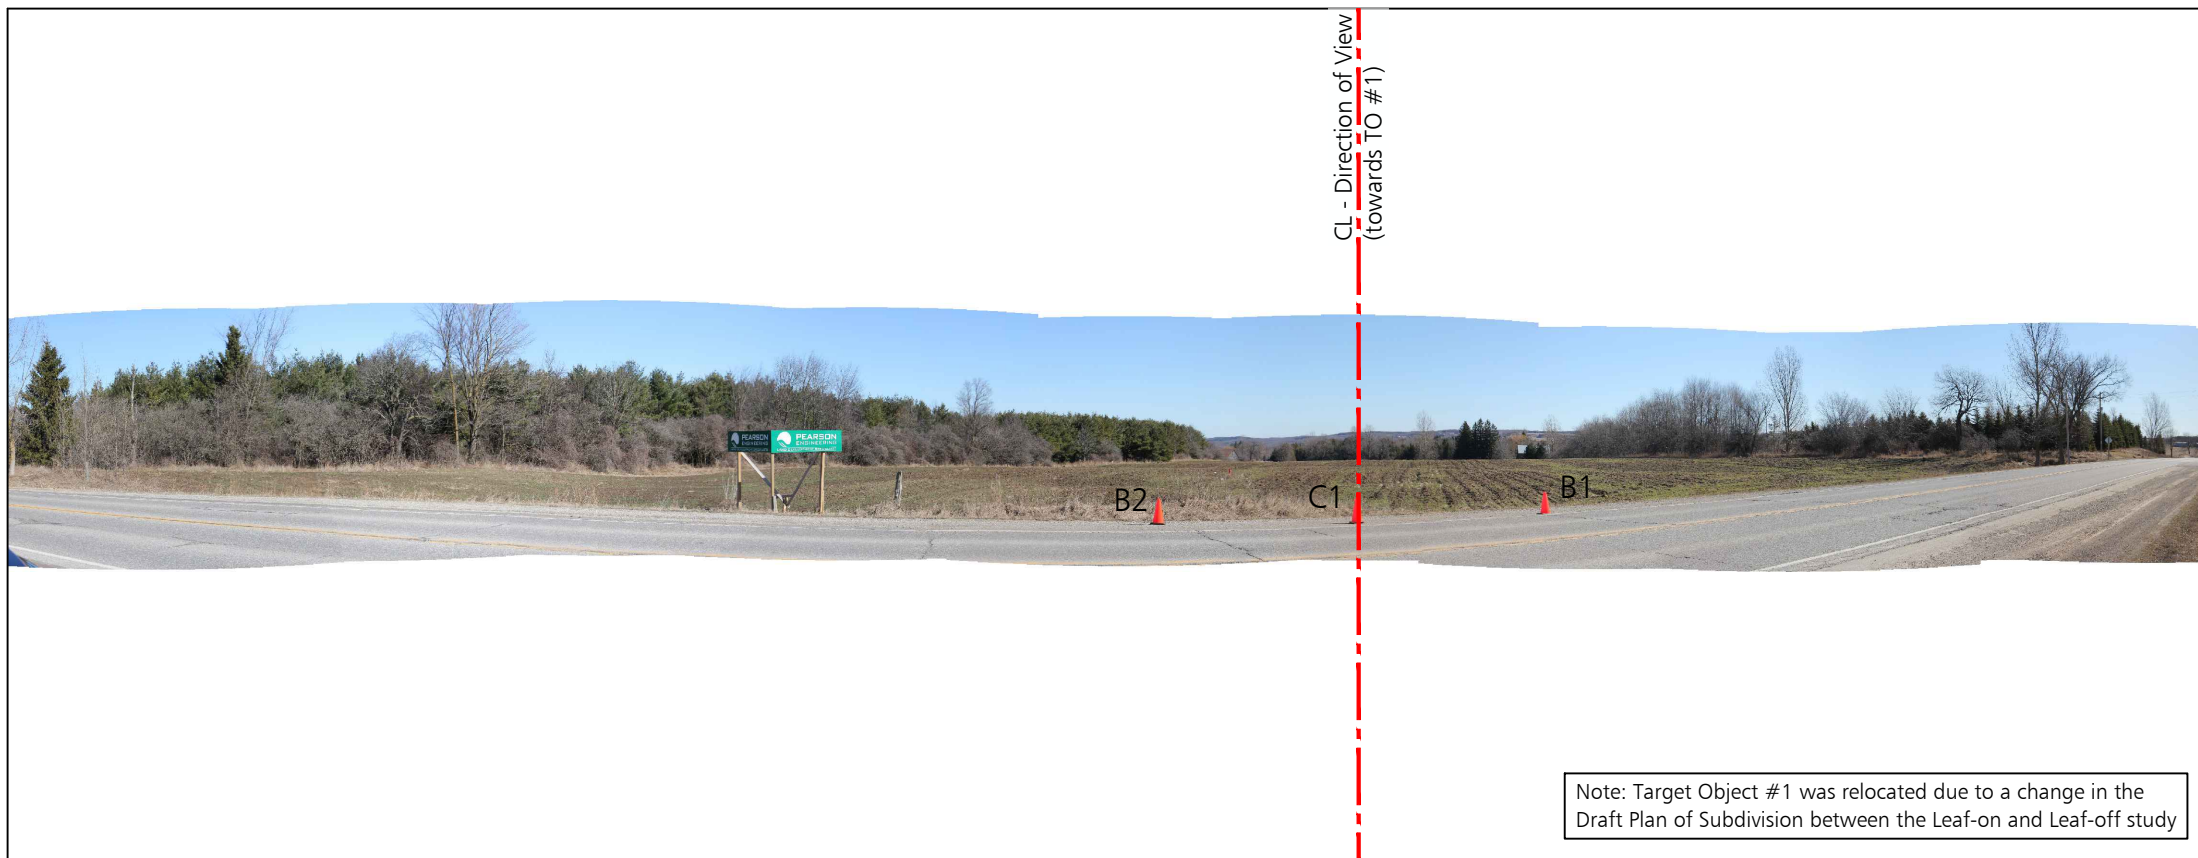
Existing Conditions Photograph (On Leaf Conditions - June 21, 2023)

Note: Target Object #1 was relocated due to a change in the Draft Plan of Subdivision between the Leaf-on and Leaf-off study

Existing Conditions Photograph (Off Leaf Conditions - March 7, 2024)

- As the subject property is visible from this viewpoint during both leaf off and leaf on conditions, we recommend strengthening the hedgerow along the Western property line by adding both deciduous and evergreen trees with deciduous shrubs. The additional plantings will provide a visual buffering thereby reducing visibility into the subject property.
- Recommended planting:
 - deciduous trees @7.0m o/c
 - evergreen trees @4.0m o/c
 - deciduous shrubs @1.0m o/c

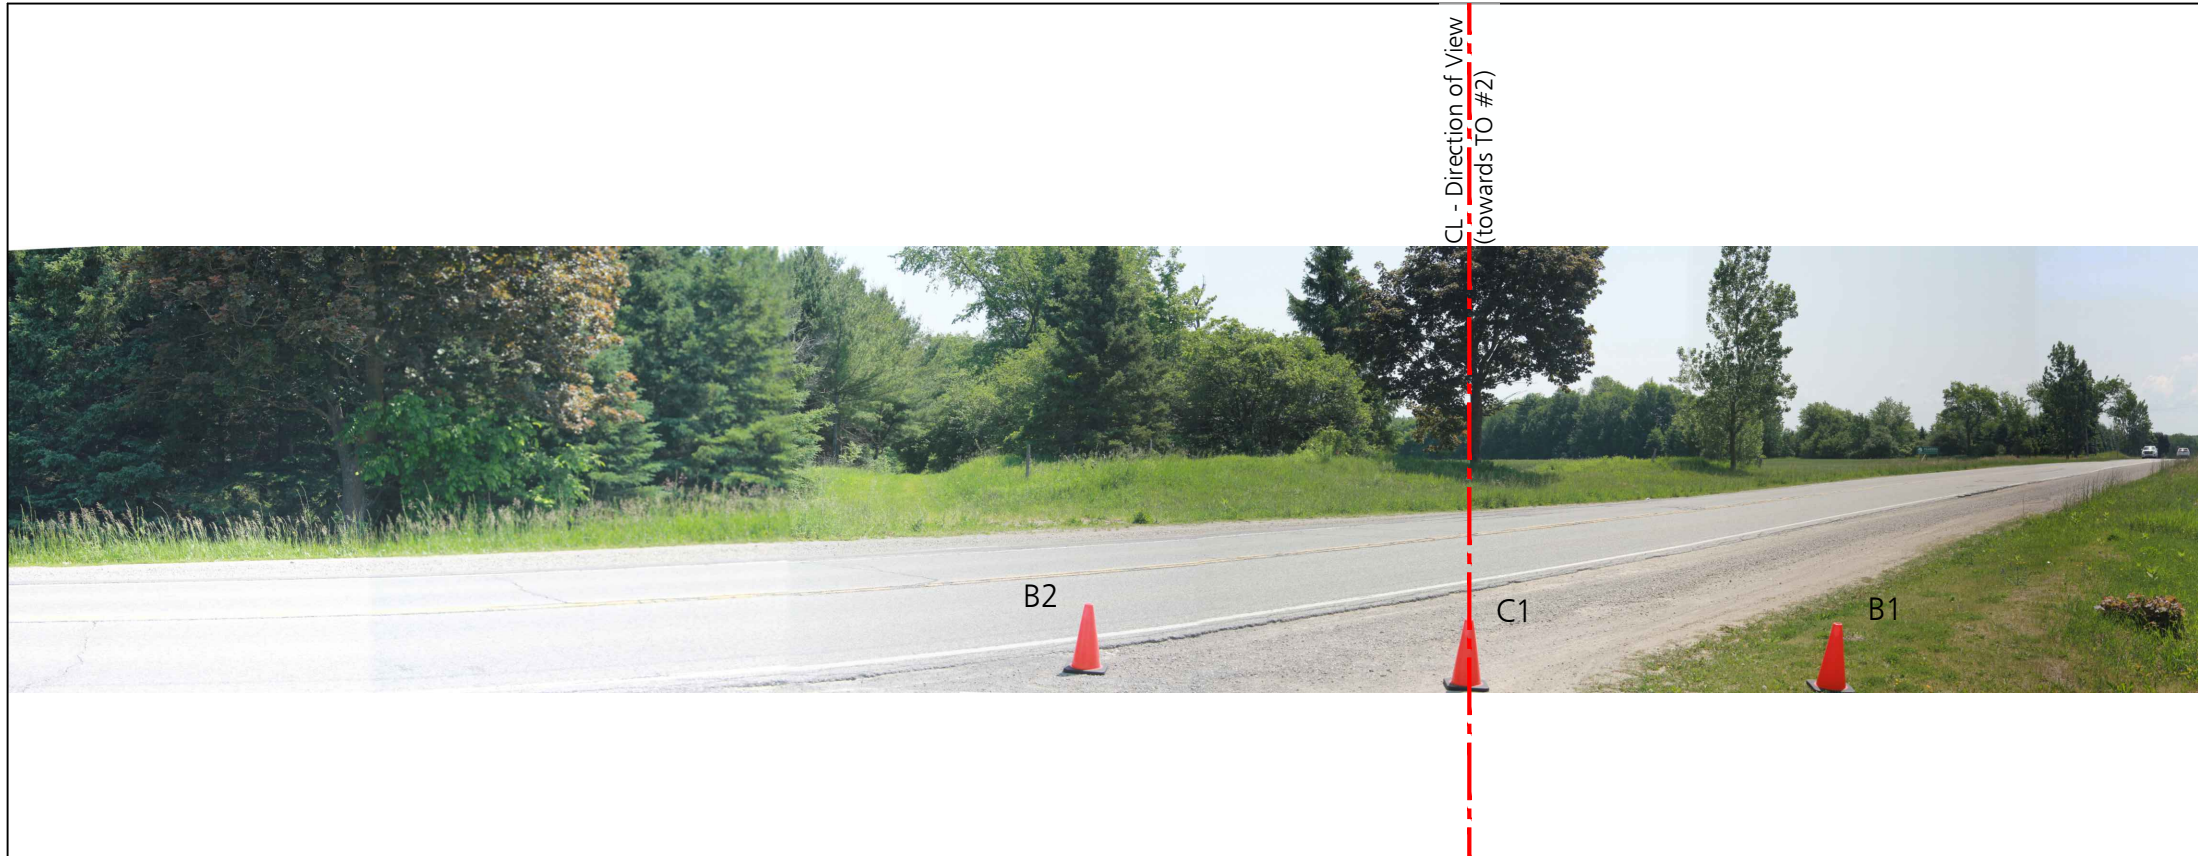
- Photograph taken from the West corner of the Subject Property along Dufferin Rd. 124 looking East into the Subject Property.
- An existing woodlot with primarily coniferous trees and some deciduous trees and shrubs exists north of the subject property
- Subject Property is visible south of the existing woodlot but not through the woodlot during leaf-on or leaf-off conditions

Existing Conditions Photograph (On Leaf Conditions - June 21, 2023)

Existing Conditions Photograph (Off Leaf Conditions - March 7, 2024)

- We recommend introducing a hedgerow along the western property line by adding both deciduous and evergreen trees with deciduous shrubs. The additional plantings will provide additional visual buffering thereby reducing visibility into the subject property.
- Recommended planting:
 - deciduous trees @7.0m o/c
 - evergreen trees @4.0m o/c
 - deciduous shrubs @1.0m o/c

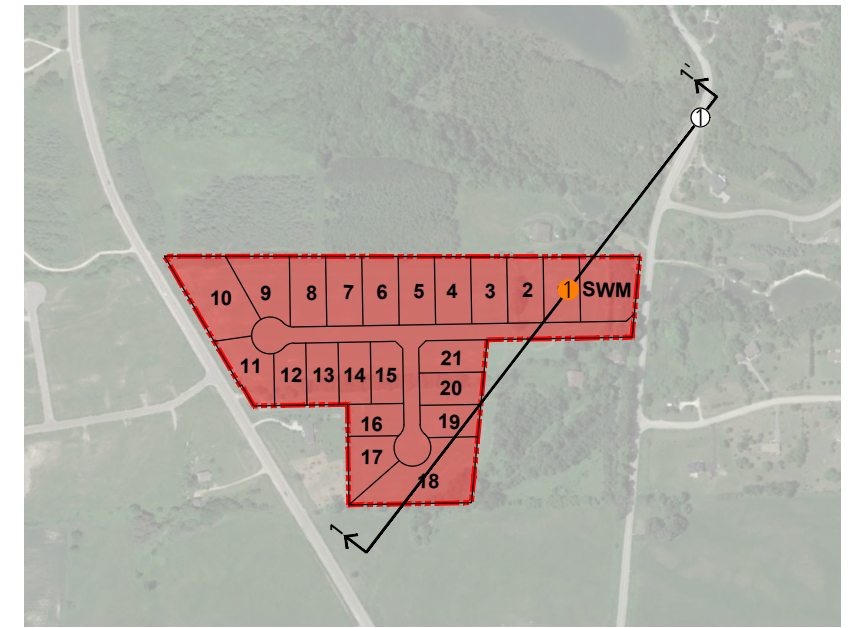
Key Plan - N.T.S.

A Key Plan (showing the Property and the surrounding lands) accompanies the Cross Section drawing. The Key Plan shows more clearly the lines of sight for the selected Viewpoint studied in the Line-of-sight Cross Section. Also visible on the Key plan is the existing vegetation that surrounds the subject property which is to remain.

— Unobstructed Sightline
 - - - Obstructed Sightline

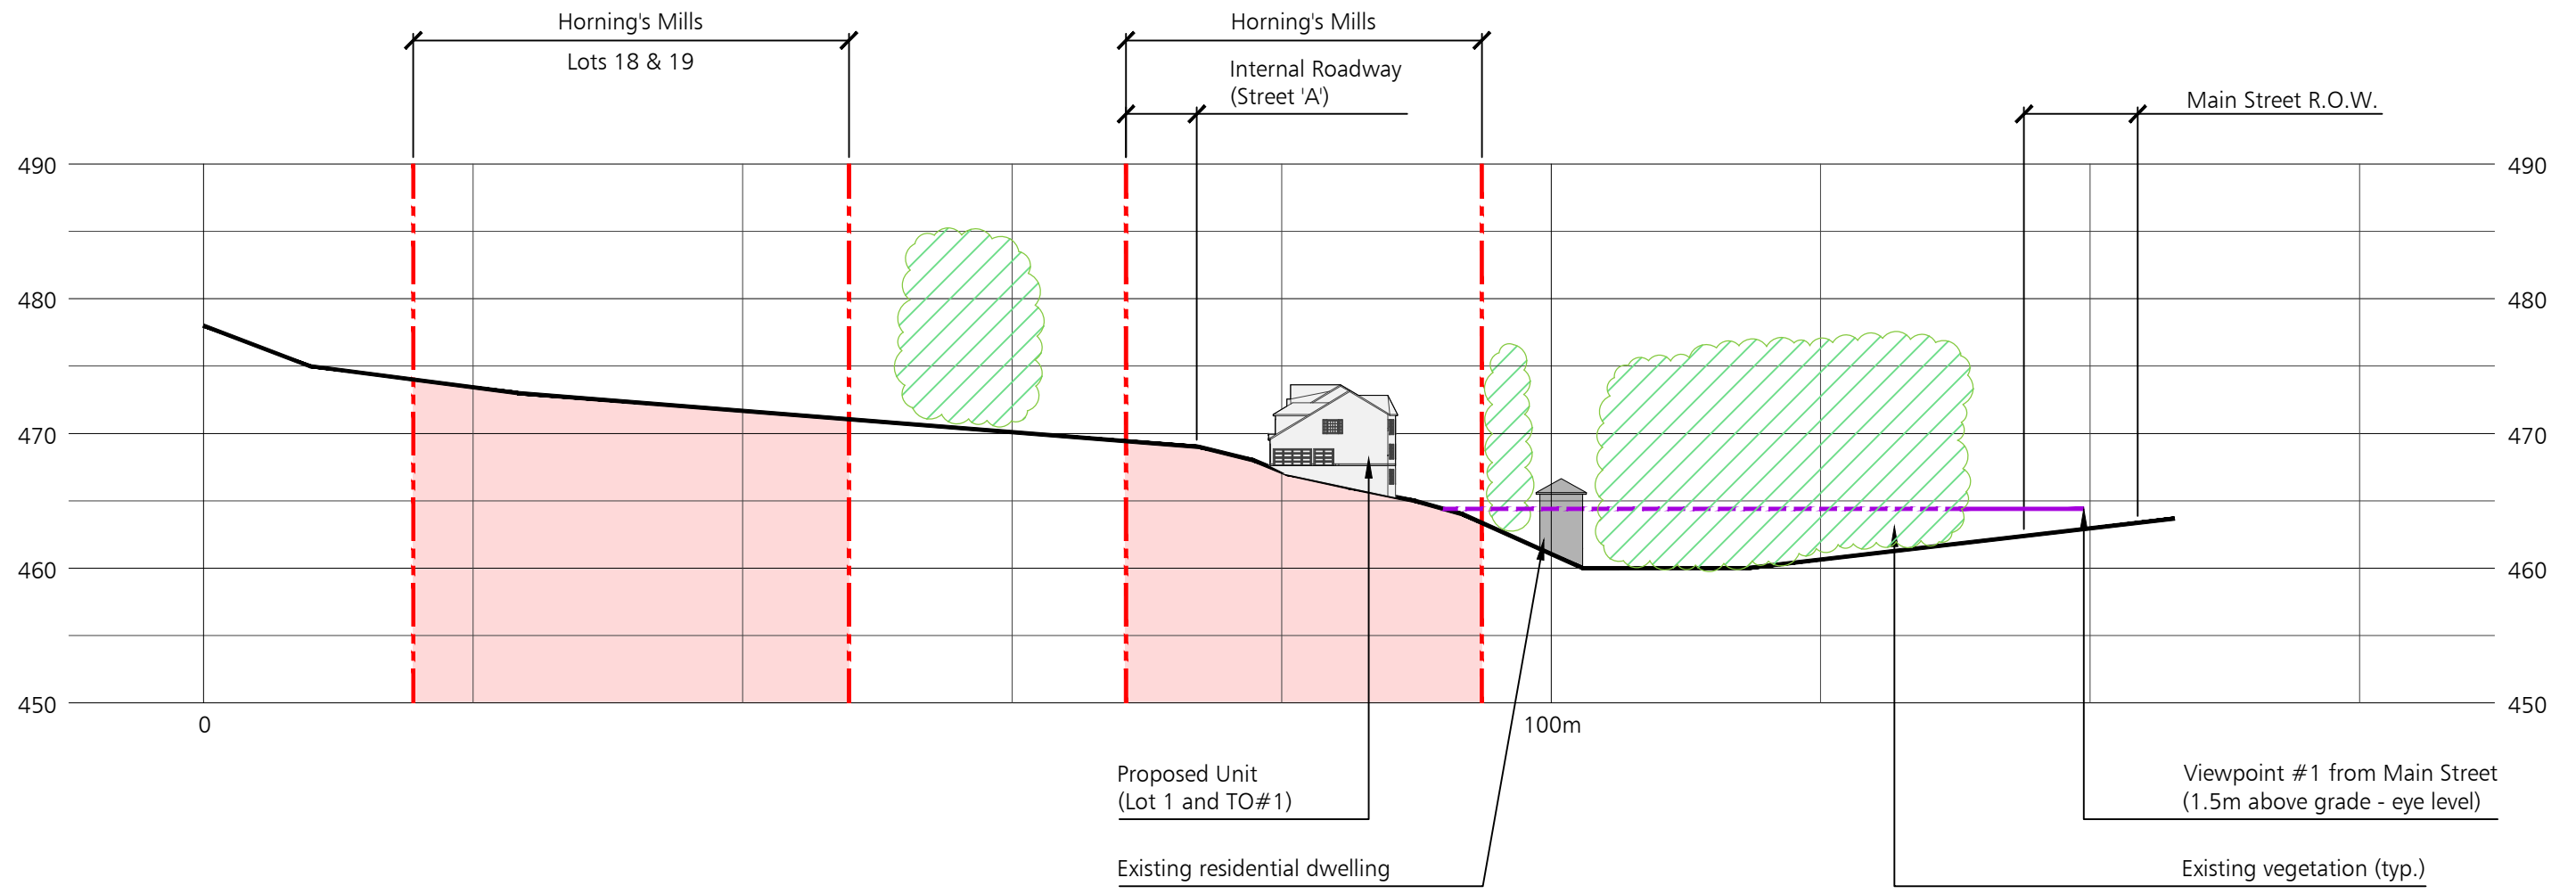
Section 1-1' - 1:50

As requested by the NEC, BTi carried out a single line-of-sight cross section from Viewpoint #1, through Target Object #1 and on through the rest of the property.

A line-of-sight cross section illustrates in a 2-dimensional way a cross section view of an individual viewshed from a Viewpoint. The alignment of the lines of sight on the Cross Section drawing follows the middle of the view as seen in the viewshed (i.e., centre of the panoramic pictures) for the Viewpoint. The line-of-sight originates from the Viewpoint location, crosses the Property boundary and continues in a straight line to the Viewpoint's Target Object (centre of a lot) and then beyond the Property.

The Line-of-Sight Cross Sections drawing depicts what is seen of the existing landscape conditions in the path of the line-of-sight: topography, elevation and grade changes, wooded areas, buildings, and public roads/streets. The drawing also depicts what is seen within the property line boundary, being the Viewpoint's Target Object, the proposed internal roadway, and Lots 18 & 19..

Per the approved Stage 2 TOR, the line-of-sight cross section was prepared in a 2-D sectional view using a vertical (elevation) and horizontal (ground level) ratio of 1:1, and a viewing height of 1.5 metres above ground level.

As can be seen from the Key Plan and the Line-of-sight Cross Section, there is an existing woodlot between Viewpoint #1 and the subject property. There is also a significant grade change as Viewpoint #1 is approximately 6m lower than the target object in Lot #1. The Line-of-sight Cross Section and the leaf off photo capture for Viewpoint #1 illustrates that the existing woodlot and change in elevation together provides a strong visual buffer of the development from this Viewpoint location.

Based on the line of sight cross section produced during this phase of work, BTi proposes and recommends that further work is NOT necessary for the following Viewpoint #1 which is consistent with the findings and recommendations made with the photo capture work for Viewpoint #1.
