**ROADS SUB-COMMITTEE
SPECIAL MEETING AGENDA
WEDNESDAY, OCTOBER 2, 2019 - 1:30 P.M.
MEETING HELD IN THE COUNCIL CHAMBERS**

Road Management Plan

Township of Melancthon

**September 2019
300043927.0000**

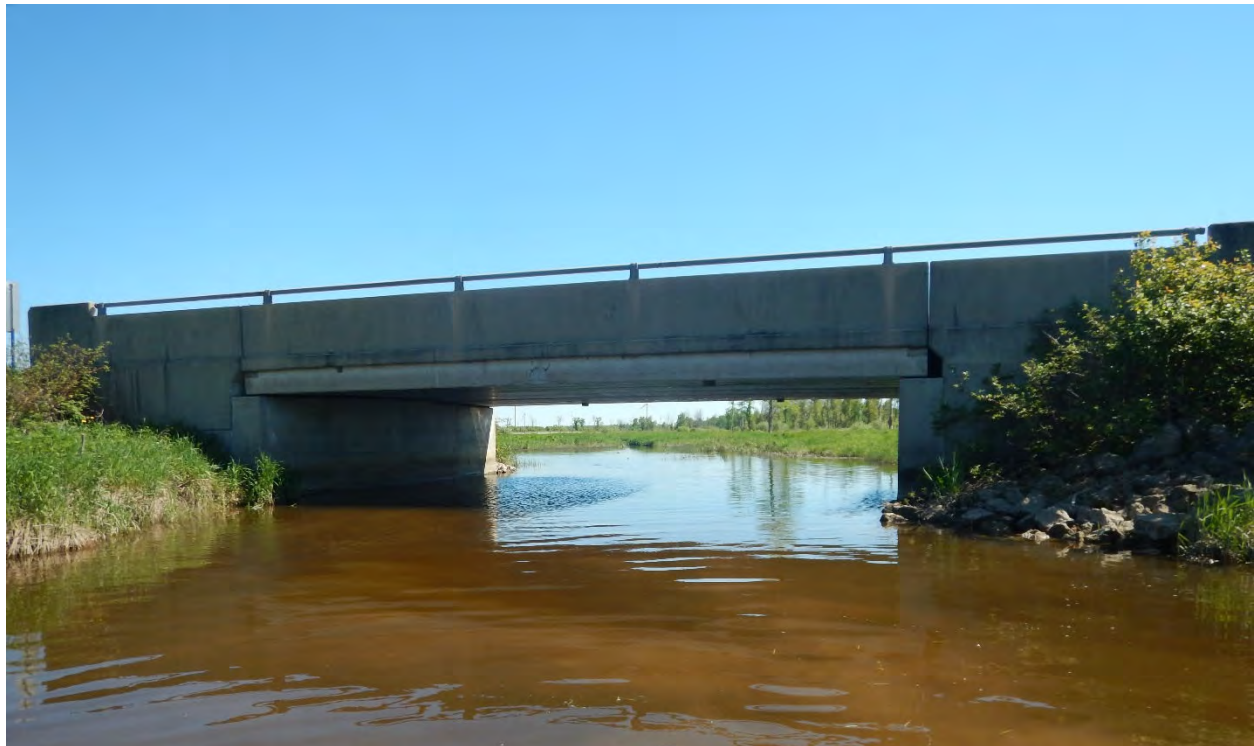
Structure 009 is generally in good condition but is demonstrating signs of concrete deterioration caused by the salt laden water leaking through the expansion joints. Based on the current BCI, minor rehabilitation should be considered as the BCI approaches 60 to ensure the structure does not deteriorate beyond repair. Concrete repairs, waterproofing and paving, and expansion joint replacement should be included in the rehabilitation project within approximately 6 years. Consideration may be given to converting the bridge to a semi-integral configuration during future rehabilitation to eliminate future maintenance and durability concerns related to the expansion joint. Consideration should also be given to installing a steel beam guide rail system, end treatments and structure connections to help protect oncoming traffic.

Maintenance Need	Element and Comments	Estimated Cost
Bridge Cleaning	Clean deck top and seals / sealants.	\$1,000.00
Maintenance Needs Total		\$1,000.00

Roadside Protection Repairs	Priority	Estimated Cost
Install Guide Rail, end treatments and structure connections.	1 to 5 Years	\$52,000.00

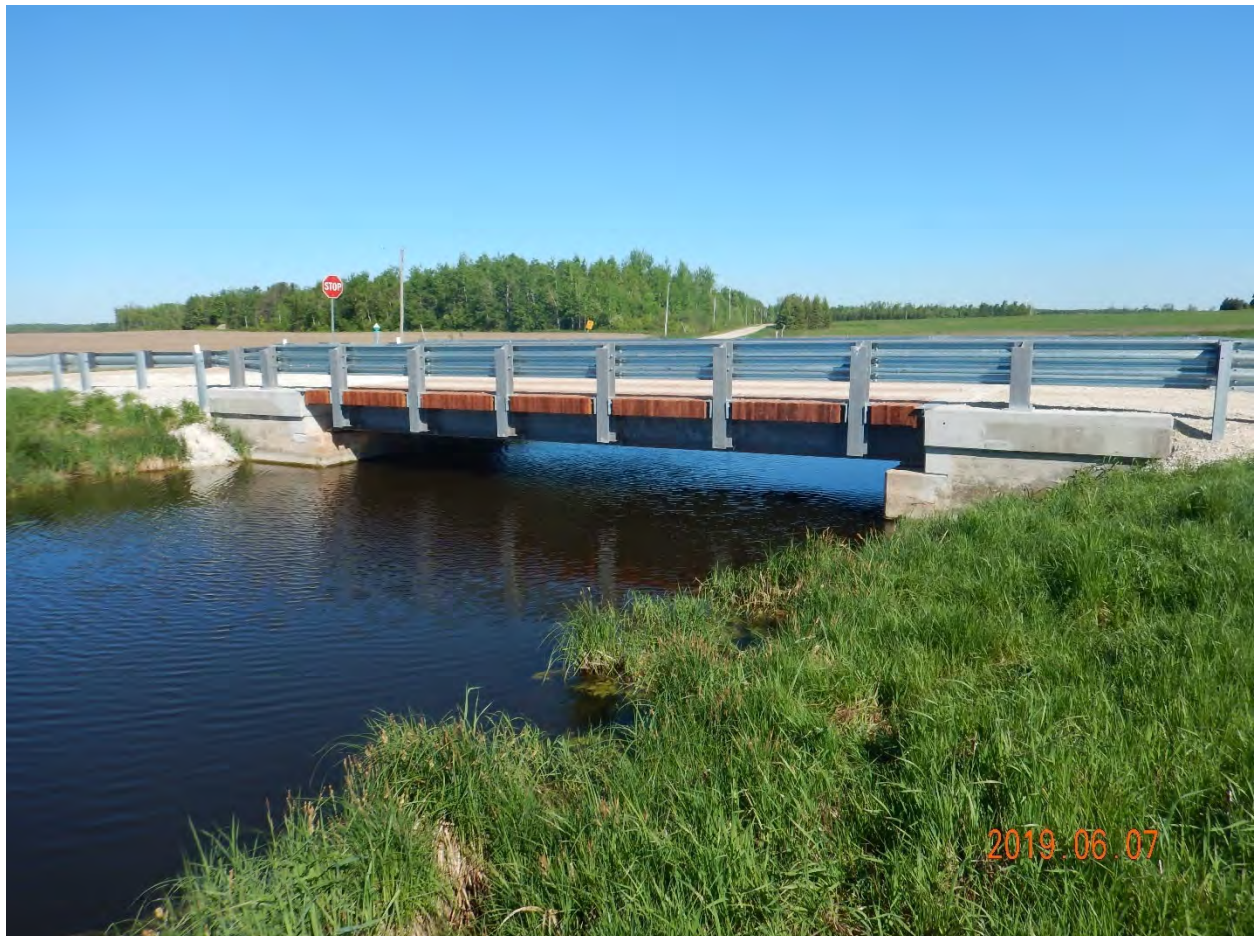
Structure 010 was rehabilitated in 2018 and is generally in excellent condition with only minor maintenance recommended at this time.

Maintenance Need	Element and Comments	Estimated Cost
Bridge Cleaning	Sweep deck top.	\$1,000.00
Maintenance Needs Total		\$1,000.00

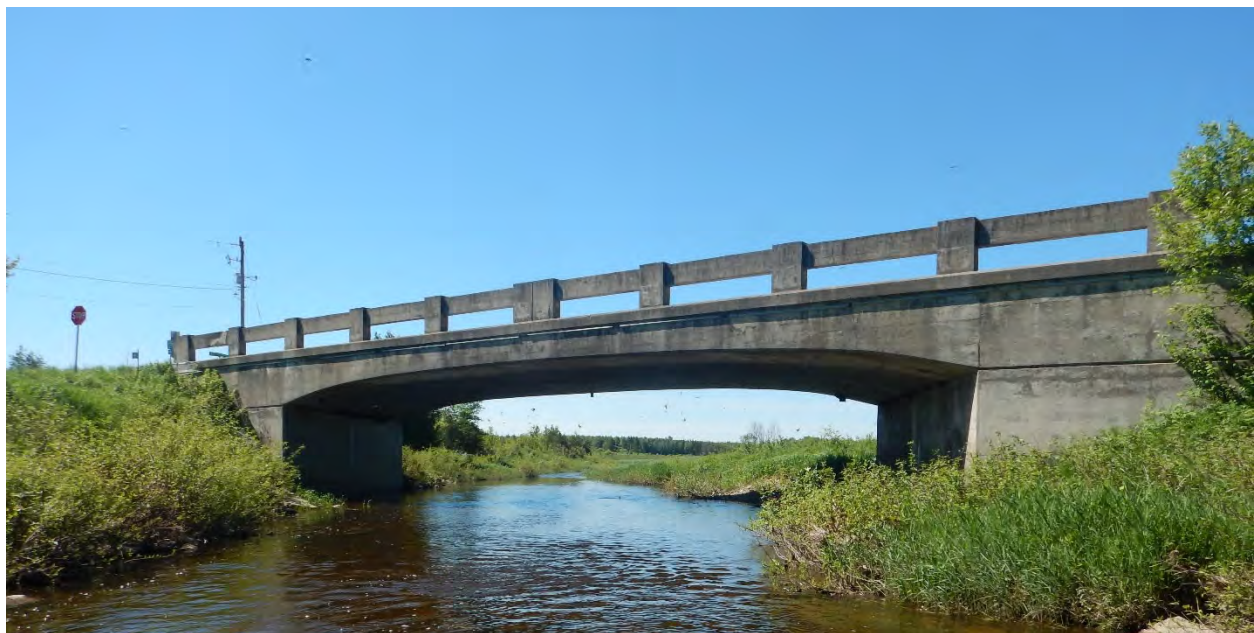
Structure 011 is generally in good to fair condition but is demonstrating signs of concrete deterioration on the deck top, and moisture penetration primarily through the deck construction joint. Based on the current BCI, a minor rehabilitation should be considered as the BCI approaches 60 to ensure the structure does not deteriorate beyond repair. Concrete repairs, waterproofing and paving, barrier replacement, and deck drain replacement should be included in the rehabilitation project within 5 years to help extend the service life of the structure. It is also recommended that a Detailed Deck Condition Survey, be completed prior to rehabilitation to determine the extent of deck repairs. Consideration should also be given to installing a steel beam guide rail system, end treatments and structure connections to help protect oncoming traffic. Based on the presence of swallow nests noted during the inspection, it is recommended that bird netting be installed on the structure in the season ahead of the scheduled rehabilitation work.

Maintenance Need	Element and Comments	Estimated Cost
Hazard Signs	Install hazard warning sign at SW quadrant.	\$250.00
Maintenance Needs Total		\$250.00

Additional Investigations	Priority	Estimated Cost
Detailed Deck Condition Survey.	Normal	\$10,000.00

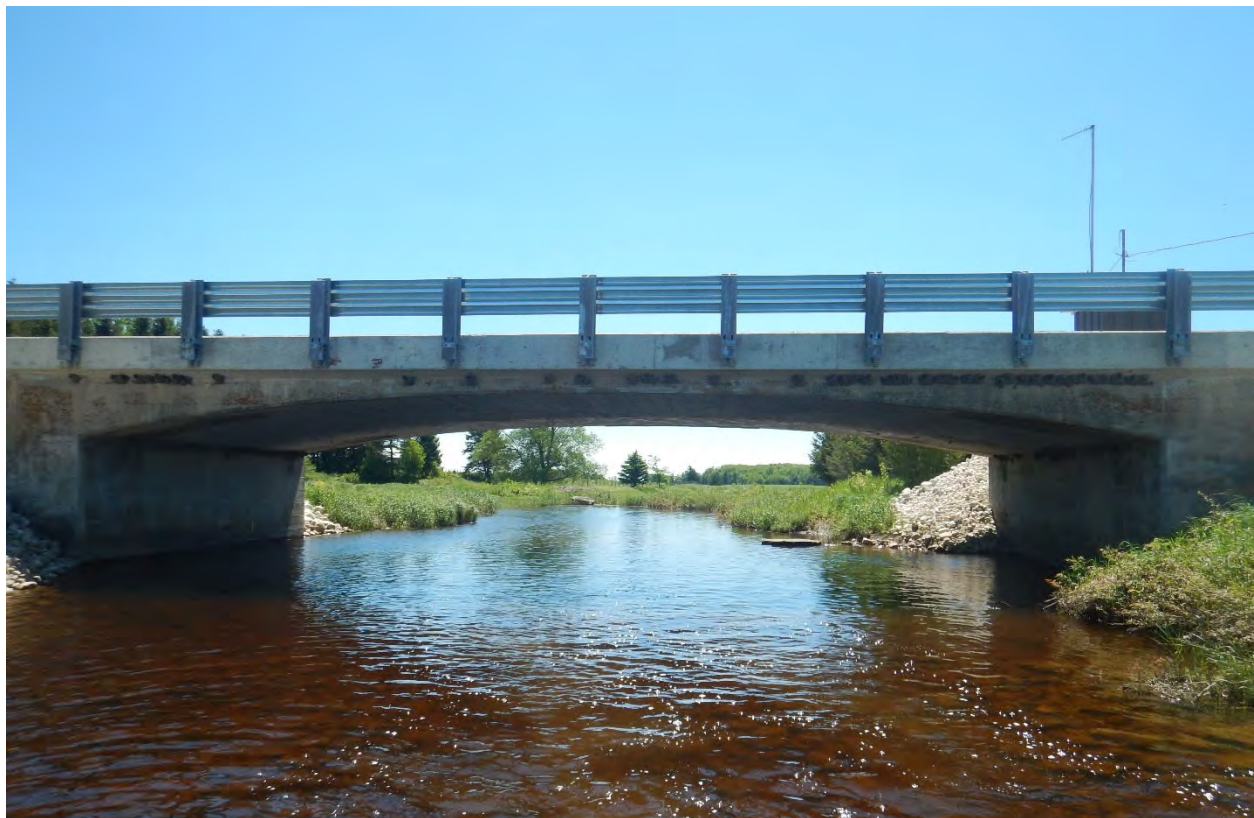
Structure 015, which was rehabilitated in 2017, is generally in good condition with no capital works required at this time. Routine maintenance should be ongoing to help maximize the lifespan of the structure.

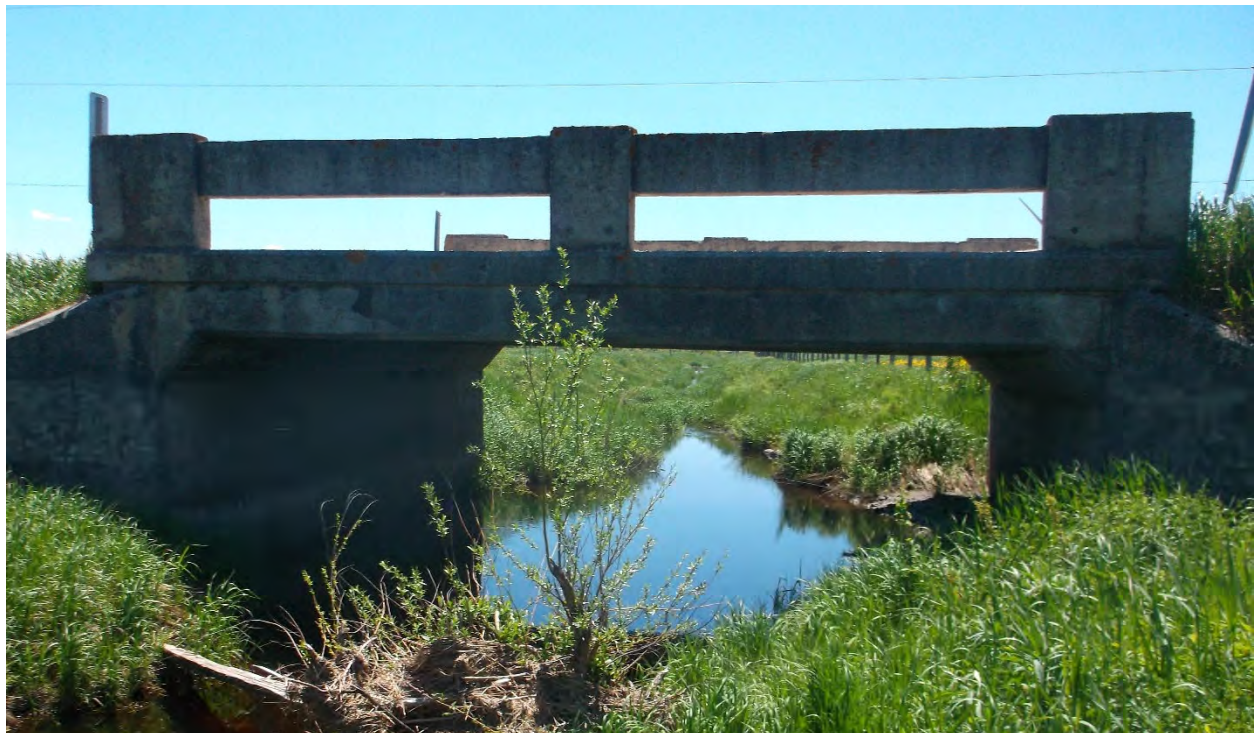
Structure 018 is generally in good to fair condition but is demonstrating signs concrete deterioration, and moisture penetration. Based on the current BCI, a minor rehabilitation should be considered as the BCI approaches 60 to ensure the structure does not deteriorate beyond repair. Concrete repairs, waterproofing and paving, barrier replacement, and erosion protection should be included in the rehabilitation project within approximately 4 years. However, given the narrow, sub-standard driving platform width, consideration may be given to forgoing the rehabilitation and scheduling the replacement of the structure within 14 years. Consideration should also be given to installing a steel beam guide rail system, end treatments and structure connections to help protect oncoming traffic.

Roadside Protection Repairs	Priority	Estimated Cost
Install Guide Rail, end treatments and structure connections.	1 to 5 Years	\$52,000.00

Rehabilitation/Repair Required	Priority	Estimated Cost
Type A concrete repairs to deck top and curbs.	1 to 5 years	\$2,500.00
Type B concrete repairs to soffit.	1 to 5 years	\$5,000.00
Type C concrete repairs to abutment walls and wingwalls.	1 to 5 years	\$15,000.00
Install thrie beam barrier system.	1 to 5 years	\$45,000.00
Waterproof and pave.	1 to 5 years	\$25,000.00
Install slope protection.	1 to 5 years	\$10,000.00
General Items - Insurance, Mobilization, Access etc.	1 to 5 years	\$70,000.00
Rehabilitation Cost Subtotal		\$172,500.00

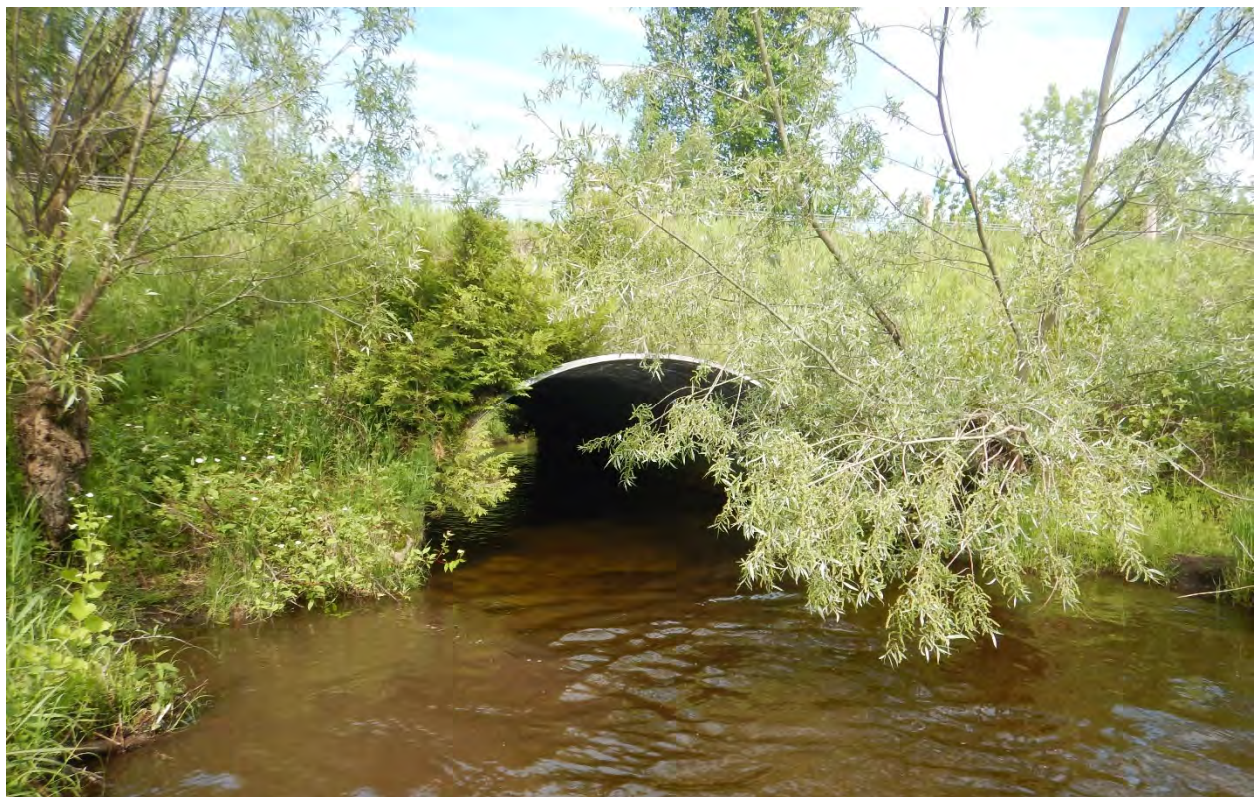
Structure 2001 is generally in good condition but is demonstrating signs of light to moderate surface corrosion along the waterline. Based on the structure type and span a rehabilitation is not recommended and replacement of the structure is recommended once the BCI reaches 40, in approximately 15 years. Consideration should also be given to repairing the 3-cable guide rail system to help protect oncoming traffic.

Maintenance Need	Element and Comments	Estimated Cost
Hazard Signs	Install hazard warning signs at structure.	\$1,000.00
Maintenance Needs Total		\$1,000.00

Roadside Protection Repairs	Priority	Estimated Cost
Repair Guide Rail (Replace rotten posts, Raise 3-cable).	1 to 5 Years	\$6,000.00

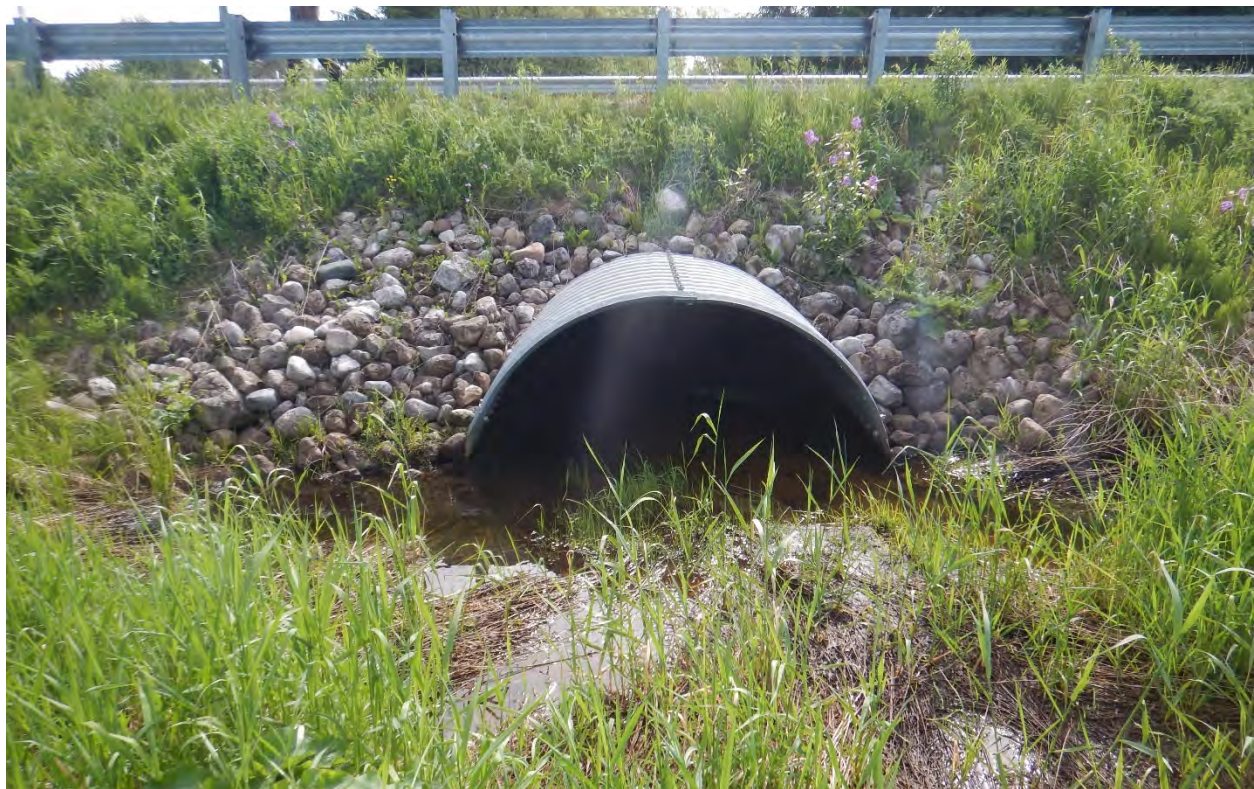
Structure 2005 is generally in excellent condition with only minor maintenance recommended at this time. The Township may consider removing this structure from future biennial inspection lists since the span is less than 3 metres (2.3 metres).

Maintenance Need	Element and Comments	Estimated Cost
Guide Rail	Tighten loose end treatment cables.	\$500.00
Maintenance Needs Total		\$500.00

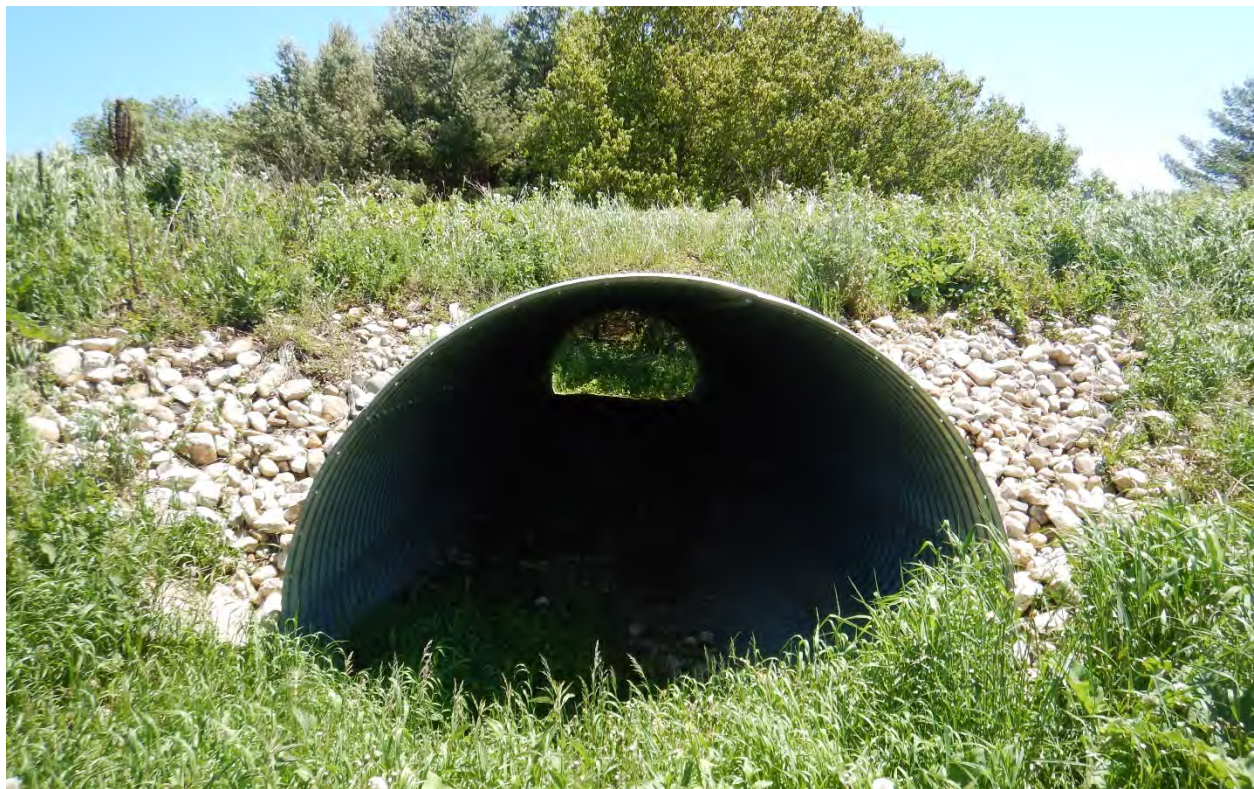
Structure 2010 was replaced in 2016 and is generally in excellent condition. Consideration should be given to investigating the need for steel beam guide rail, end treatments to help protect oncoming traffic. No water was flowing through the structure at time of inspection.

Roadside Protection Repairs	Priority	Estimated Cost
Investigate need for Guide Rail.	1 to 5 Years	\$1,000.00

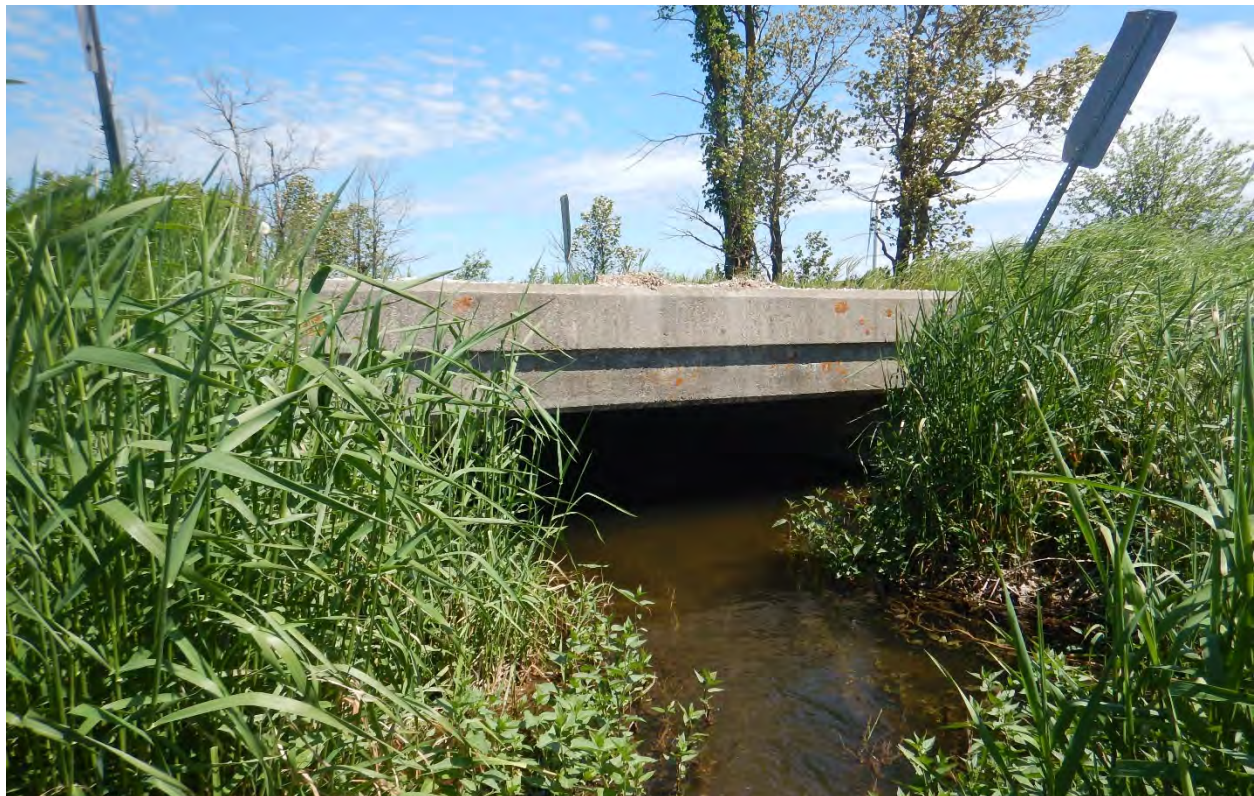
Structure 2012 is generally in good condition with the exception of wide cracks and movement noted in the wingwalls. It is recommended that the cracks and movement in the wingwalls be monitored during future biennial inspections. Based on the current BCI, span, and low clearance, a rehabilitation is not recommended, and replacement of the structure is recommended once the BCI reaches 40, in approximately 10 years. The repairs listed above may be completed to help extend the lifespan of the structure but are not considered economical as a standalone contract. Consideration should also be given to installing a steel beam guide rail system, end treatments to help protect oncoming traffic.

Maintenance Need	Element and Comments	Estimated Cost
Bridge Cleaning	Remove vegetation along curbs, remove excess vegetation and fill above wingwalls.	\$1,500.00
Hazard Signs	Replace damaged hazard warning signs at structure and install narrow bridge signs.	\$1,000.00
Maintenance Needs Total		\$2,500.00

Additional Investigations	Priority	Estimated Cost
Monitoring of Deformations, Settlements and Movements, and Monitoring Crack Widths.	Normal	\$0.00

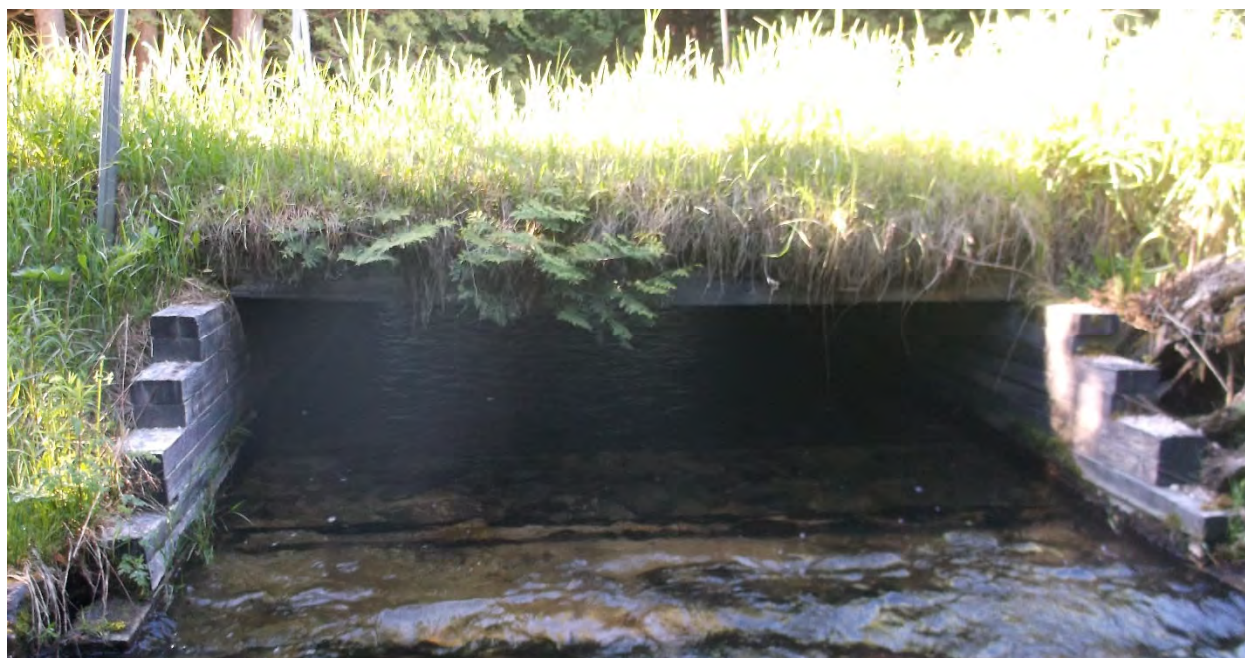
Structure 2013 is generally in fair to poor condition and is demonstrating signs of moderate to severe deterioration of the timber members throughout. Furthermore, it appears there is bow in the timber decking which may be caused by the excess of granular material placed over the deck. It is recommended that the movements in timber deck, stability of timber headwall, and wide crack in timber abutment be monitored until replacement is an option. Based on the current BCI, span, age, and condition of the abutment walls ($BCI < 40$), a rehabilitation is not recommended, and replacement is recommended to be completed within 1 year despite the overall condition of the structure. Taking into consideration the condition, vintage and design loads at the time of construction, using engineering judgement it is recommended the Township place a 15 tonne load limit over the structure until the structure is replaced. Consideration should also be given to installing a steel beam guide rail system, and end treatments to help protect oncoming traffic.

Maintenance Need	Element and Comments	Estimated Cost
Bridge Cleaning	Remove tree at SE quadrant.	\$1,000.00
Hazard Signs	Reinstate NE hazard warning sign at structure.	\$250.00
Maintenance Needs Total		\$1,250.00

Roadside Protection Repairs	Priority	Estimated Cost
Install Guide Rail and end treatments.	1 to 5 Years	\$52,000.00

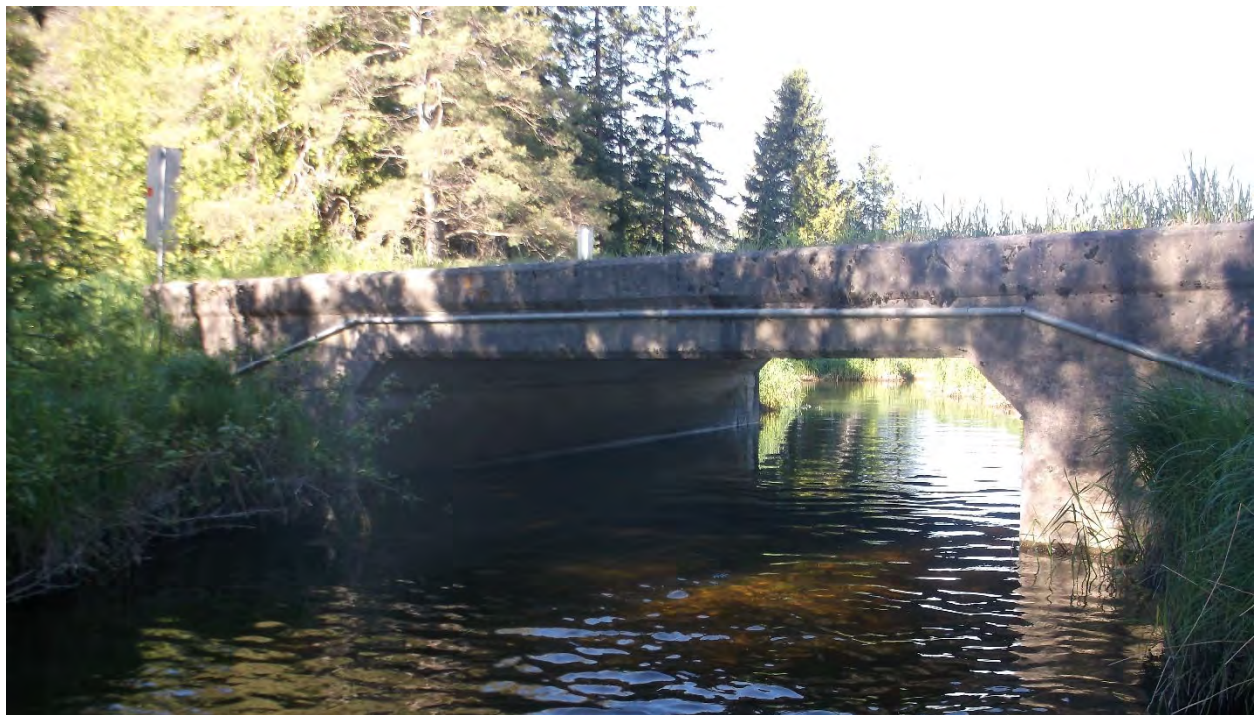
Structure 2014 is generally in good condition with only minor maintenance recommended at this time. Consideration should also be given to installing a steel beam guide rail system, and end treatments to help protect oncoming traffic.

Maintenance Need	Element and Comments	Estimated Cost
Bridge Cleaning	Remove vegetation along curbs.	\$1,000.00
Maintenance Needs Total		\$1,000.00

Roadside Protection Repairs	Priority	Estimated Cost
Install Guide Rail and end treatments.	1 to 5 Years	\$52,000.00

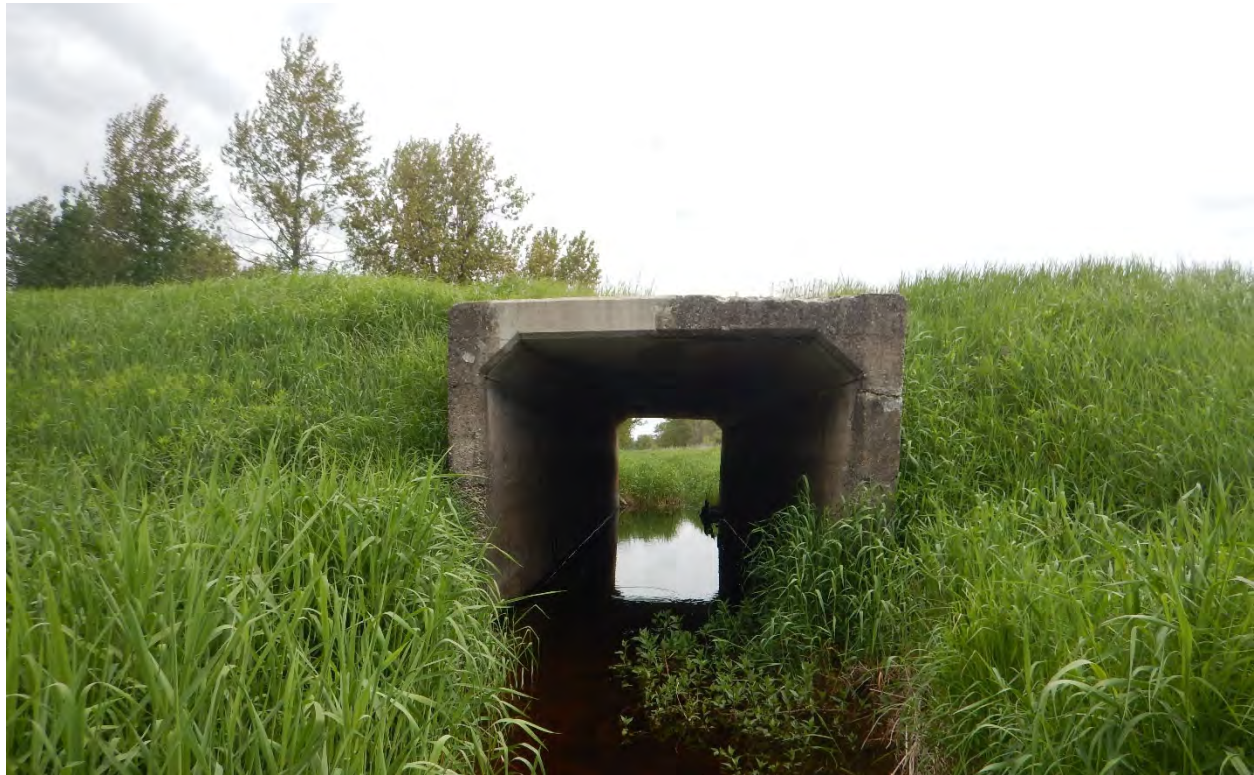
Structure 2016, which has been previously rehabbed, is generally in good condition but is demonstrating signs of concrete deterioration, and moisture penetration. Based on the span, a rehabilitation is not recommended, and replacement of the structure is recommended once the BCI reaches 40, in approximately 16 years. Consideration should be given to investigating the need for steel beam guide rail, and end treatments to help protect oncoming traffic. The Township may consider removing this structure from their biennial bridge inspection list since the span is less than 3 m.

Maintenance Need	Element and Comments	Estimated Cost
Rout and Seal	Repairs required to approach wearing surface.	\$500.00
Hazard Signs	Install hazard warning signs at structure.	\$1,000.00
Maintenance Needs Total		\$1,500.00

Roadside Protection Repairs	Priority	Estimated Cost
Investigate need for Guide Rail.	1 to 5 Years	\$1,000.00

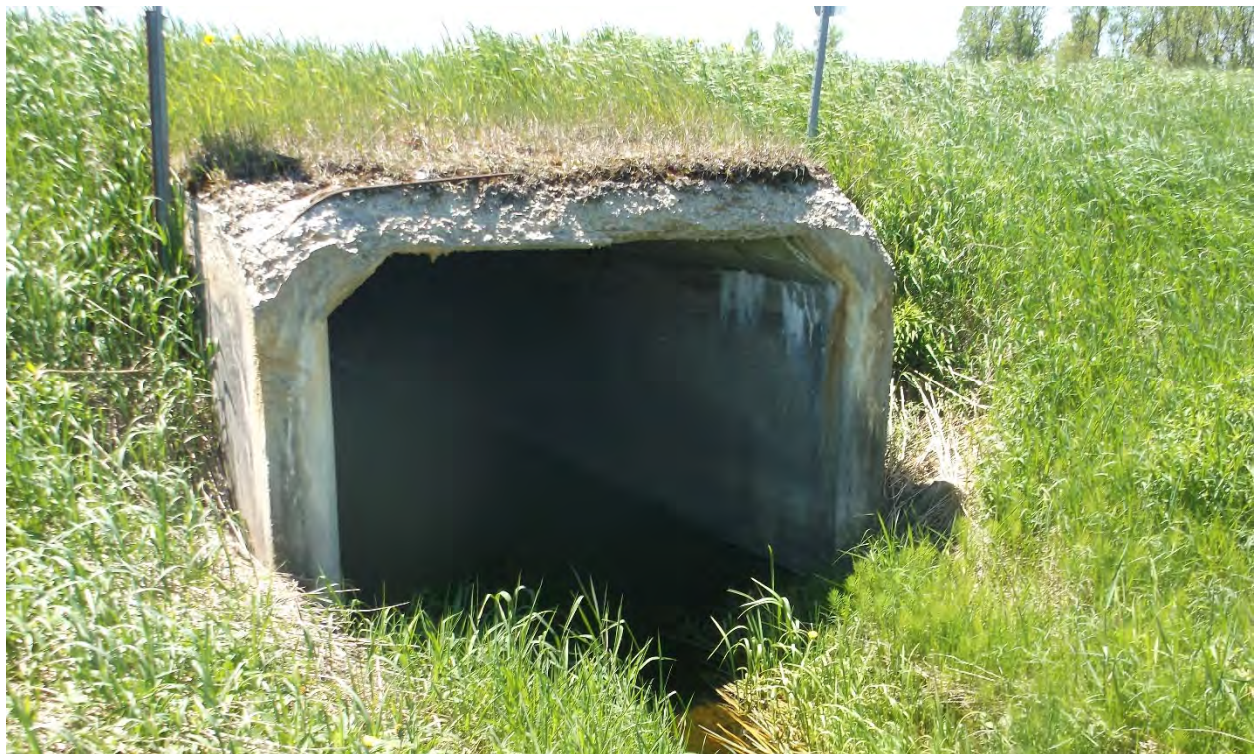
Structure 2018 is generally in good to fair condition but is demonstrating signs of severe concrete deterioration on the culvert inlet. Based on the span, a rehabilitation is not recommended, and replacement of the structure is recommended once the BCI reaches 40, in approximately 15 years. Consideration should also be given to installing a steel beam guide rail system, and end treatments to help protect oncoming traffic. The repairs listed above may be completed to help extend the lifespan of the structure but would not be considered economical as a standalone contract. The Township may consider removing this structure from their biennial inspection list since the span is less than 3 m.

Maintenance Need	Element and Comments	Estimated Cost
Hazard Signs	Reinstate NW hazard warning sign at structure.	\$250.00
Maintenance Needs Total		\$250.00

Roadside Protection Repairs	Priority	Estimated Cost
Install Guide Rail and end treatments.	1 to 5 Years	\$52,000.00

Rehabilitation/Repair Required	Priority	Estimated Cost
Type A concrete repairs to deck top.	N/A	\$5,000.00
Type C concrete repairs to barrels, inlet and outlet.	N/A	\$15,000.00
Remove fill, waterproof and pave.	N/A	\$20,000.00
General Items - Insurance, Mobilization, Access etc.	N/A	\$70,000.00
Rehabilitation Cost Subtotal		\$110,000.00

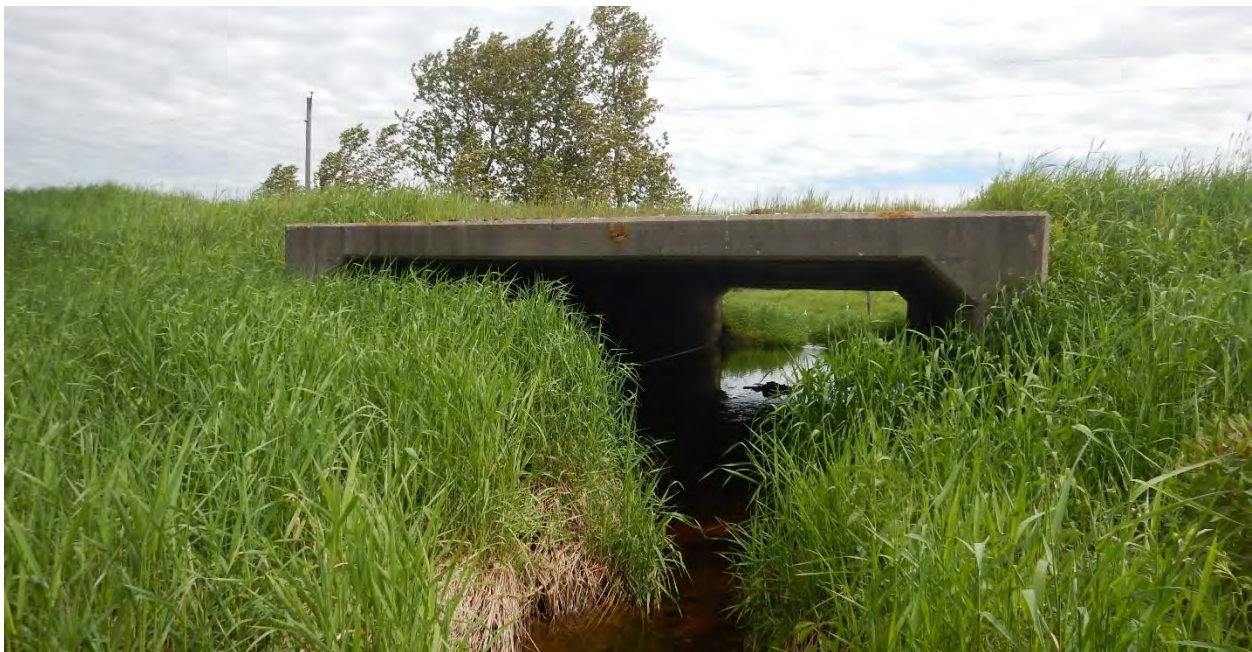
Structure 2019 is generally in good condition with only minor maintenance recommended at this time. Consideration should be given to installing steel beam guide rail, and end treatments to help protect oncoming traffic.

Maintenance Need	Element and Comments	Estimated Cost
Hazard Signs	Install hazard warning signs at structure.	\$1,000.00
Maintenance Needs Total		\$1,000.00

Roadside Protection Repairs	Priority	Estimated Cost
Install Guide Rail and end treatments.	1 to 5 Years	\$52,000.00

Rehabilitation/Repair Required	Priority	Estimated Cost
Type A concrete repairs to deck top.	N/A	\$5,000.00
Type C concrete repairs to barrels and inlet.	N/A	\$1,000.00
Remove fill, waterproof and pave.	N/A	\$20,000.00
General Items - Insurance, Mobilization, Access etc.	N/A	\$70,000.00
Rehabilitation Cost Subtotal		\$96,000.00

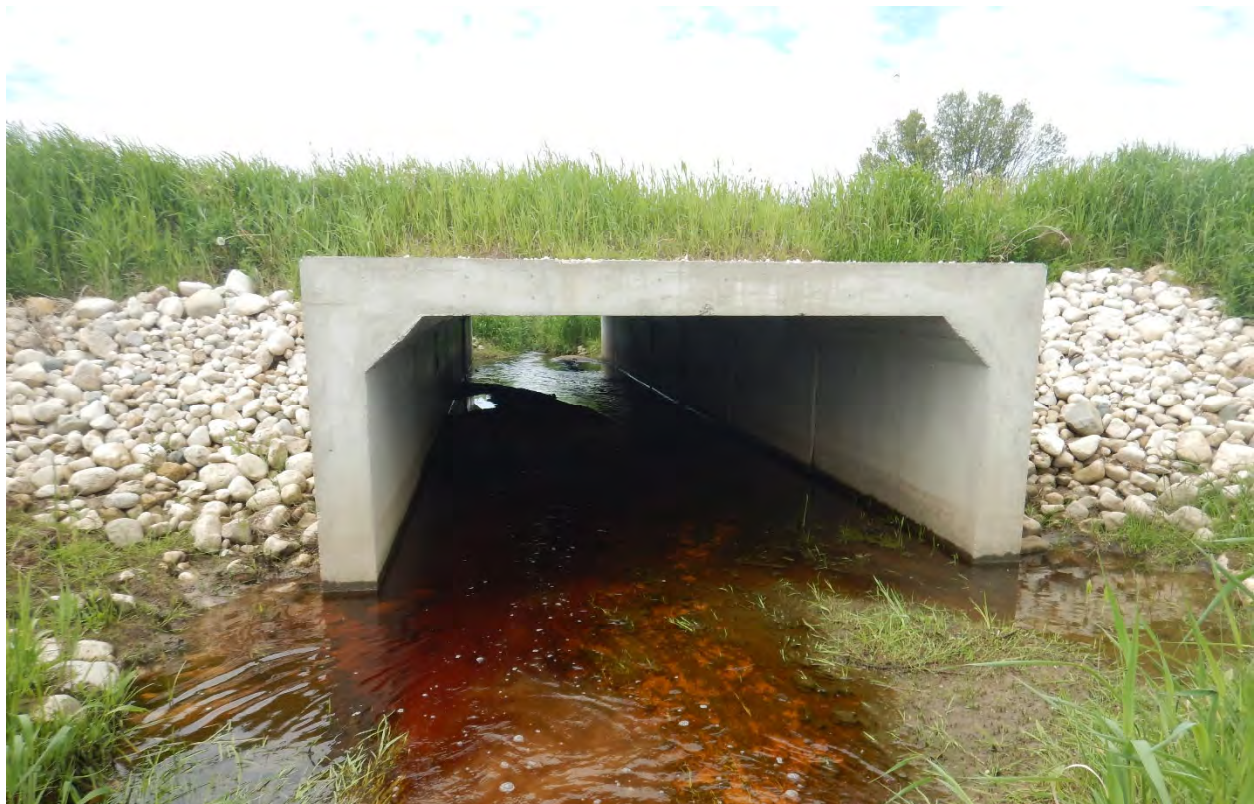
Structure 2020 is generally in excellent condition with only minor maintenance recommended at this time. Consideration should be given to investigating the need for steel beam guide rail to help protect oncoming traffic.

Maintenance Need	Element and Comments	Estimated Cost
Hazard Signs	Install hazard warning signs at structure.	\$1,000.00
Maintenance Needs Total		\$1,000.00

Roadside Protection Repairs	Priority	Estimated Cost
Investigate need for Guide Rail.	1 to 5 Years	\$1,000.00

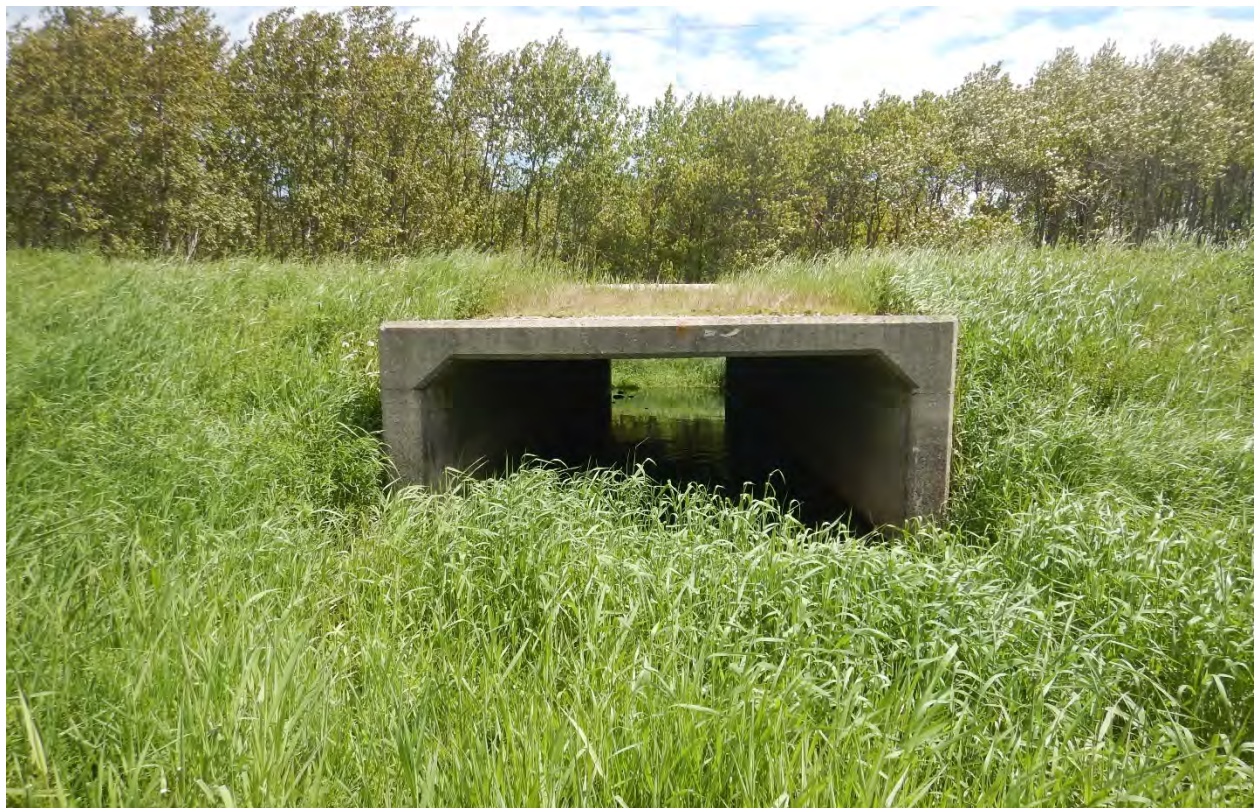
Structure 2022 is generally in good condition with only minor maintenance recommended at this time. Consideration should be given to investigating the need for steel beam guide rail, and end treatments to help protect oncoming traffic.

Maintenance Need	Element and Comments	Estimated Cost
Hazard Signs	Install hazard warning signs at structure.	\$1,000.00
Maintenance Needs Total		\$1,000.00

Roadside Protection Repairs	Priority	Estimated Cost
Investigate need for Guide Rail.	1 to 5 Years	\$1,000.00

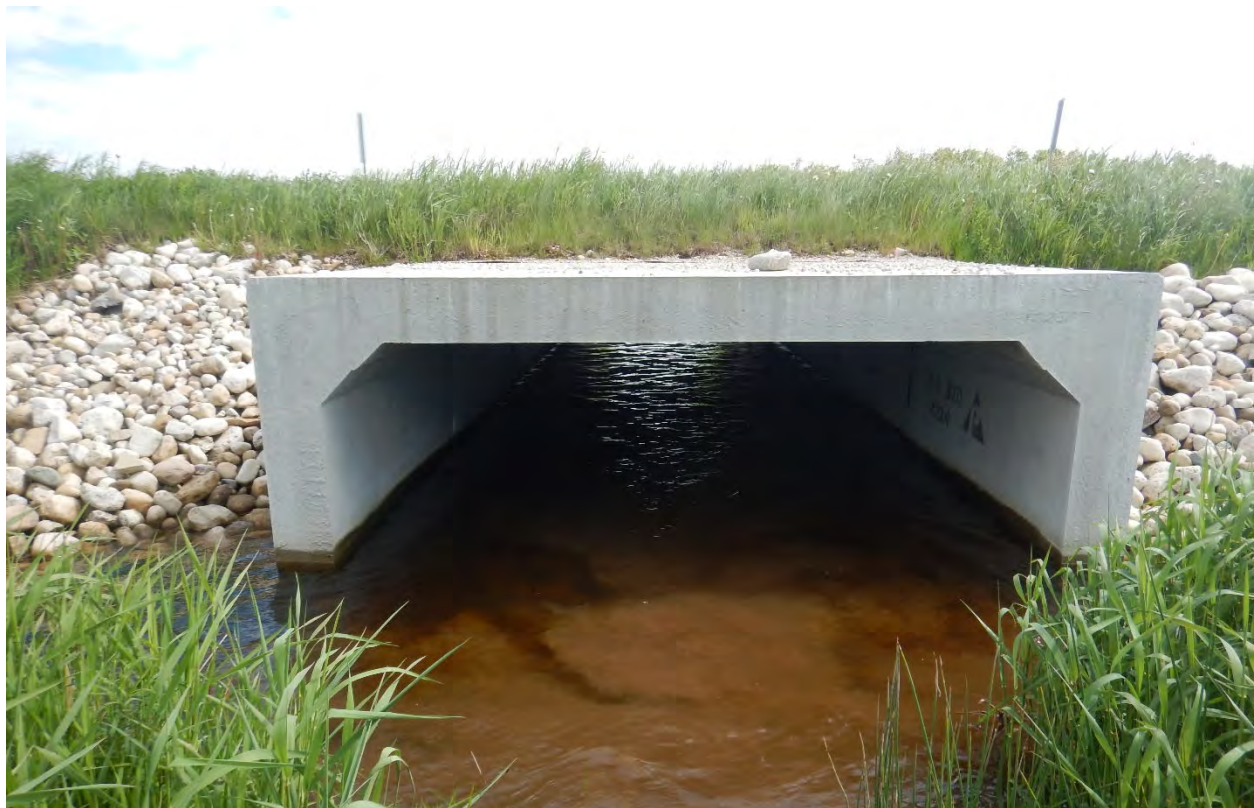
Structure 2024 was recently replaced in 2016 and is generally in excellent condition. Consideration should be given to investigating the need for steel beam guide rail, and end treatments to help protect oncoming traffic.

Roadside Protection Repairs	Priority	Estimated Cost
Investigate need for Guide Rail.	1 to 5 Years	\$1,000.00

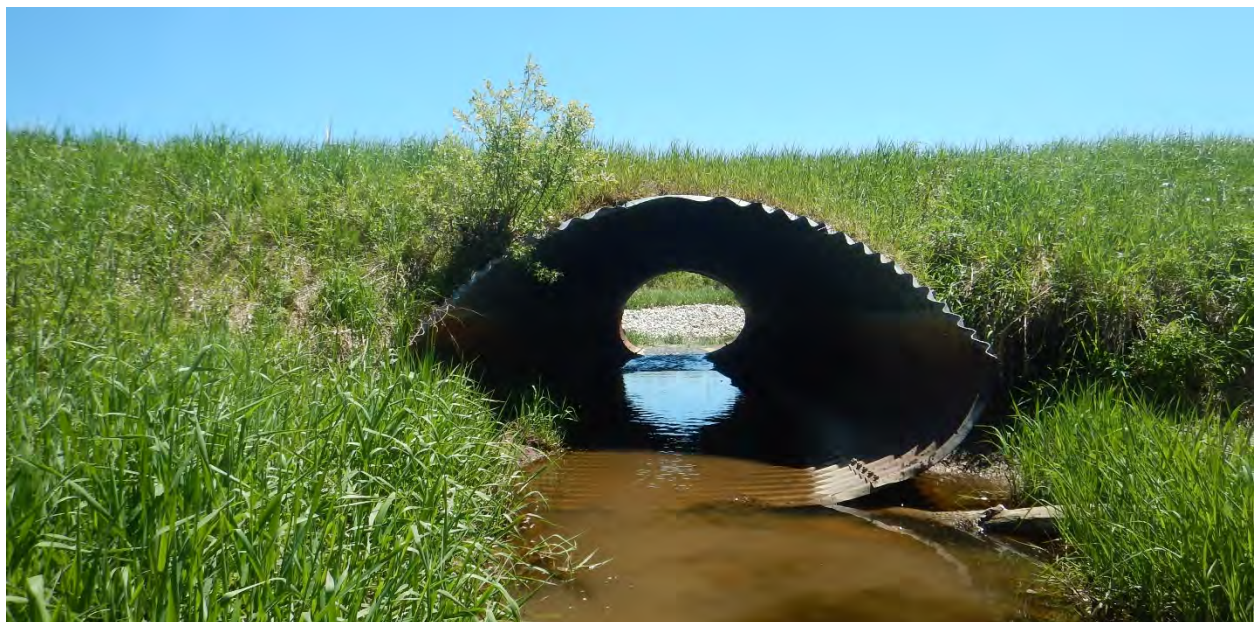
Structure 2025 is generally in good to fair condition but is demonstrating signs of moderate to severe surface corrosion and section loss throughout the culvert barrel. Based on the span, a rehabilitation is not recommended, and replacement of the structure is recommended once the BCI reaches 40, in approximately 14 years. Consideration should be given to investigating the need for steel beam guide rail, and end treatments to protect oncoming traffic.

Maintenance Need	Element and Comments	Estimated Cost
Hazard Signs	Install hazard warning signs at structure.	\$1,000.00
Maintenance Needs Total		\$1,000.00

Roadside Protection Repairs	Priority	Estimated Cost
Investigate need for Guide Rail.	1 to 5 Years	\$1,000.00

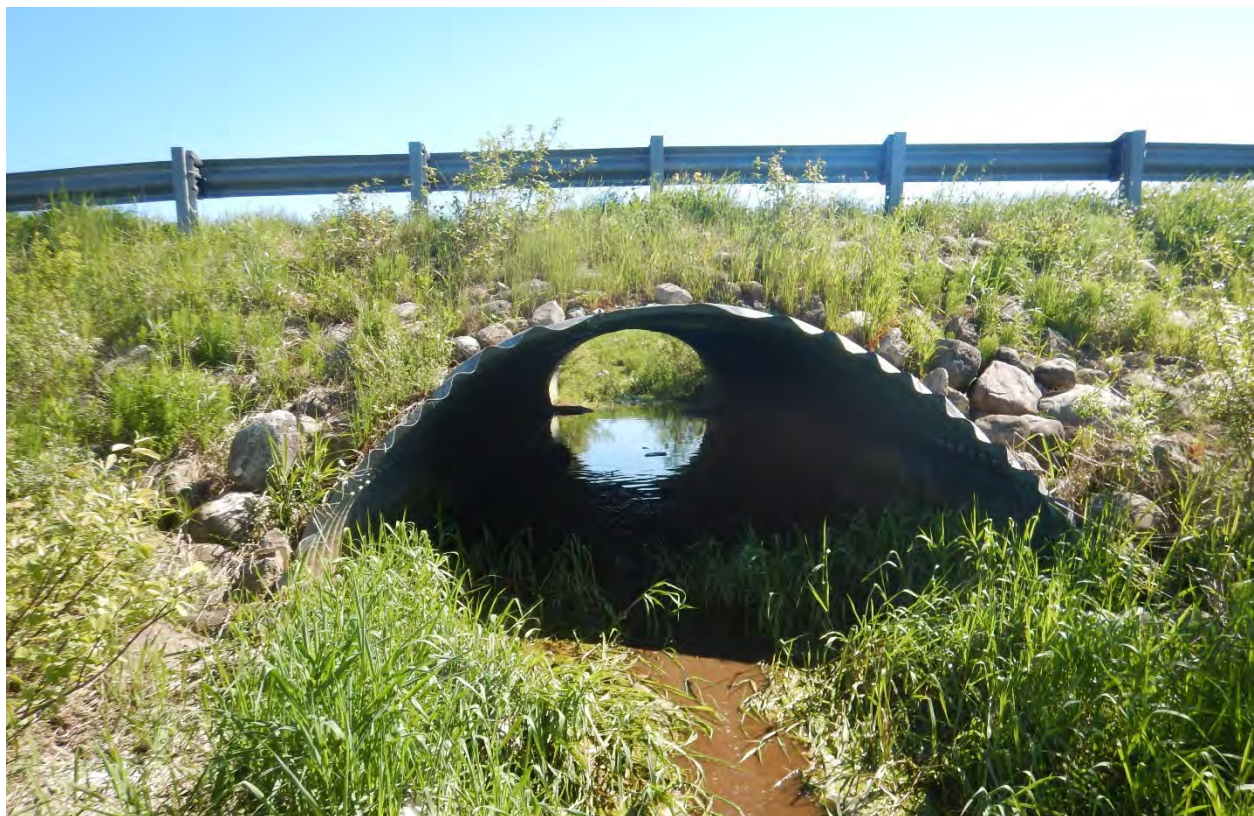
Structure 2026 is generally in excellent to good condition. However, several areas of minor localized deformations and cusping were noted but may be from original construction. The deformations and cusping should be monitored during future biennial inspections to ensure they are not actively progressing. Consideration should also be given to replacing the steel beam guide rail system, end treatments to help protect oncoming traffic.

Additional Investigations	Priority	Estimated Cost
Monitoring of deformations, settlements and movements.	Normal	\$0.00

Roadside Protection Repairs	Priority	Estimated Cost
Replace Guide Rail and end treatments.	1 to 5 Years	\$52,000.00
