**ROADS SUB-COMMITTEE
SPECIAL MEETING AGENDA
WEDNESDAY, OCTOBER 2, 2019 - 1:30 P.M.
MEETING HELD IN THE COUNCIL CHAMBERS**

Road Management Plan

Township of Melancthon

**September 2019
300043927.0000**

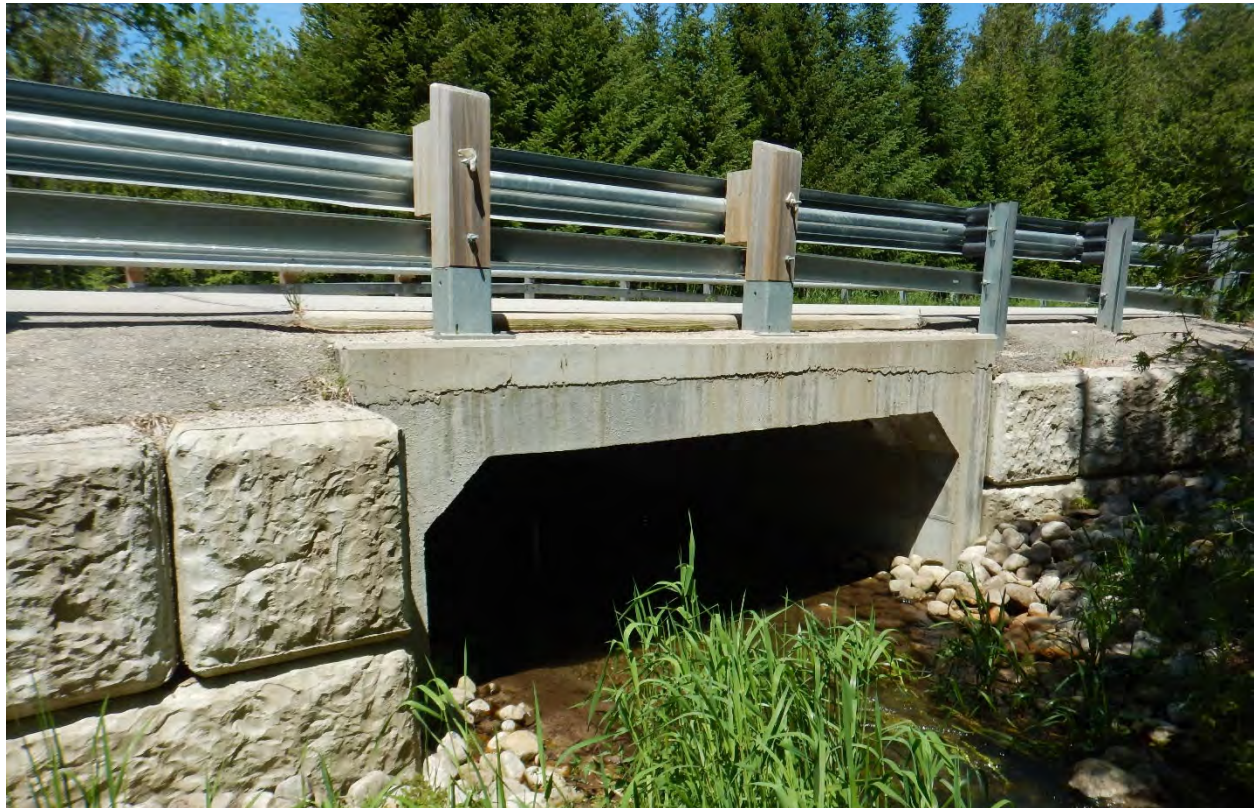
Structure 2027 is generally in excellent condition with only minor maintenance recommended at this time.

Maintenance Need	Element and Comments	Estimated Cost
Guide Rail	Bury channel ends, tighten loose end treatment cables.	\$1,000.00
Maintenance Needs Total		\$1,000.00

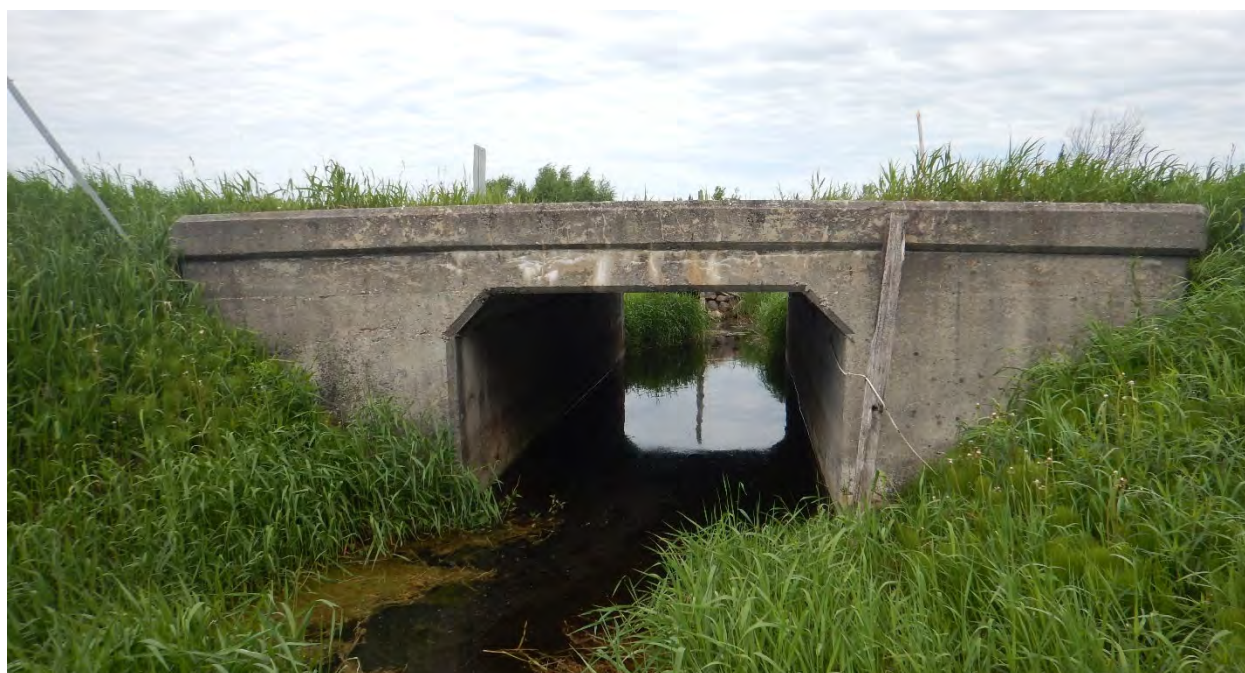
Structure 2029 is generally in good condition but is demonstrating signs of potential movement/rotation of the south abutment and SE wingwall. Based on the span, a rehabilitation is not recommended, and replacement of the structure is recommended once the BCI reaches 40, in approximately 17 years. However, if the movements/rotations in the substructure progress then the replacement timeline should be expedited. It is also recommended that a monitoring program be established to monitor the movement/rotation observed in the substructure. Consideration should also be given to installing a steel beam guide rail system, and end treatments to help protect oncoming traffic. The repairs listed above may be completed to help extend the lifespan of the structure but would not be considered economical as a standalone contract.

Maintenance Need	Element and Comments	Estimated Cost
Hazard Signs	Reinstate SE hazard warning sign at structure	\$1,000.00
Maintenance Needs Total		\$1,000.00

Additional Investigations	Priority	Estimated Cost
Monitoring of deformations, settlements and movements.	Normal	\$5,000.00

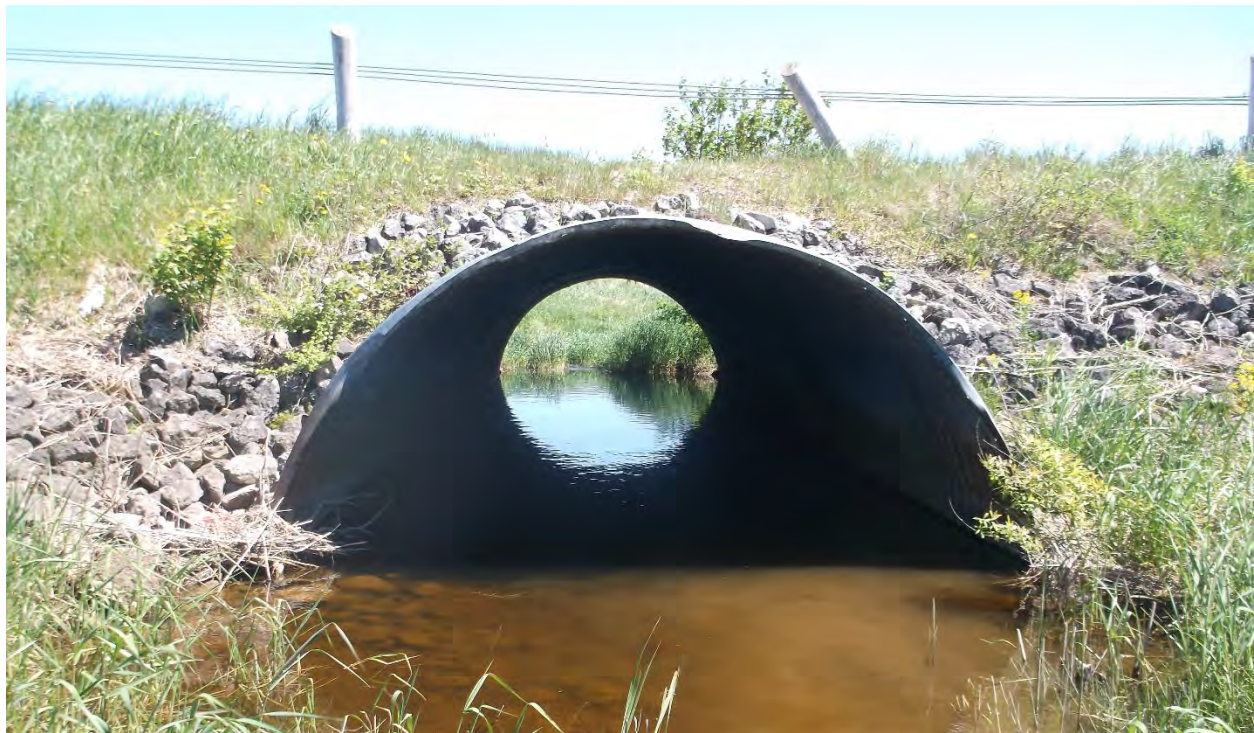
Structure 2031 is generally in excellent to good condition. It is recommended that the localized deformation in the culvert barrel be monitored during future biennial inspections to ensure it is not actively progressing. Consideration should also be given to replacing the steel beam guide rail system, and end treatments to help protect oncoming traffic.

Maintenance Need	Element and Comments	Estimated Cost
Hazard Signs	Install hazard warning signs at structure.	\$1,000.00
Maintenance Needs Total		\$1,000.00

Additional Investigations	Priority	Estimated Cost
Monitoring of deformations, settlements and movements.	Normal	\$0.00
