**2021 OSIM Bridge Inspection Report**

**Township of Melancthon  
157101 Highway 10  
Melancthon, ON L9V 2E6**

**December 2021  
30052974.0000**

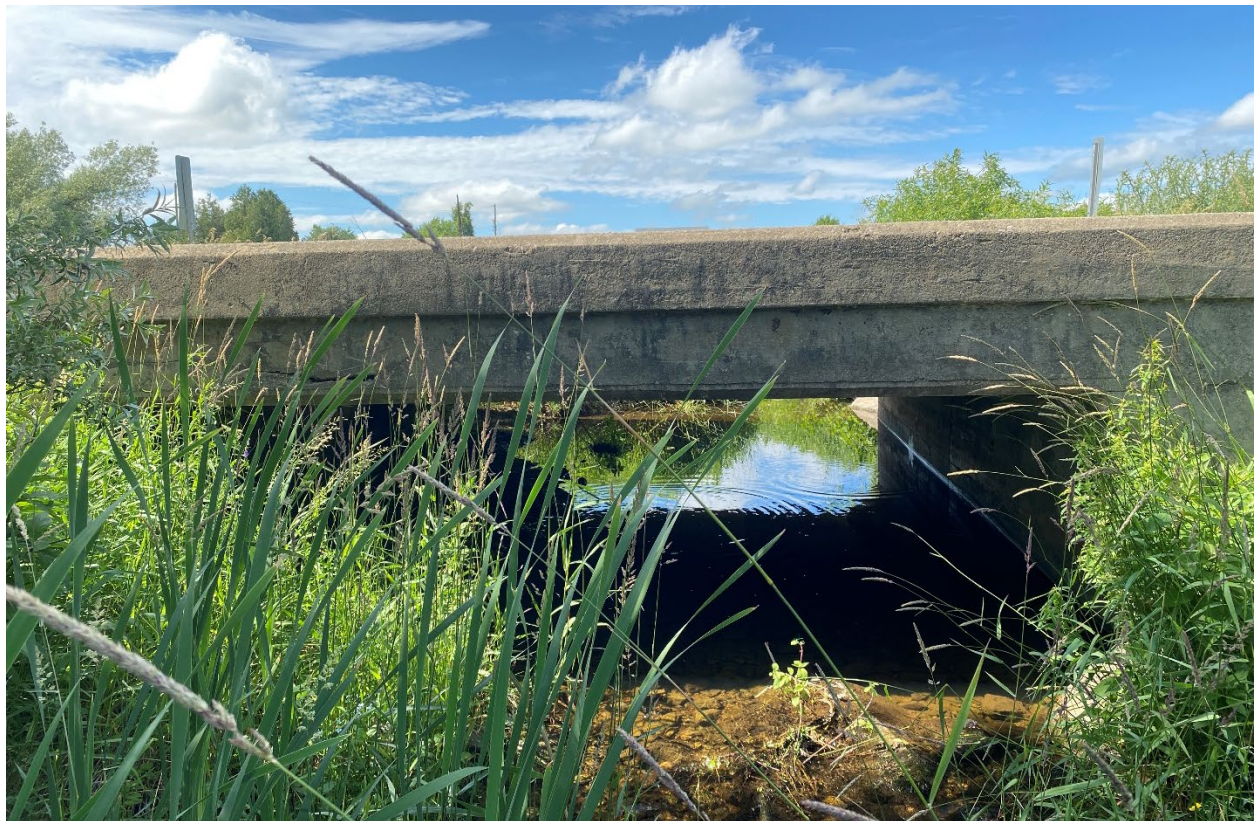
Structure 2004 is generally in good condition but is demonstrating signs of moisture penetration on the soffit. Based on the current BCI, a minor rehabilitation should be considered as the BCI approaches 60 to ensure the structure does not deteriorate beyond repair. Concrete repairs, waterproofing and paving, and erosion protection should be included in the rehabilitation project within approximately 7 years. However, given the narrow, sub-standard driving platform width, consideration may be given to forgoing the rehabilitation and scheduling the replacement of the structure within 17 years.

**Recommendation:** Minor Rehabilitation is recommended within 7 years.

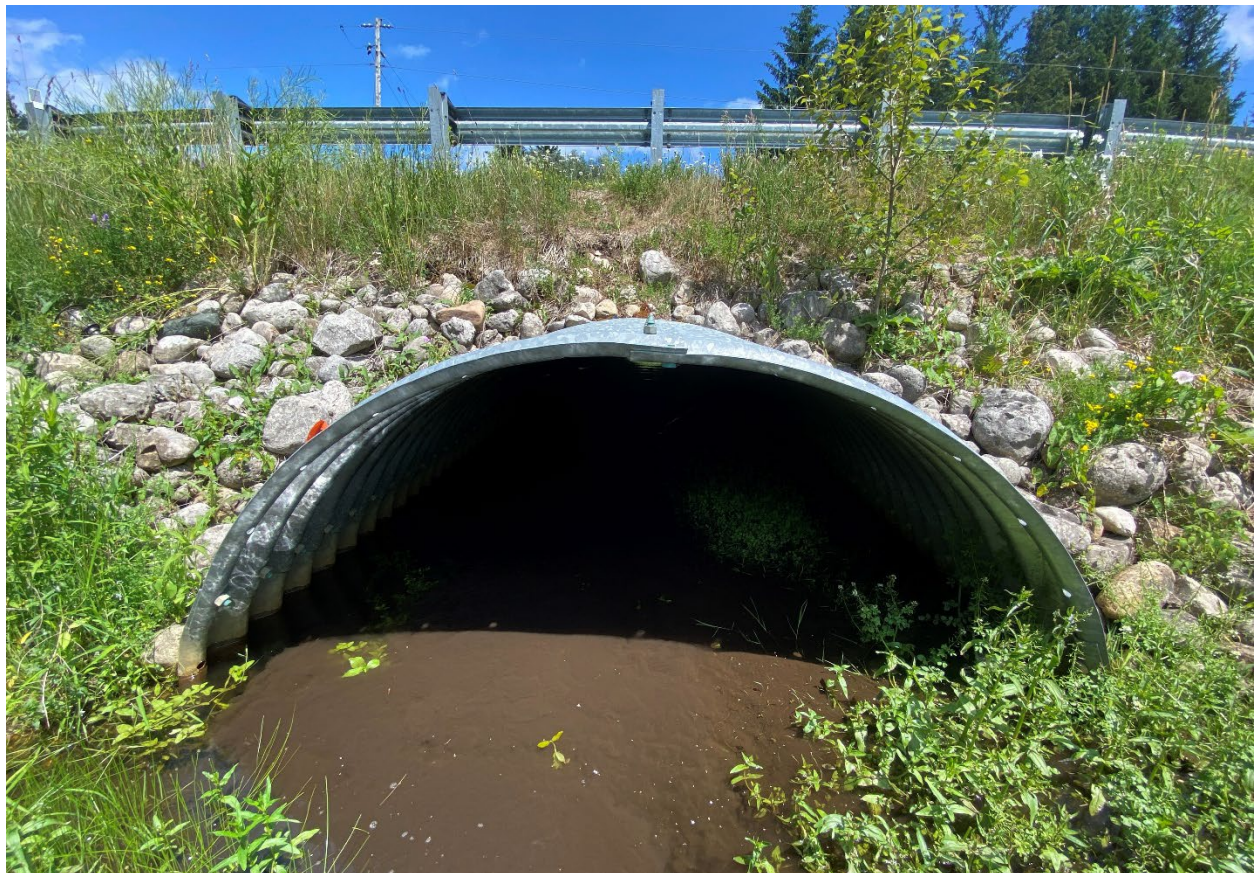
Structure 2005 is generally in excellent condition with only minor maintenance recommended at this time. The Township should ensure routine maintenance is completed to help maximize the service life of the structure. The Township may consider removing this structure from future biennial inspection lists since the span is less than 3 metres.

**Recommendation:** No Capital Works is estimated to be required within the next 10 years.

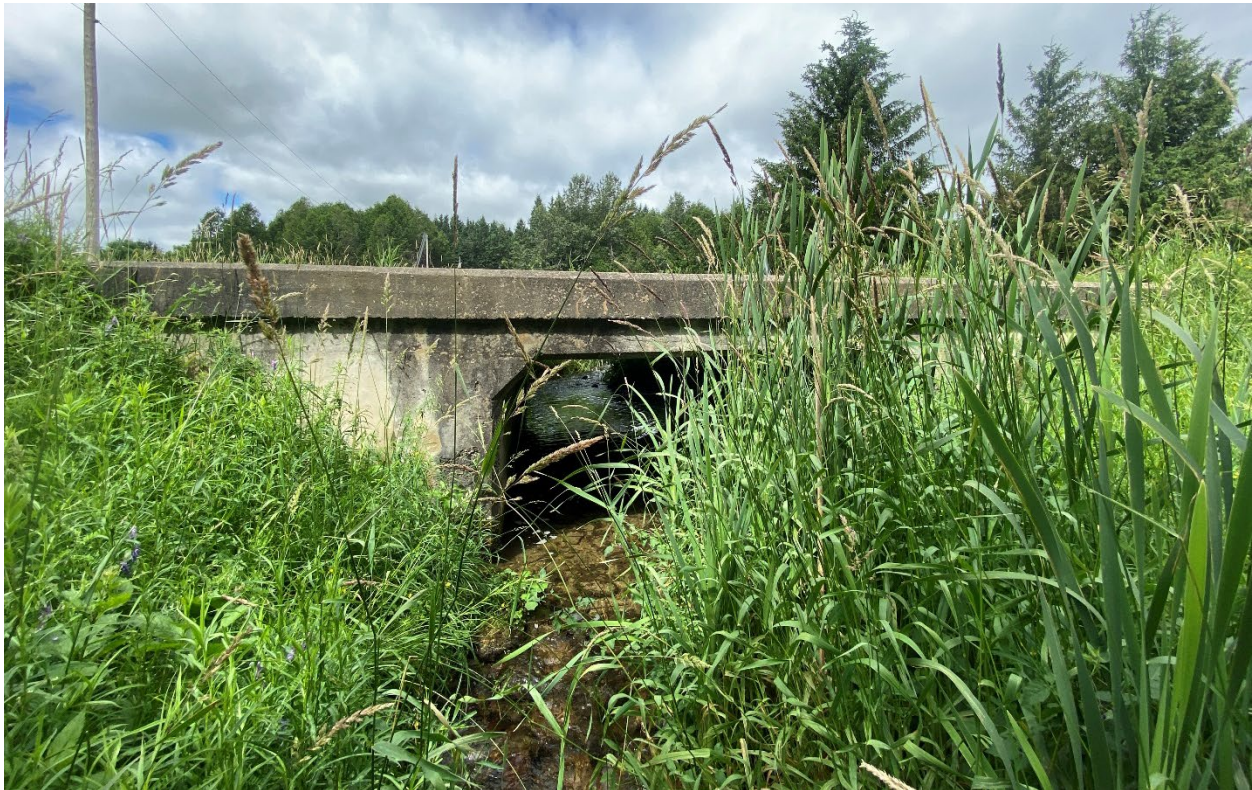
Structure 2006 is generally in good condition with only minor maintenance recommended at this time. Based on the current BCI, span of 3m (less than 4.5m), and low clearance a rehabilitation is not recommended and replacement of the structure is recommended once the BCI reaches 40, in approximately 17 years.

**Recommendation:** No Capital Works is estimated to be required within the next 10 years.

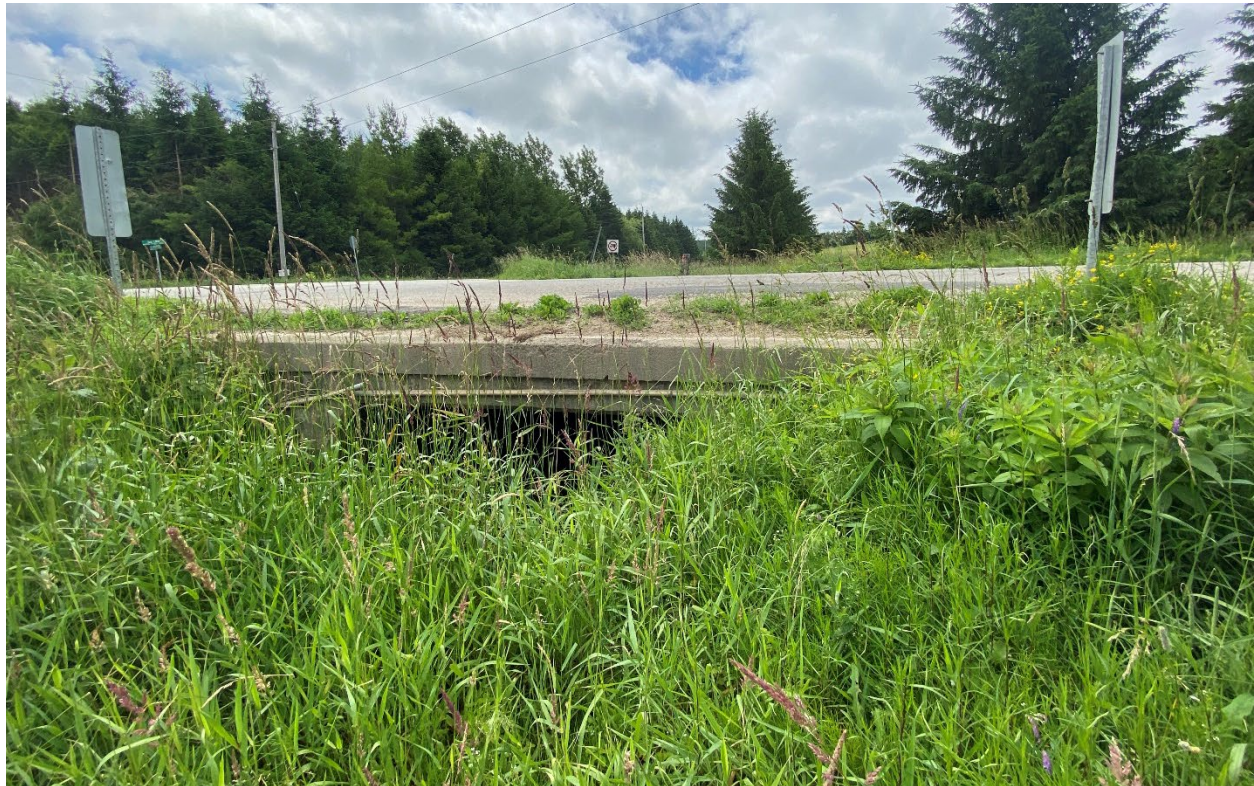
Structure 2007 is generally in good to fair condition but is demonstrating signs of moisture penetration through the cracks in the soffit. Based on the span and low clearance, a rehabilitation is not recommended and replacement of the structure is recommended once the BCI reaches 40, in approximately 15 years. Consideration should also be given to investigating the need for a steel beam guide rail system with end treatments to help protect oncoming traffic. The repairs listed above may be completed to help extend the lifespan of the structure but would not be considered economical as a standalone contract.

**Recommendation:** No Capital Works is estimated to be required within the next 10 years.

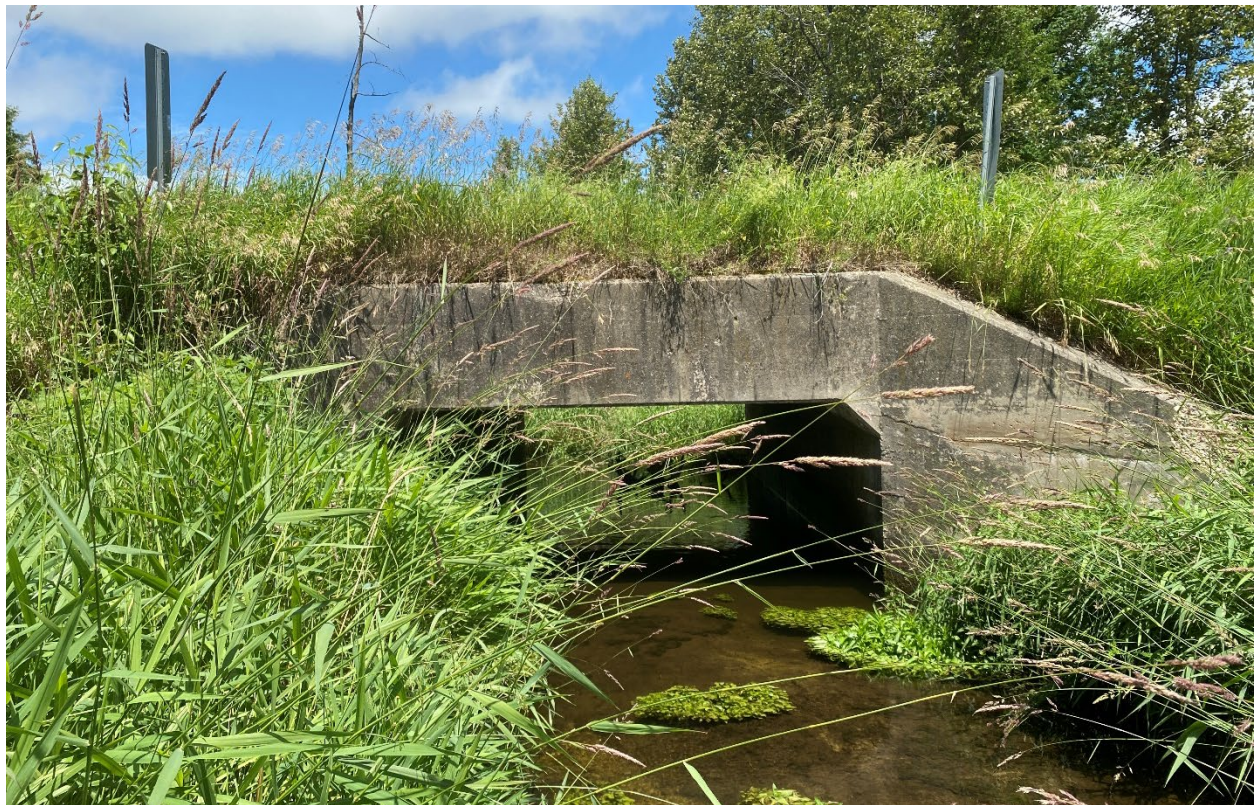
Structure 2008 is generally in good condition with only minor maintenance recommended at this time. Based on the span, a rehabilitation is not recommended and replacement of the structure is recommended once the BCI reaches 40, in approximately 16 years. The repairs listed above may be completed to help extend the lifespan of the structure but would not be considered economical as a standalone contract.

**Recommendation:** No Capital Works is estimated to be required within the next 10 years.

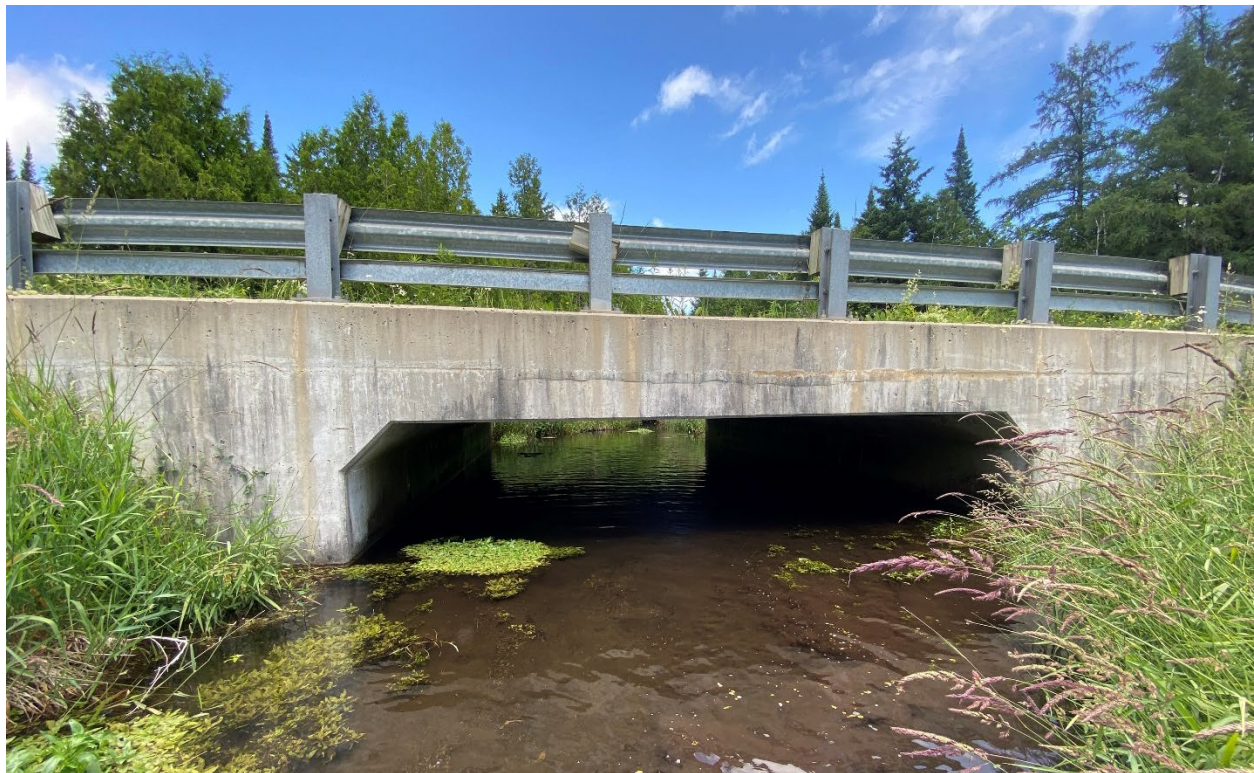
Structure 2009 is generally in excellent to good condition with only minor maintenance recommended at this time. The Township should ensure routine maintenance is completed to help maximize the service life of the structure. Consideration should be given to replacing the steel beam guide rail system, and end treatments to help protect oncoming traffic as well as installing a drip edge detail in the concrete soffit to help prevent future water damage.

**Recommendation:** No Capital Works is estimated to be required within the next 10 years.

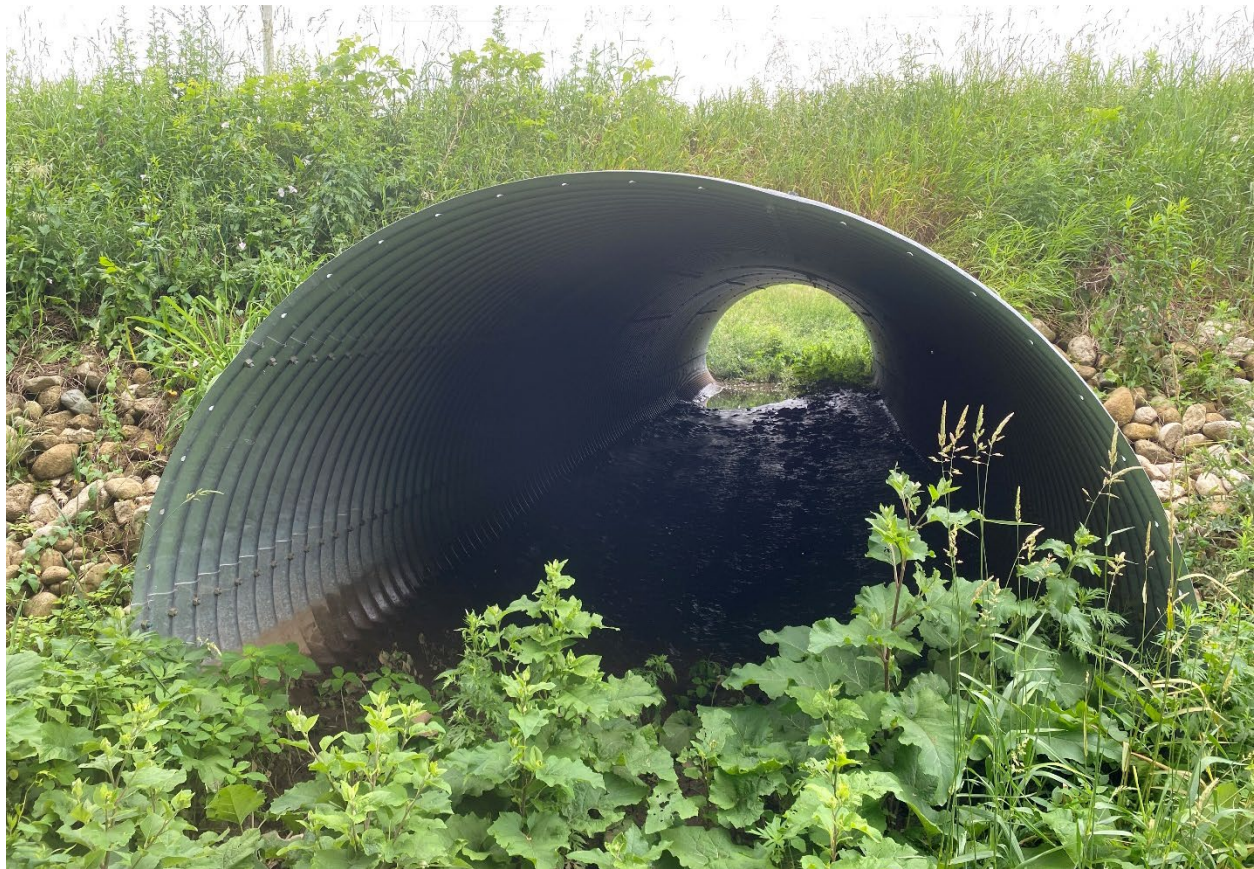
Structure 2010 was replaced in 2016 and is generally in excellent condition. The Township should ensure routine maintenance is completed to help maximize the service life of the structure. Consideration should be given to investigating the need for steel beam guide rail with end treatments to help protect oncoming traffic.

**Recommendation:** No Capital Works is estimated to be required within the next 10 years.

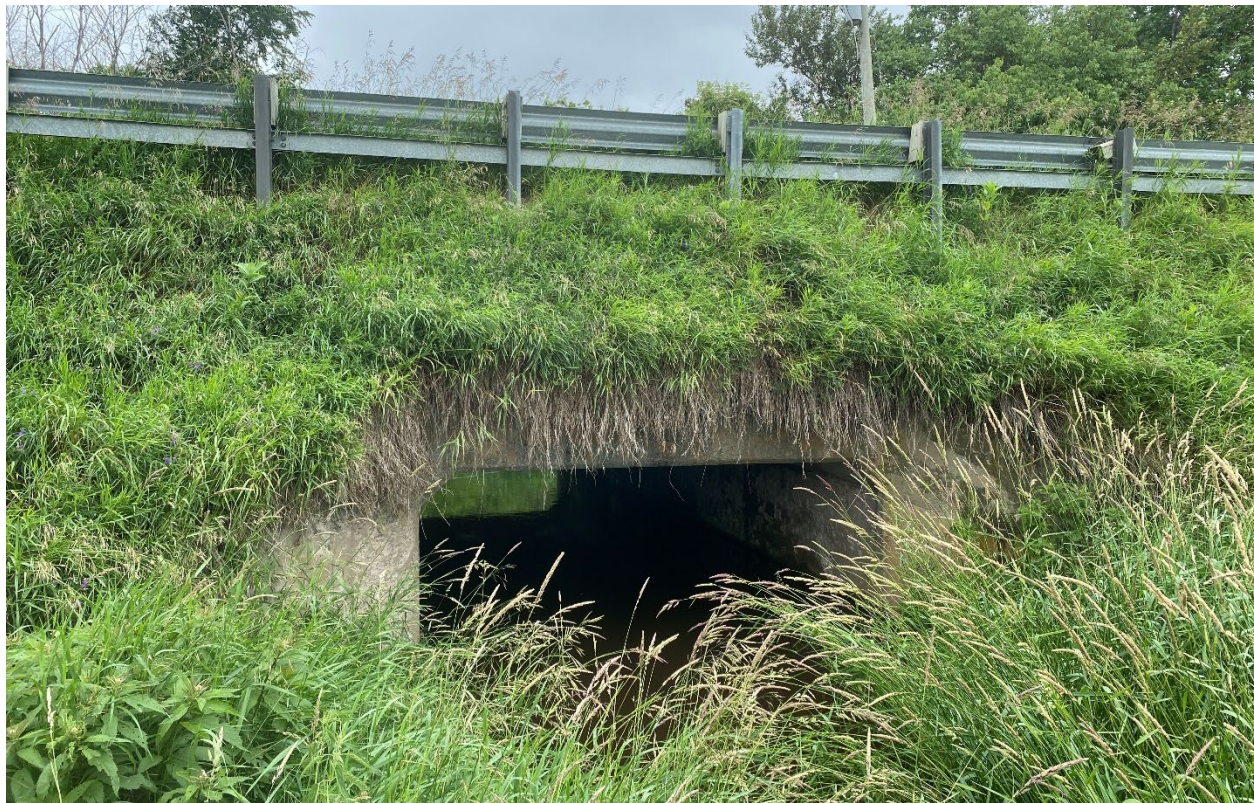
Structure 2011 is generally in fair condition and is demonstrating signs of severe concrete deterioration, and moisture penetration. The overgrown vegetation and excess fill overtop of the wingwalls and fascia appear to be contributing to the concrete defects and should be removed to prevent further deterioration. Based on the span, a rehabilitation is not recommended and replacement of the structure is recommended once the BCI reaches 40, in approximately 7 years. The repairs listed above may be completed to help extend the lifespan of the structure but are not considered economical as a standalone contract.

**Recommendation:** Structure replacement is recommended within 8 years.

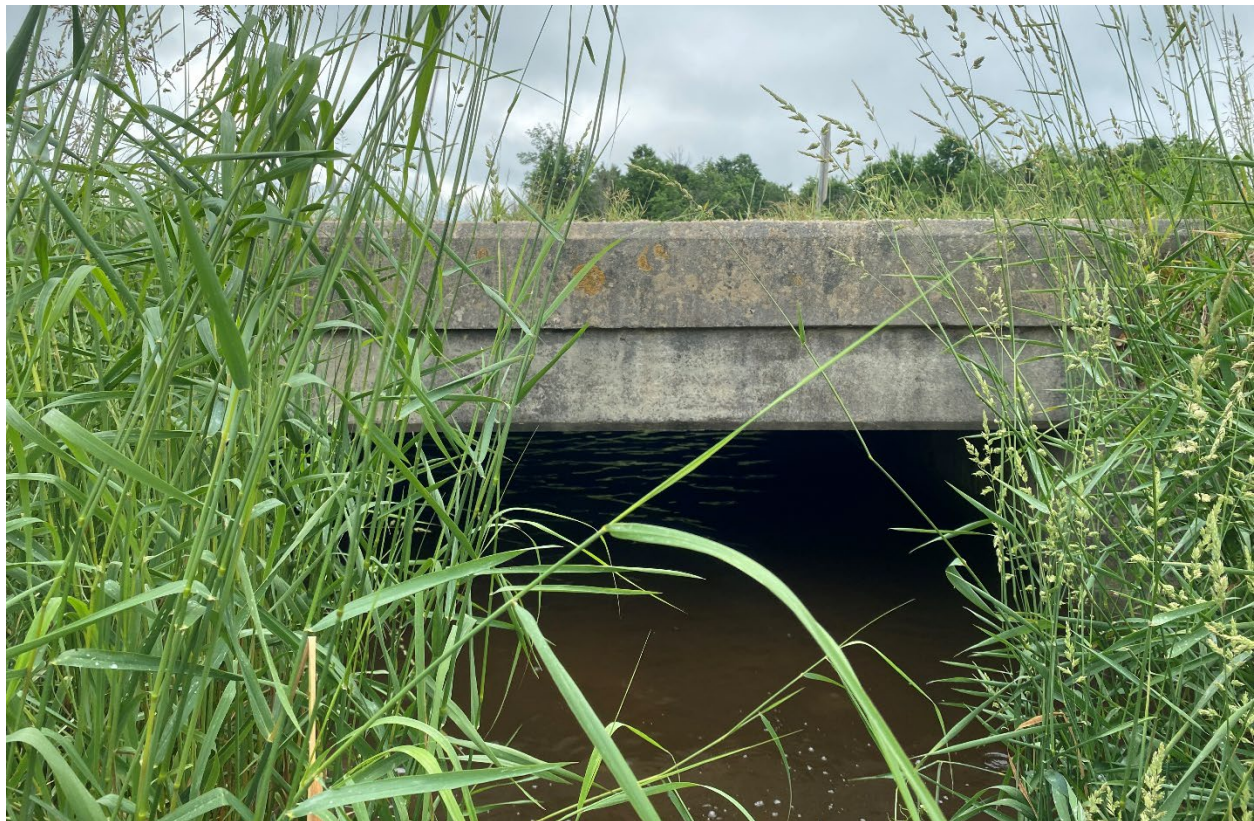
Structure 2012 is generally in good condition with the exception of wide cracks & movement noted in the wingwalls. It is recommended that the cracks & movement in the wingwalls be monitored during future biennial inspections. Based on the current BCI, span, and low clearance, a rehabilitation is not recommended and replacement of the structure is recommended once the BCI reaches 40, in approximately 10 years. The repairs listed above may be completed to help extend the lifespan of the structure but are not considered economical as a standalone contract.

**Recommendation:** Structure replacement is recommended within 10 years.

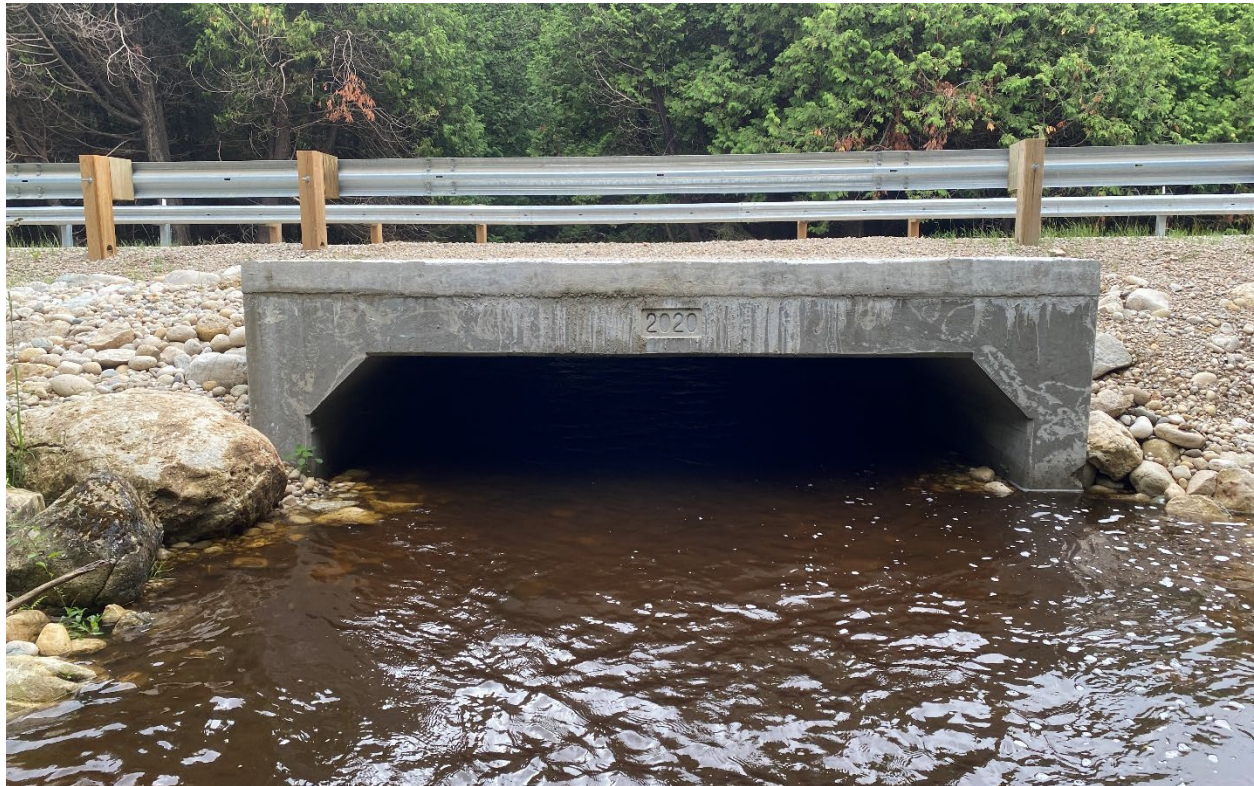
Structure 2013 was replaced in 2020 and is generally in excellent condition with no capital works needed at this time. The Township should ensure routine maintenance is completed to help maximize the service life of the structure.

**Recommendation:** No Capital Works is estimated to be required within the next 10 years.

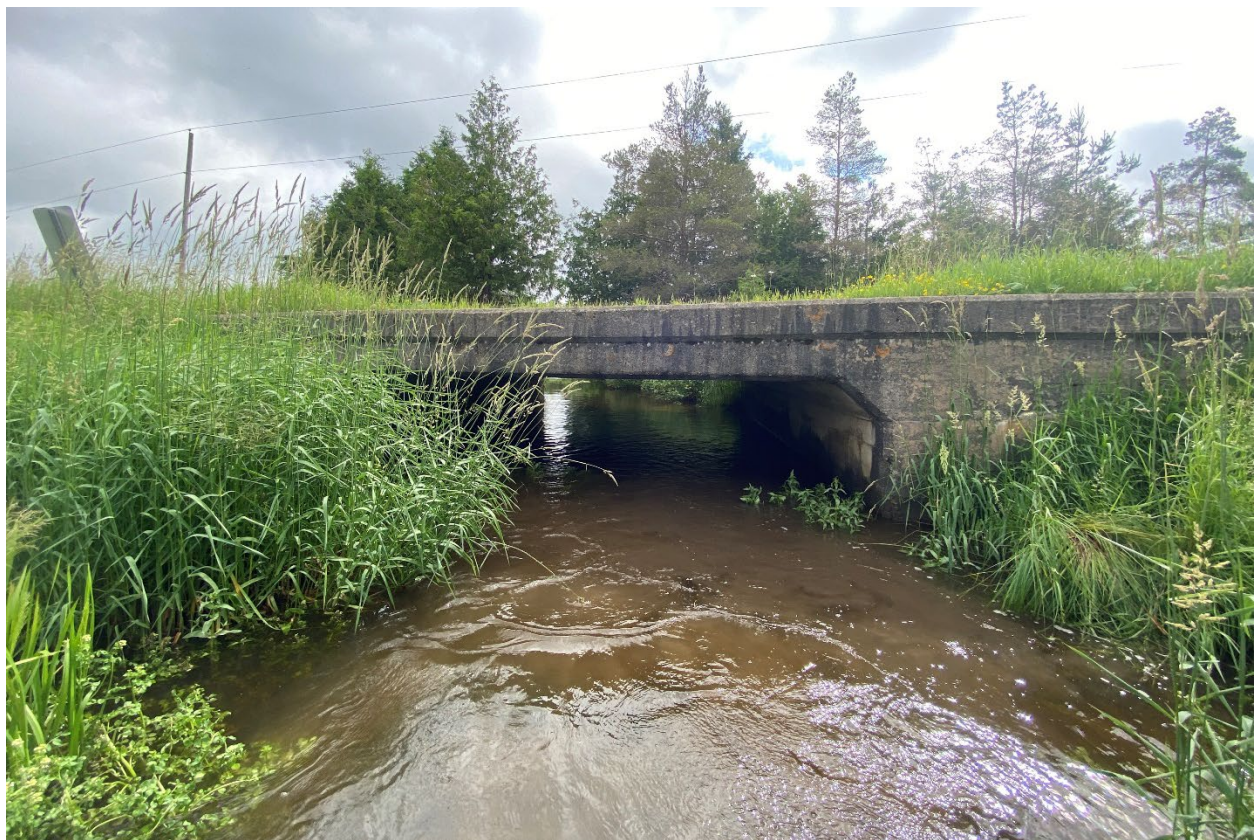
Structure 2014 is generally in good condition with only minor maintenance recommended at this time. The Township should ensure routine maintenance is completed to help maximize the service life of the structure.

**Recommendation:** No Capital Works is estimated to be required within the next 10 years.

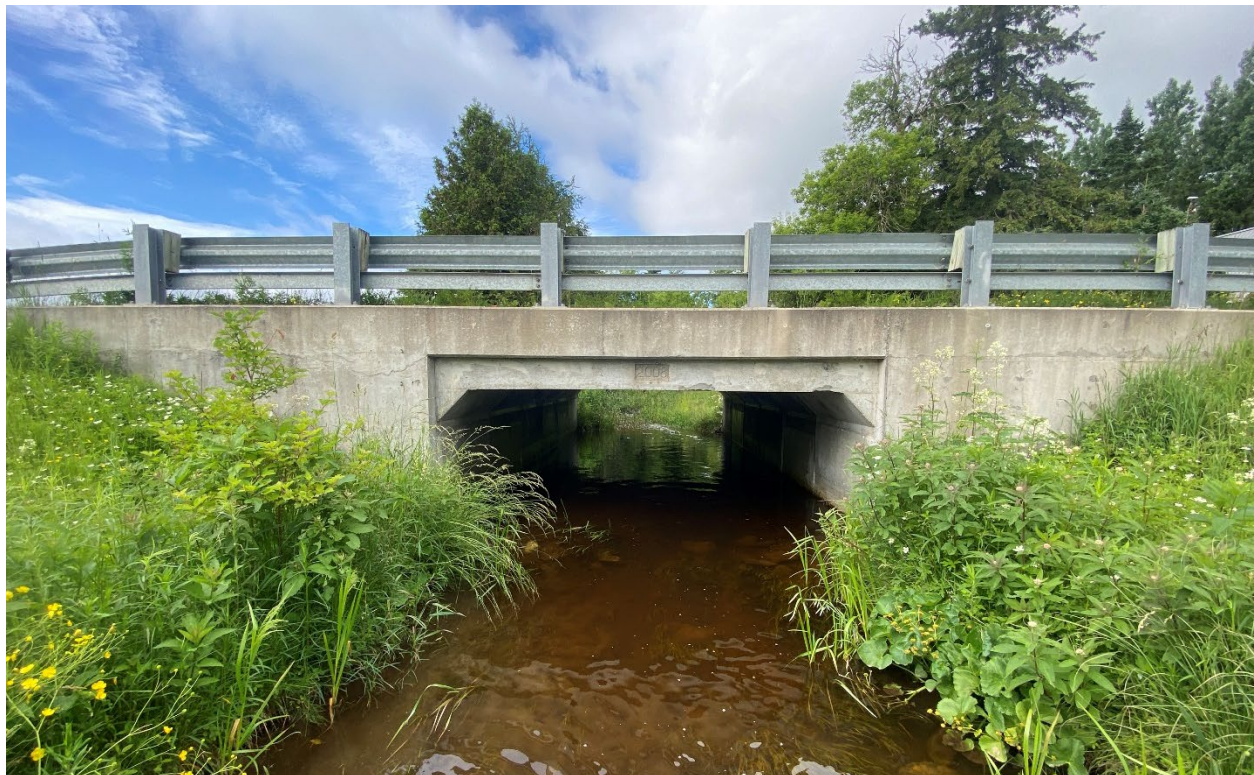
Structure 2015, which was constructed in 2008, is generally in excellent to good condition with only minor maintenance recommended at this time. The Township should ensure routine maintenance is completed to help maximize the service life of the structure.

**Recommendation:** No Capital Works is estimated to be required within the next 10 years.

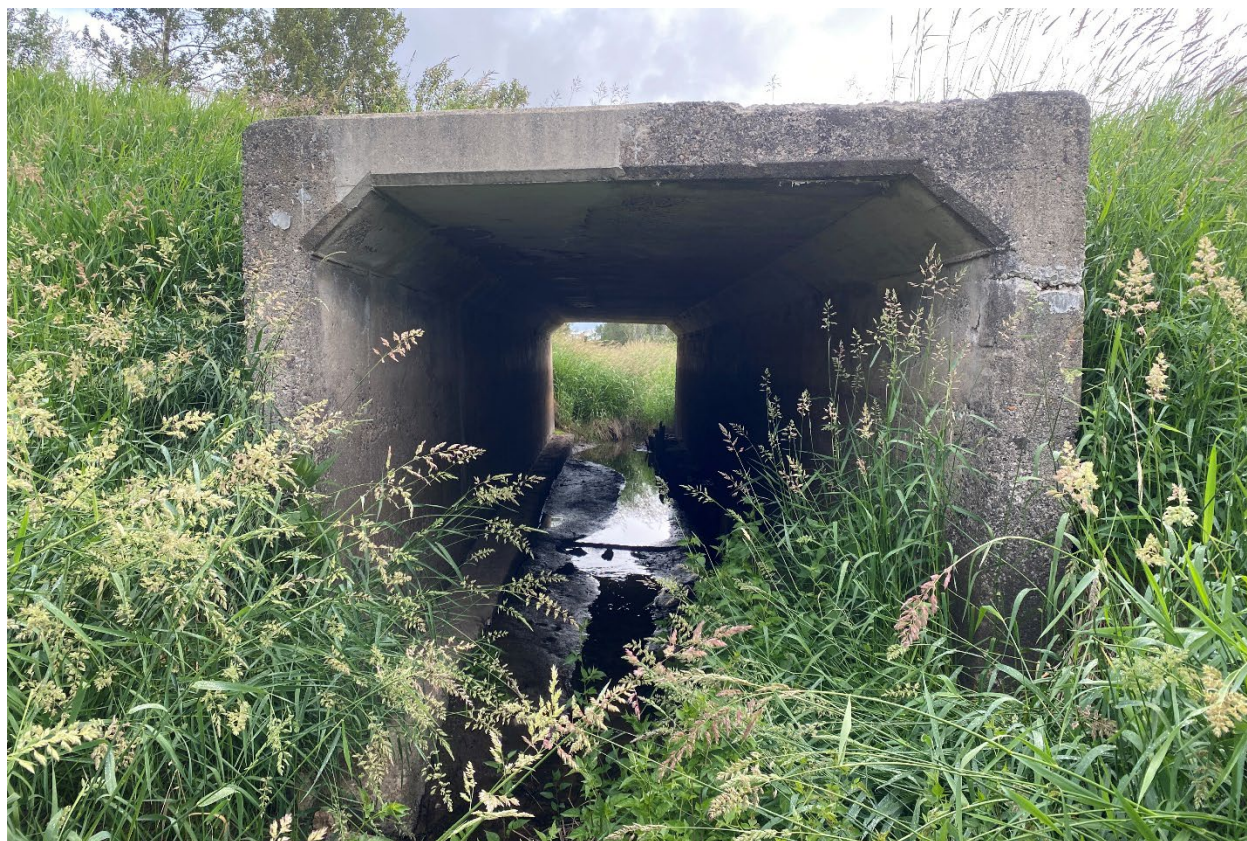
Structure 2016, which has been previously rehabilitated, is generally in good condition but is demonstrating signs of concrete deterioration, and moisture penetration. Based on the span, a rehabilitation is not recommended and replacement of the structure is recommended once the BCI reaches 40, in approximately 16 years. Consideration should be given to investigating the need for steel beam guide rail, and end treatments to help protect oncoming traffic. The Township may consider removing this structure from their biennial bridge inspection list since the span is less than 3m.

**Recommendation:** No Capital Works is estimated to be required within the next 10 years.

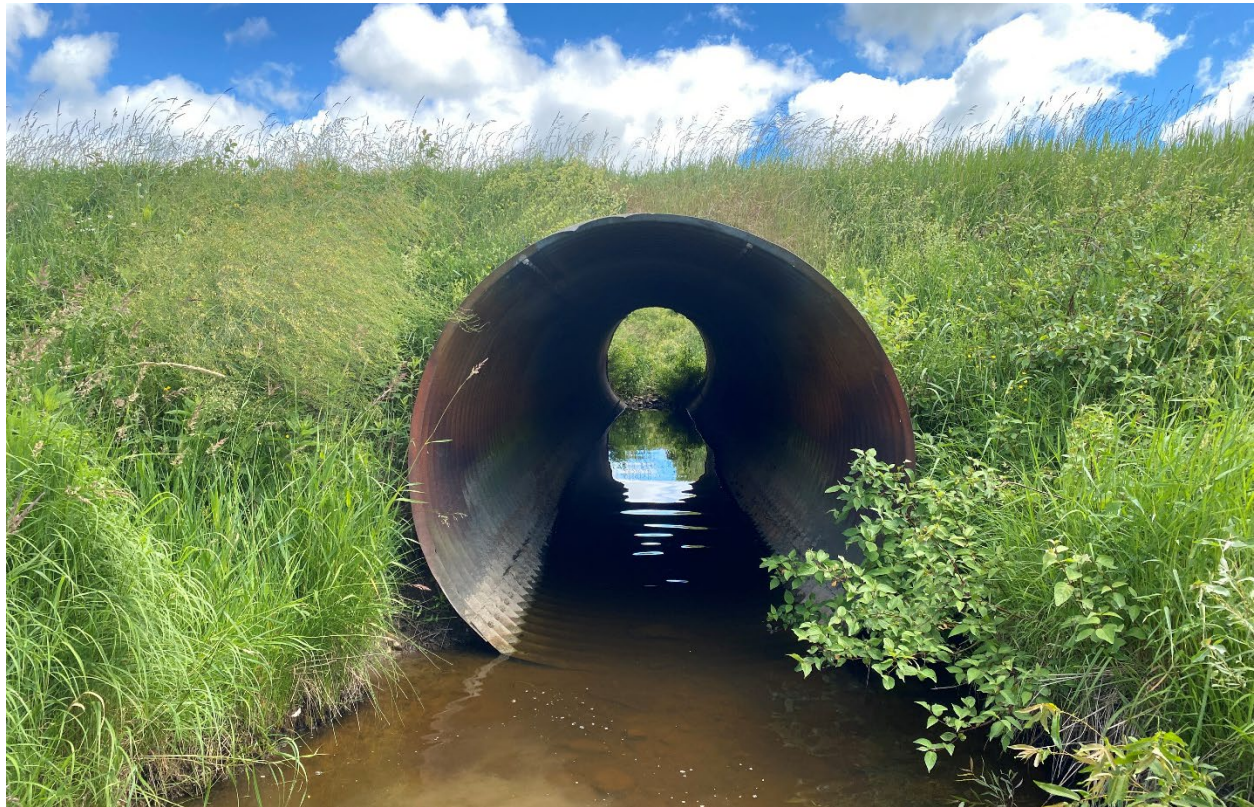
Structure 2017 is generally in fair to poor condition and is demonstrating signs of severe section loss > 10% along the waterline. Based on the span, a rehabilitation is not recommended and replacement of the structure is recommended once the BCI reaches 40, in approximately 9 years. Alternatively, the repairs listed above may be completed to help extend the lifespan of the structure. Consideration should be given to investigating the need for steel beam guide rail, and end treatments to help protect oncoming traffic.

**Recommendation:** Structure replacement is recommended within 9 years.

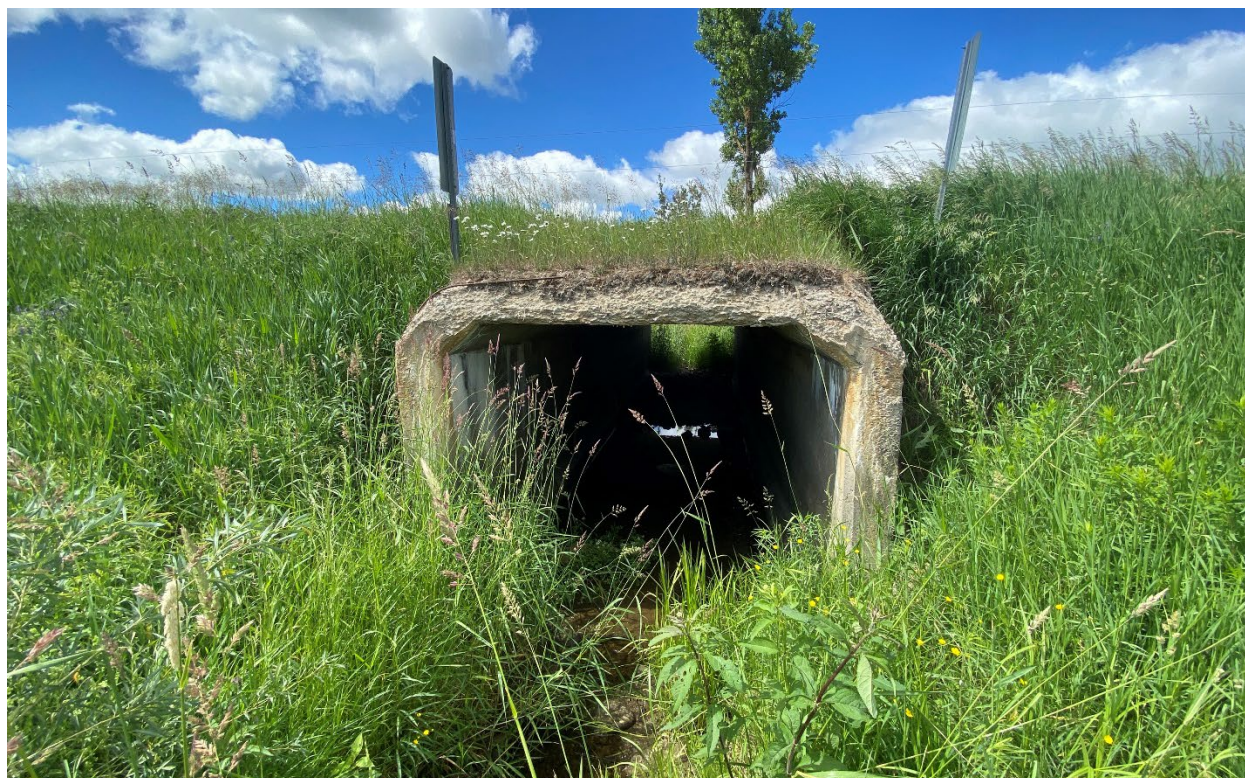
Structure 2018 is generally in good to fair condition but is demonstrating signs of severe concrete deterioration on the culvert inlet. Based on the span, a rehabilitation is not recommended and replacement of the structure is recommended once the BCI reaches 40, in approximately 14 years. Consideration should also be given to installing a steel beam guide rail system with end treatments to help protect oncoming traffic. The repairs listed above may be completed to help extend the lifespan of the structure but would not be considered economical as a standalone contract. The Township may consider removing this structure from their biennial inspection list since the span is less than 3 metres.

Maintenance Need	Element and Comments	Estimated Cost
Bridge Cleaning	Remove vegetation around hazard warning signs	\$500.00
Hazard Signs	Raise hazard warning signs at structure	\$500.00
<b>Maintenance Needs Total</b>		<b>\$1,000.00</b>

Rehabilitation/Repair Required	Priority	Estimated Cost
Type A concrete repairs to deck top,	N/A	\$5,000.00
Type C concrete repairs to barrels, inlet, outlet,	N/A	\$15,000.00
Waterproof and pave	N/A	\$20,000.00
General Items - Insurance, Mobilization, Access etc.	N/A	\$75,000.00
<b>Rehabilitation Cost Subtotal</b>		<b>\$115,000.00</b>

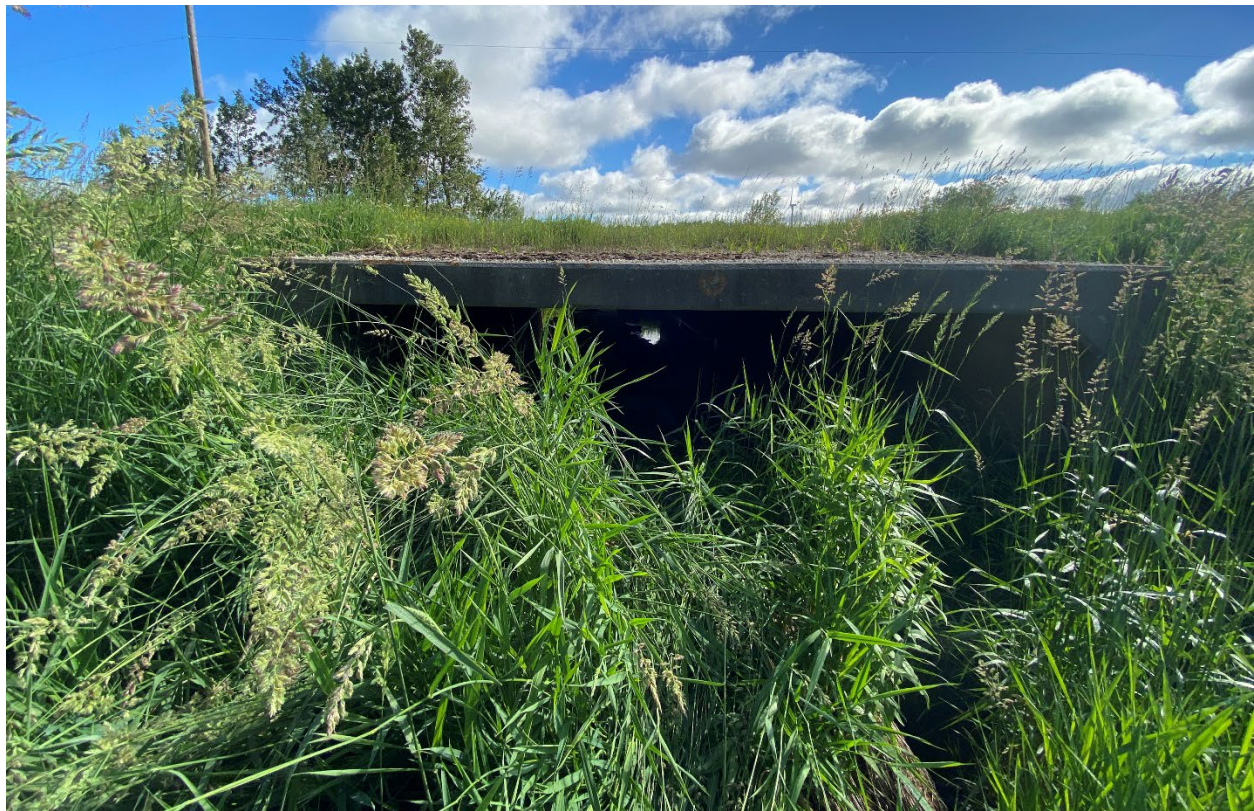
Structure 2019 is generally in good condition with only minor maintenance recommended at this time. The repairs listed above may be completed to help extend the lifespan of the structure but would not be considered economical as a standalone contract. Consideration should be given to installing steel beam guide rail with end treatments to help protect oncoming traffic.

Maintenance Need	Element and Comments	Estimated Cost
Hazard Signs	Install hazard warning signs at structure	\$1,000.00
<b>Maintenance Needs Total</b>		<b>\$1,000.00</b>

Rehabilitation/Repair Required	Priority	Estimated Cost
Type A concrete repairs to deck top,	N/A	\$5,000.00
Type C concrete repairs to barrels, inlet,	N/A	\$1,000.00
Waterproof and pave	N/A	\$20,000.00
General Items - Insurance, Mobilization, Access etc.	N/A	\$75,000.00
<b>Rehabilitation Cost Subtotal</b>		<b>\$101,000.00</b>

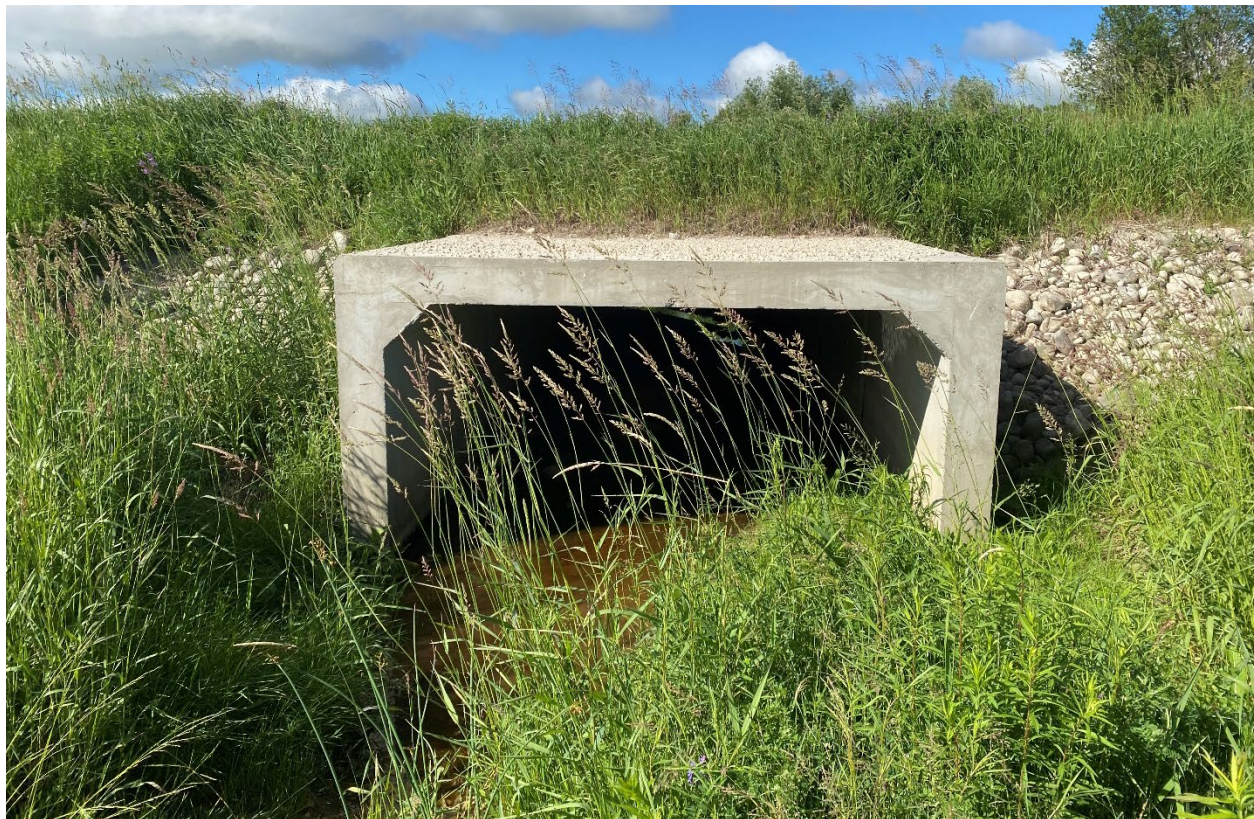
Structure 2020 is generally in excellent condition with only minor maintenance recommended at this time. The Township should ensure routine maintenance is completed to help maximize the service life of the structure. Consideration should be given to investigating the need for steel beam guide rail to help protect oncoming traffic.

Maintenance Need	Element and Comments	Estimated Cost
Hazard Signs	Install hazard warning signs at structure	\$1,000.00
<b>Maintenance Needs Total</b>		<b>\$1,000.00</b>

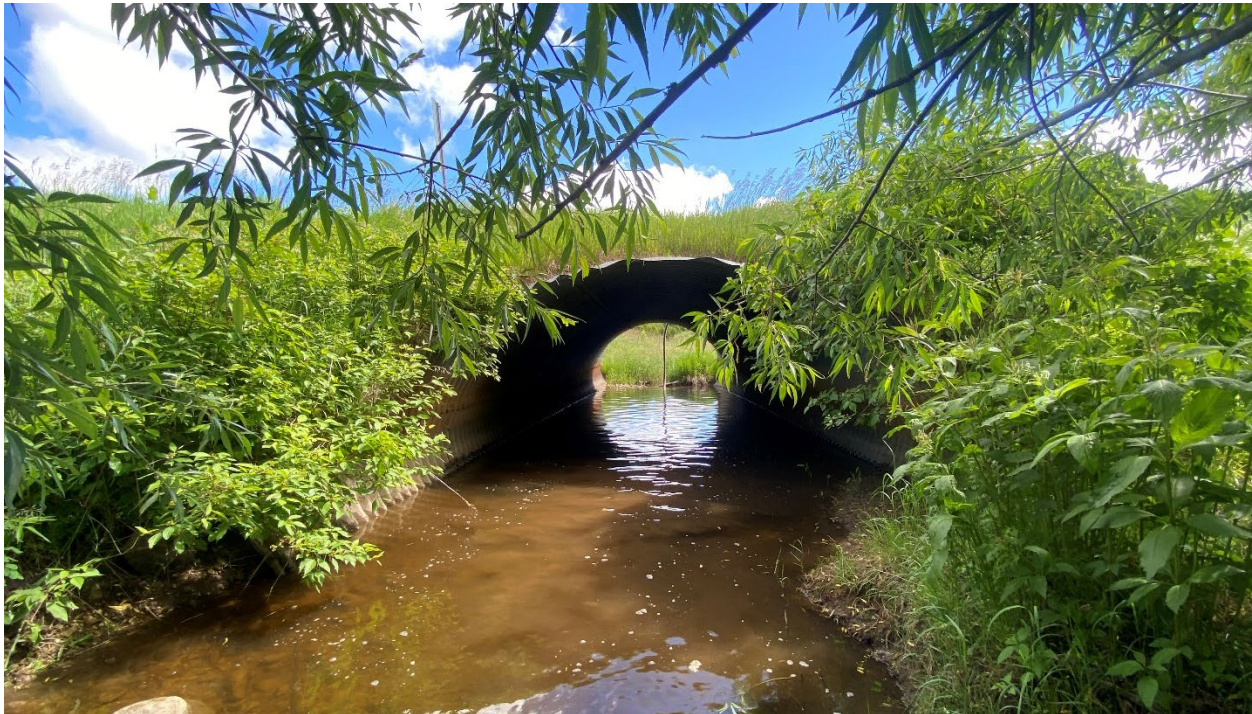
Structure 2021 is generally in poor condition with bolt hole cracking throughout the culvert barrel. Based on the structure type a rehabilitation is not recommended and replacement of the structure is recommended once the BCI reaches 40, in approximately 5 years. Steel reinforcement was welded to the bolt hole cracks in 2019 however, the Township should establish a monitoring program for the bolt hole cracking until the structure can be replaced. Consideration should be given to investigating the need for steel beam guide rail, end treatments to help protect oncoming traffic.

**Recommendation:** Structure replacement is recommended within 5 years.

Additional Investigations	Priority	Estimated Cost
Monitoring Crack Widths,	Normal	\$5,000.00

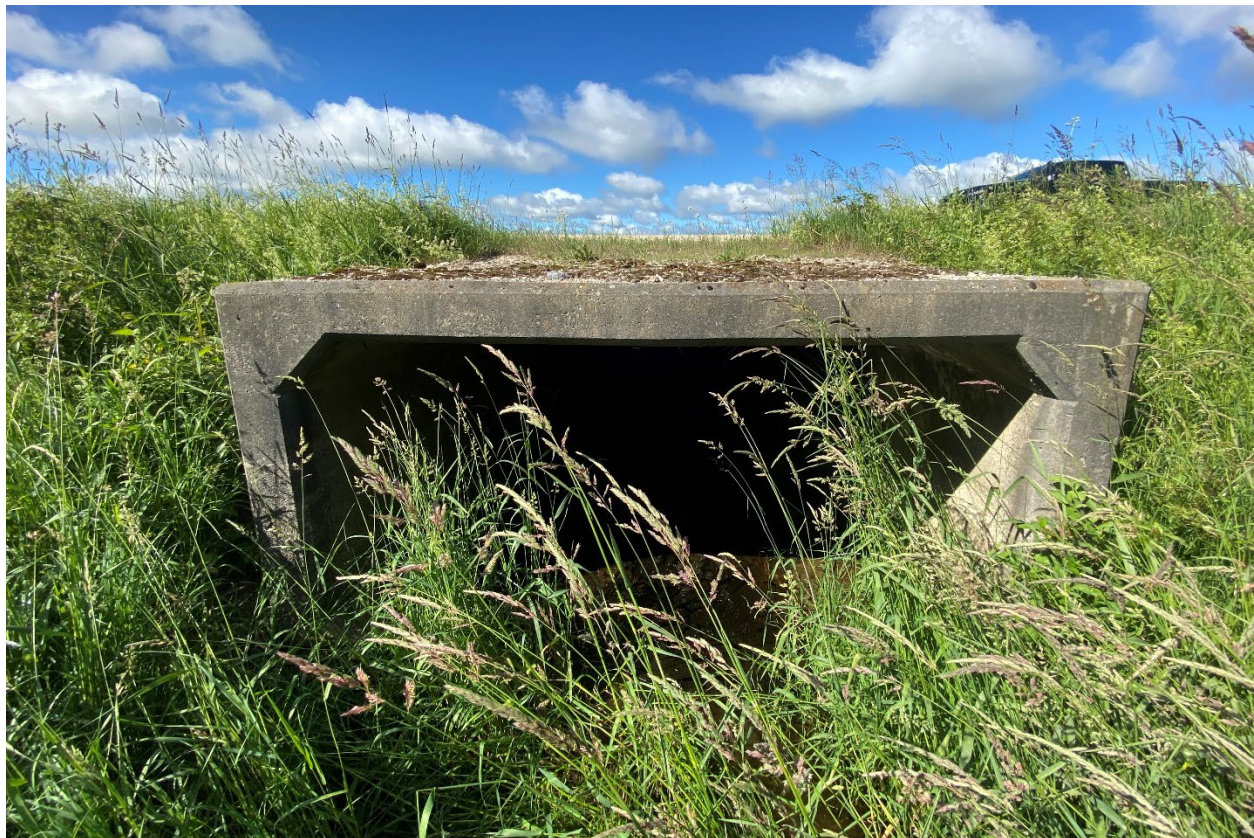
Structure 2022 is generally in good condition with only minor maintenance recommended at this time. The Township should ensure routine maintenance is completed to help maximize the service life of the structure. Consideration should be given to investigating the need for steel beam guide rail, and end treatments to help protect oncoming traffic.

Maintenance Need	Element and Comments	Estimated Cost
Hazard Signs	Install hazard warning signs at structure	\$1,000.00
<b>Maintenance Needs Total</b>		<b>\$1,000.00</b>
