**2021 OSIM Bridge Inspection Report**

**Township of Melancthon  
157101 Highway 10  
Melancthon, ON L9V 2E6**

**December 2021  
30052974.0000**

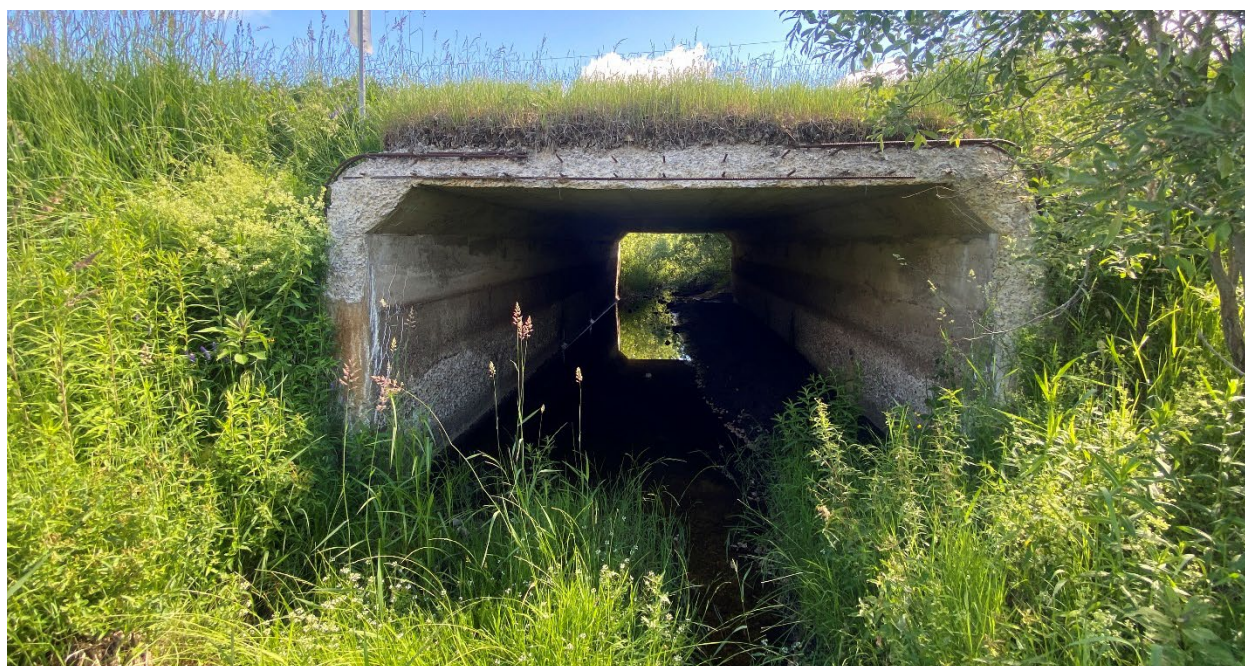
Structure 2023 is generally in fair condition and is demonstrating signs of severe concrete deterioration specifically at the culvert ends. The vegetation and fill overtop of the culvert ends appear to be contributing to the concrete deterioration and should be removed as soon as possible. Given the relatively small span, The Township may wish to continue monitoring the structure's BCI during future biennial inspections and consider replacement as the BCI reaches 40, which is estimated to occur in approximately 11 years. However, given that the culvert interior is generally in good condition, reconstructing the culvert ends, exposing the deck to repair and apply waterproofing, backfilling and paving would help extend the service life and is the recommended action. With the current BCI approaching 60, rehabilitation should be scheduled within 1-2 years. Consideration should also be given to investigating the need for steel beam guide rail, and end treatments to help protect oncoming traffic.

**Recommendation:** Minor Rehabilitation is recommended within 1 years.

Maintenance Need	Element and Comments	Estimated Cost
Bridge Cleaning	Remove fill and overgrown vegetation over culvert ends and around hazard warning signs	\$2,000.00
<b>Maintenance Needs Total</b>		<b>\$2,000.00</b>

Rehabilitation/Repair Required	Priority	Estimated Cost
Type A concrete repairs to deck top,	1 to 5 years	\$5,000.00
Type C concrete repairs to barrels, Reconstruct culvert ends	1 to 5 years	\$40,000.00
Waterproof and pave	1 to 5 years	\$25,000.00
General Items - Insurance, Mobilization, Access etc.	1 to 5 years	\$75,000.00
<b>Rehabilitation Cost Subtotal</b>		<b>\$145,000.00</b>

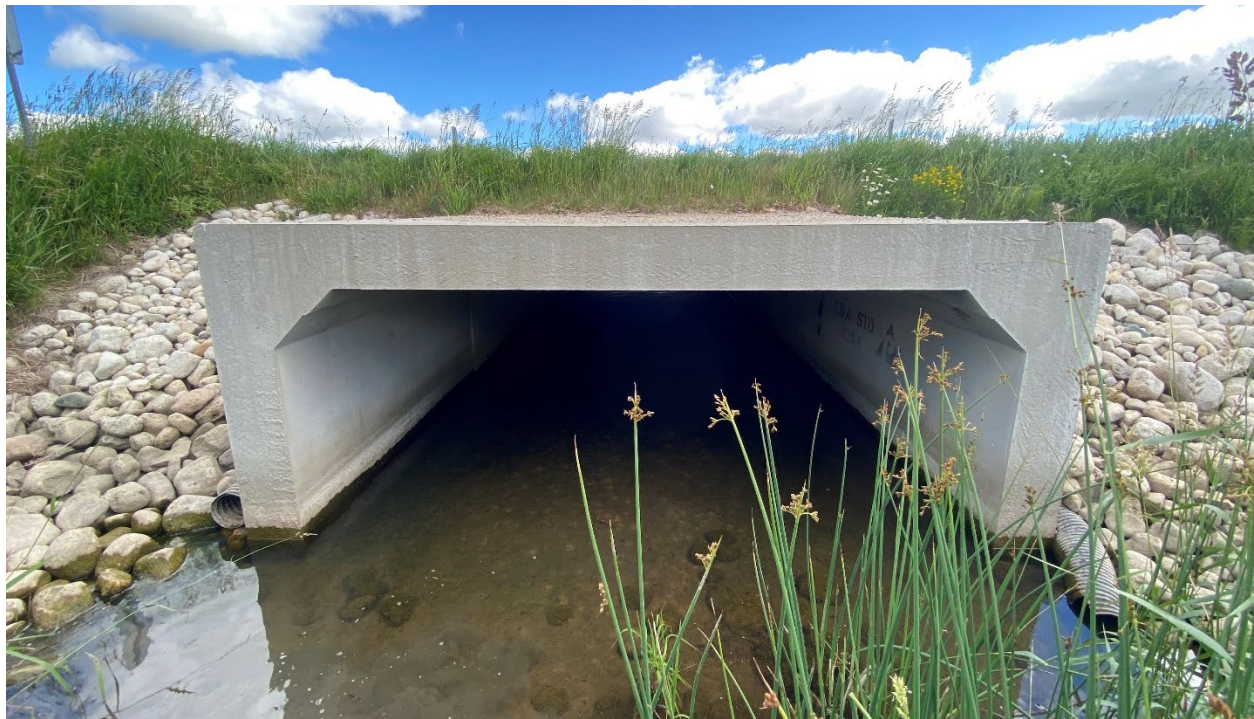
Structure 2024 was recently replaced in 2016 and is generally in excellent condition. The Township should ensure routine maintenance is completed to help maximize the service life of the structure. Consideration should be given to investigating the need for steel beam guide rail with end treatments to help protect oncoming traffic.

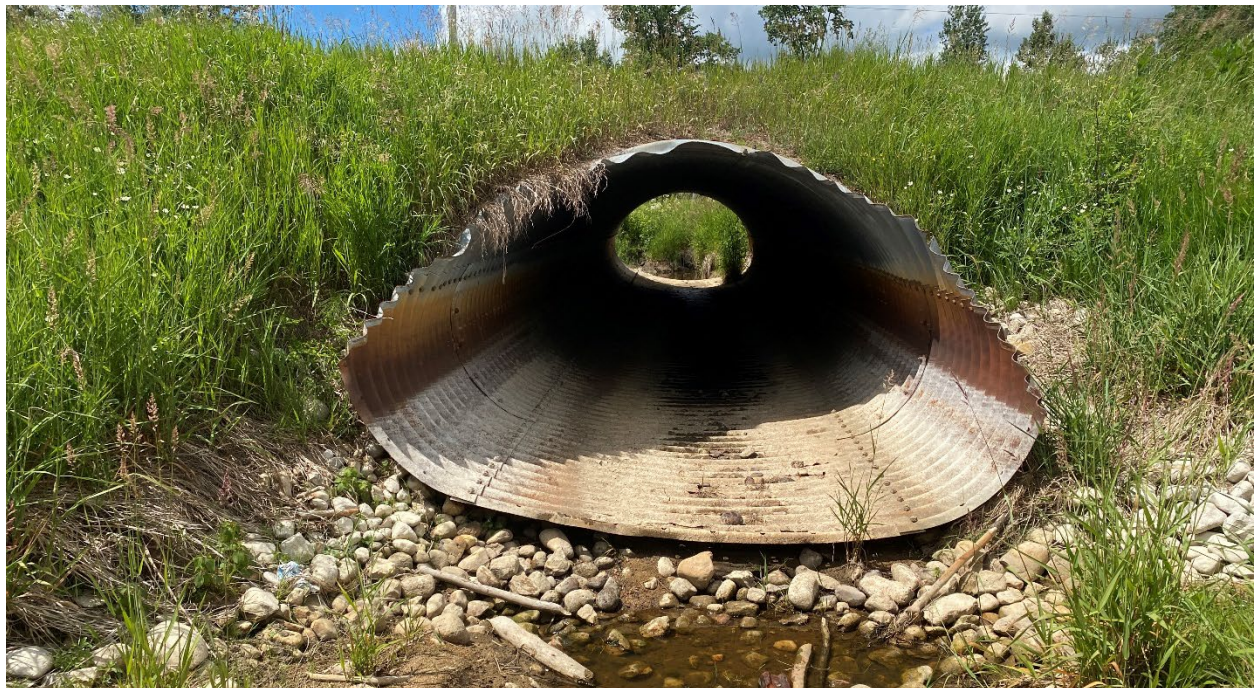
Structure 2025 is generally in good to fair condition but is demonstrating signs of moderate to severe surface corrosion and section loss throughout the culvert barrel. Based on the span, a rehabilitation is not recommended and replacement of the structure is recommended once the BCI reaches 40, in approximately 13 years. Consideration should be given to investigating the need for steel beam guide rail, and end treatments to protect oncoming traffic.

Maintenance Need	Element and Comments	Estimated Cost
Hazard Signs	Install hazard warning signs at structure	\$1,000.00
<b>Maintenance Needs Total</b>		<b>\$1,000.00</b>

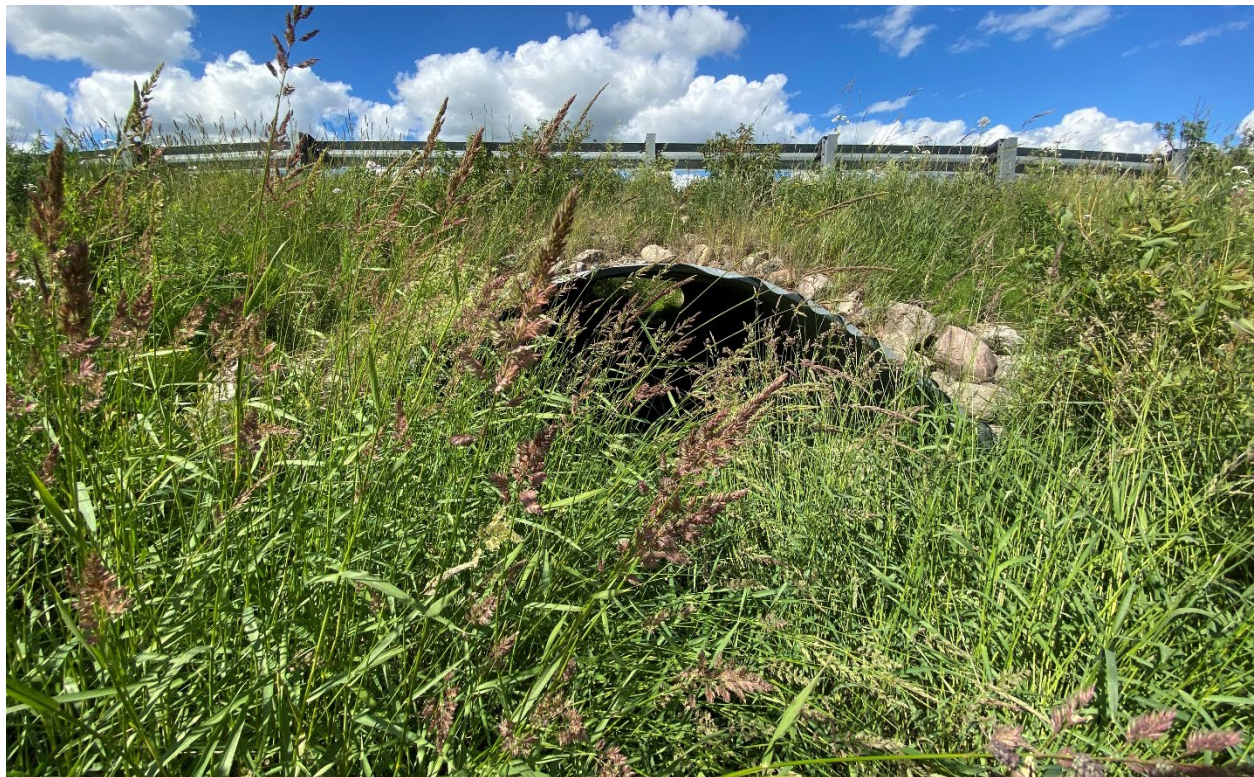
Structure 2026 is generally in excellent to good to excellent condition. However, several areas of minor localized deformations and cusping were noted but may be from original construction. The deformations and cusping should be monitored during future biennial inspections to ensure they are not actively progressing. The Township should ensure routine maintenance is completed to help maximize the service life of the structure. Consideration should also be given to replacing the steel beam guide rail system and end treatments to help protect oncoming traffic.

Roadside Protection Repairs	Priority	Estimated Cost
Replace Guide Rail, end treatments	1 to 5 Years	\$56,000.00

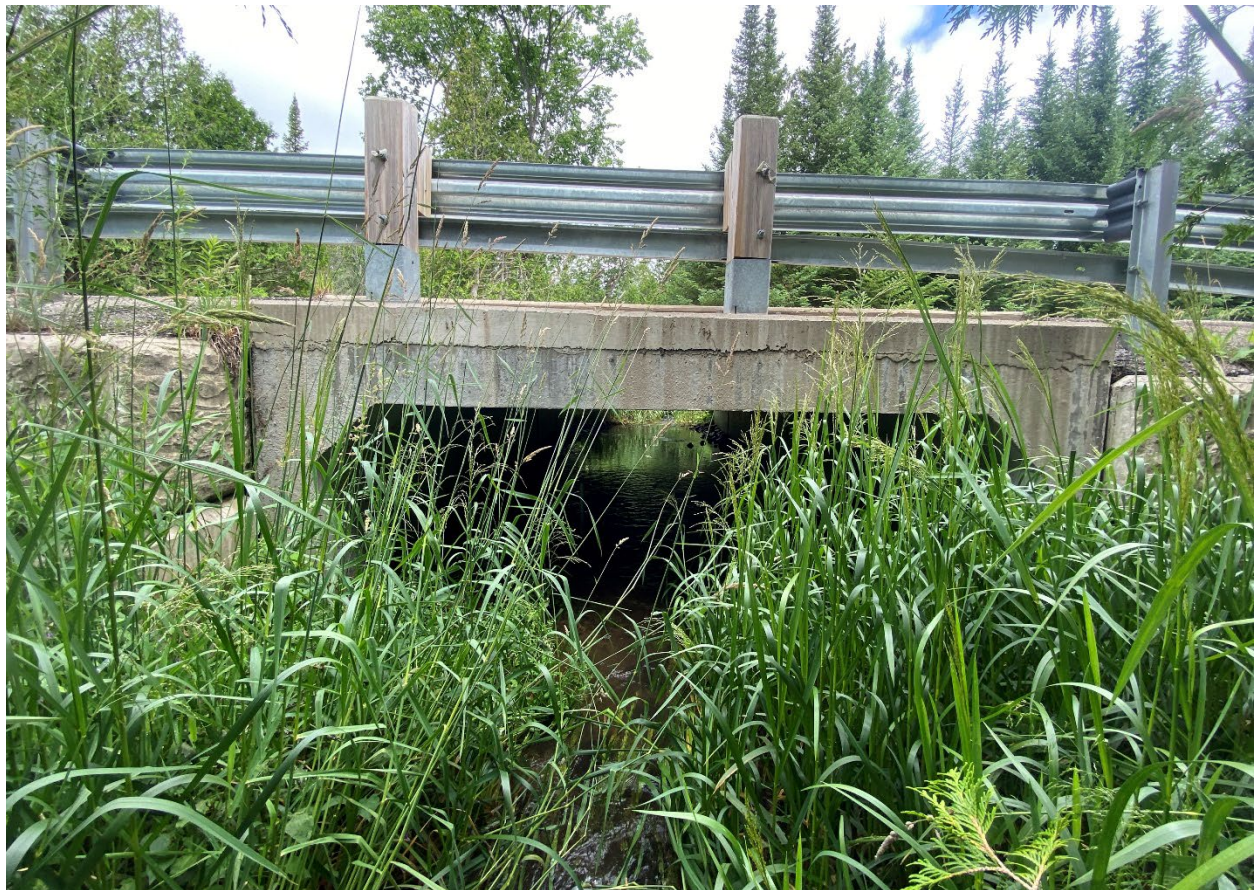
Structure 2027 is generally in excellent condition with only minor maintenance recommended at this time. The Township should ensure routine maintenance is completed to help maximize the service life of the structure.

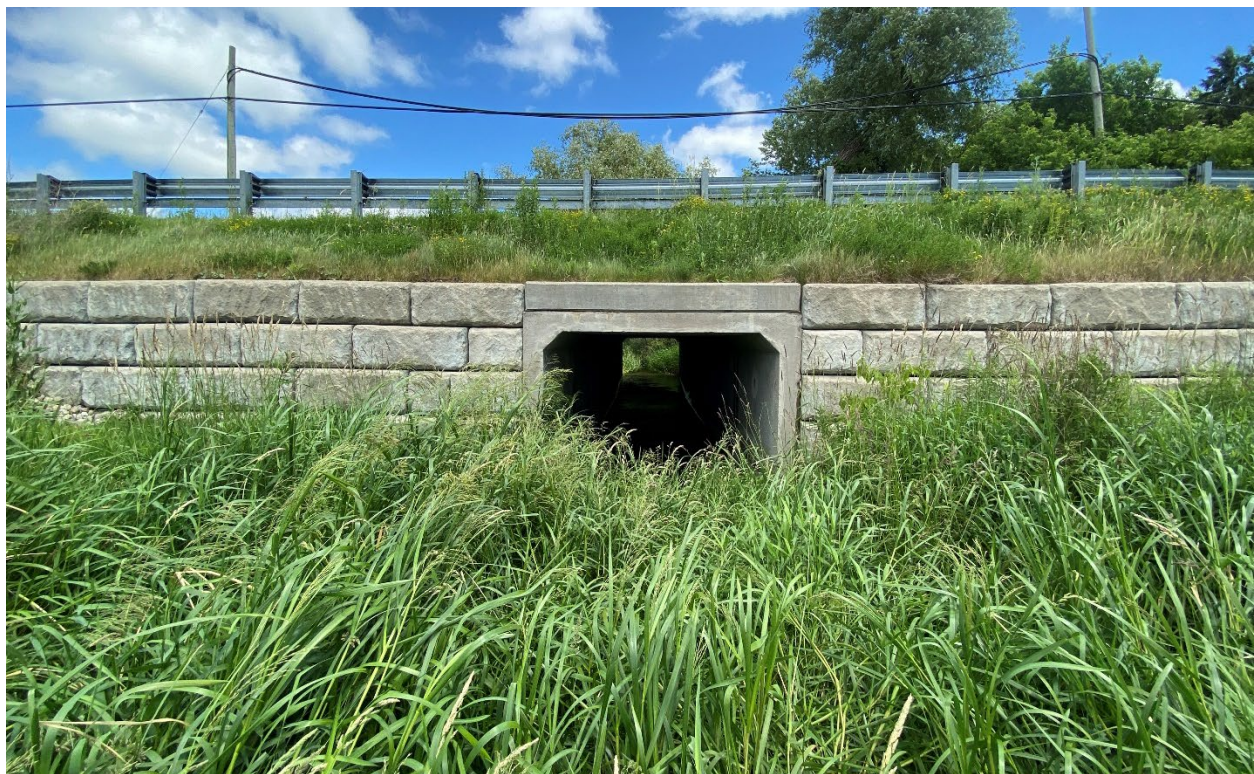
Structure 2028 is generally in excellent condition with only minor maintenance recommended at this time. The Township should ensure routine maintenance is completed to help maximize the service life of the structure. The Township may wish to consider removing the culvert from the future bridge inspection list as the span of the new structure is less than 3 metres.

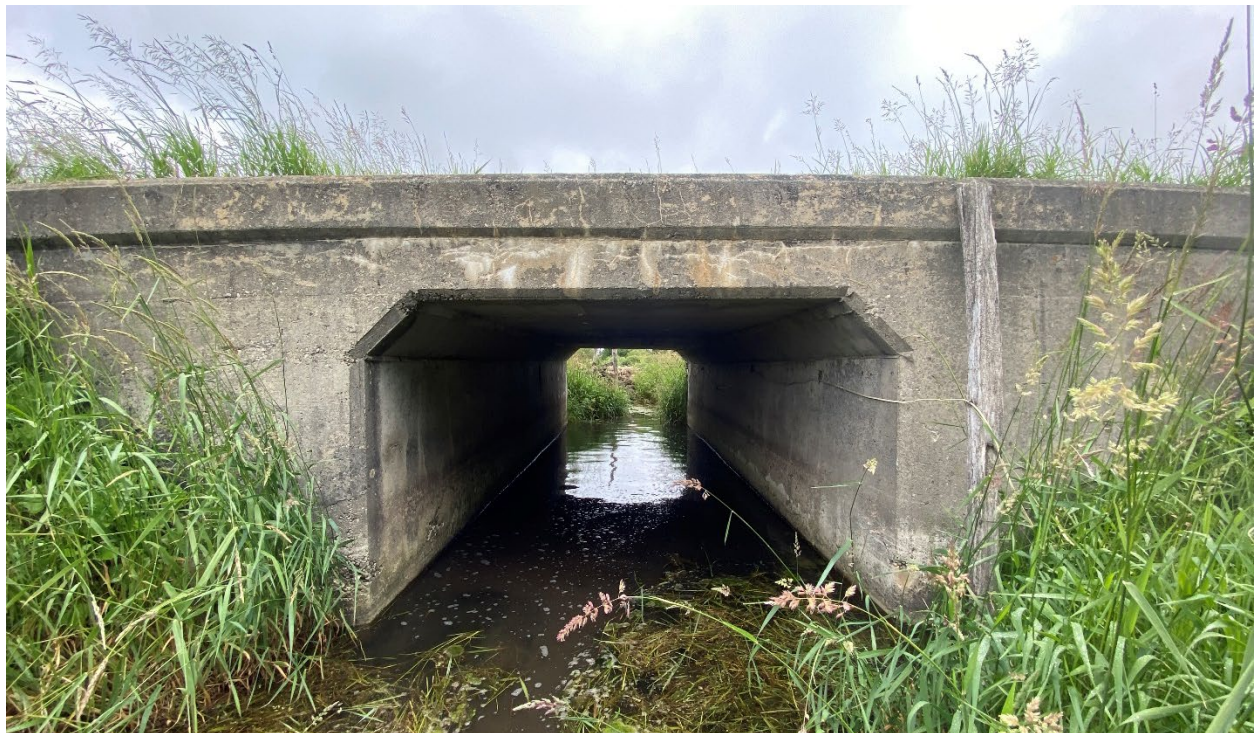
Structure 2029 is generally in good condition but is demonstrating signs of potential movement/rotation of the south abutment and SE wingwall. Based on the span, a rehabilitation is not recommended and replacement of the structure is recommended once the BCI reaches 40, in approximately 17 years. However, if the movements/rotations in the substructure progress then the replacement timeline should be expedited. It is also recommended that a monitoring program be established to monitor the movement/rotation observed in the substructure. The repairs listed above may be completed to help extend the lifespan of the structure but would not be considered economical as a standalone contract.

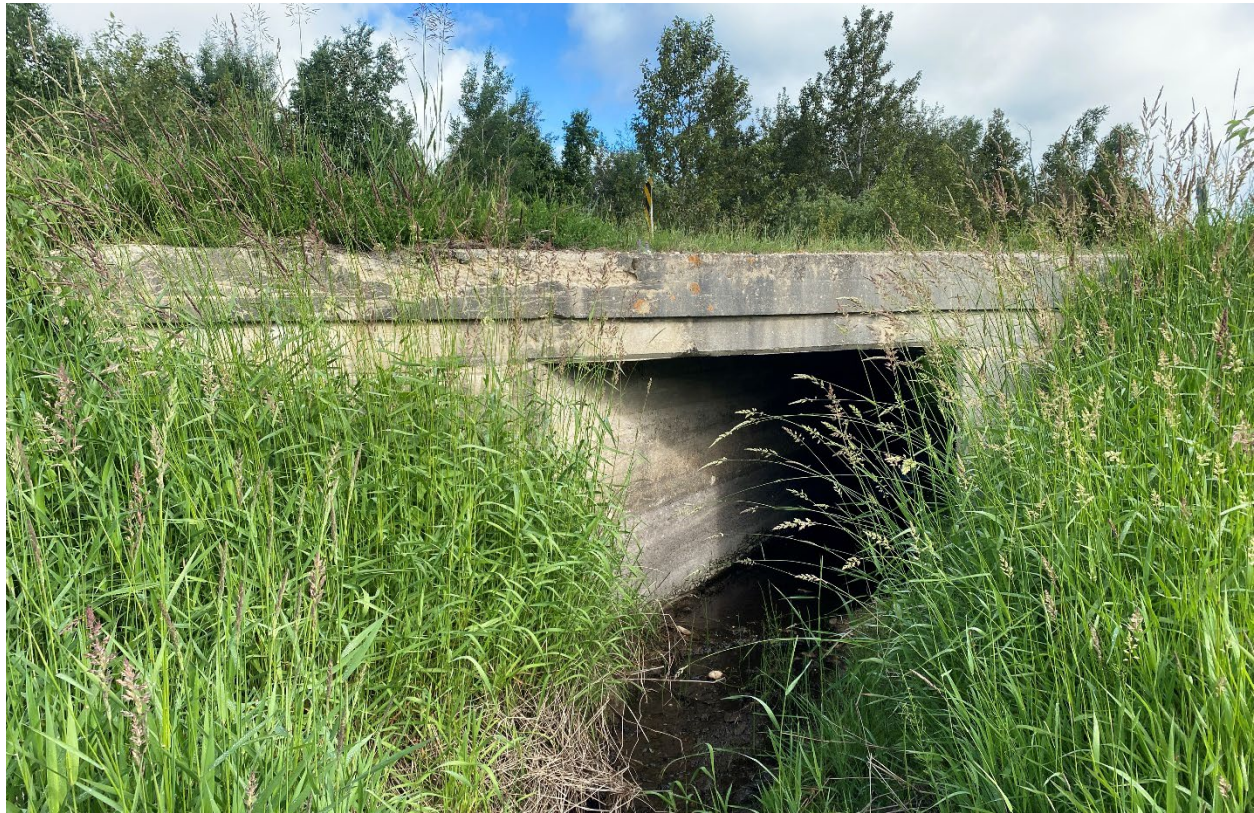
Structure 2030 is generally in fair condition and is demonstrating signs of concrete deterioration and moisture penetration throughout. Based on the span, and sub-standard driving platform width, a rehabilitation is not recommended and replacement of the structure is recommended once the BCI reaches 40, in approximately 12 years. The repairs listed above may be completed to help extend the lifespan of the structure.

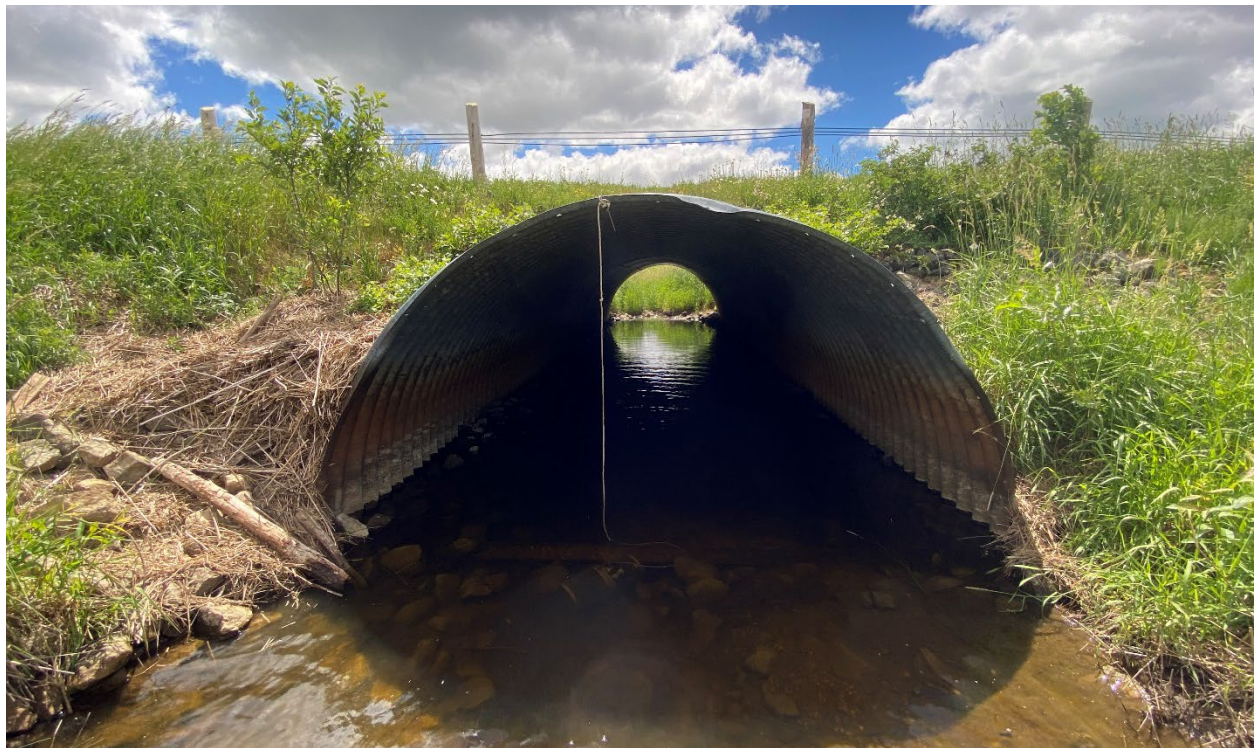
Structure 2031 is generally in excellent to good condition. It is recommended that the localized deformation in the culvert barrel be monitored during future biennial inspections to ensure it is not actively progressing. The Township should ensure routine maintenance is completed to help maximize the service life of the structure.

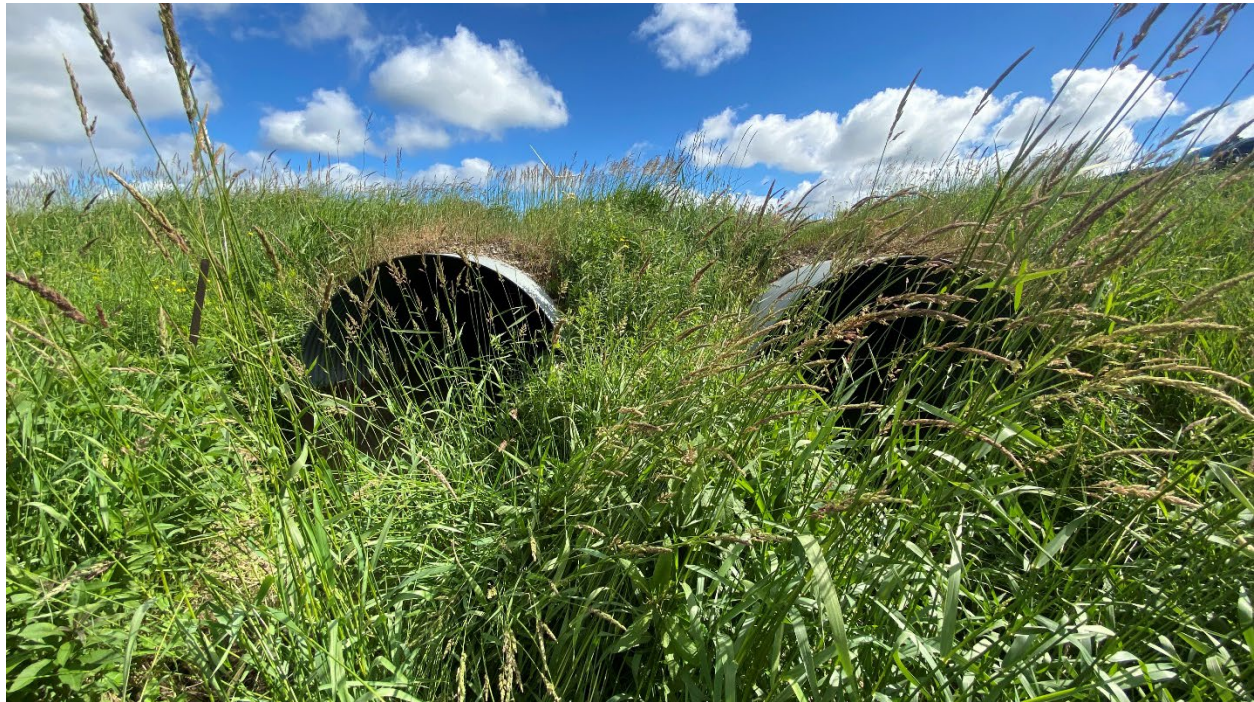
Structure 2032 is generally in fair condition but is demonstrating signs of moderate to severe surface corrosion with section loss greater than 15% in localized areas. Based on the structure type, a rehabilitation is not recommended and replacement of the structure is recommended once the BCI reaches 40, in approximately 11 years. It is recommended that the deformations noted in the south culvert barrel be monitored during future biennial inspections to ensure they are not actively progressing. Consideration should also be given to investigating the need for a steel beam guide rail system, and end treatments to help protect oncoming traffic.

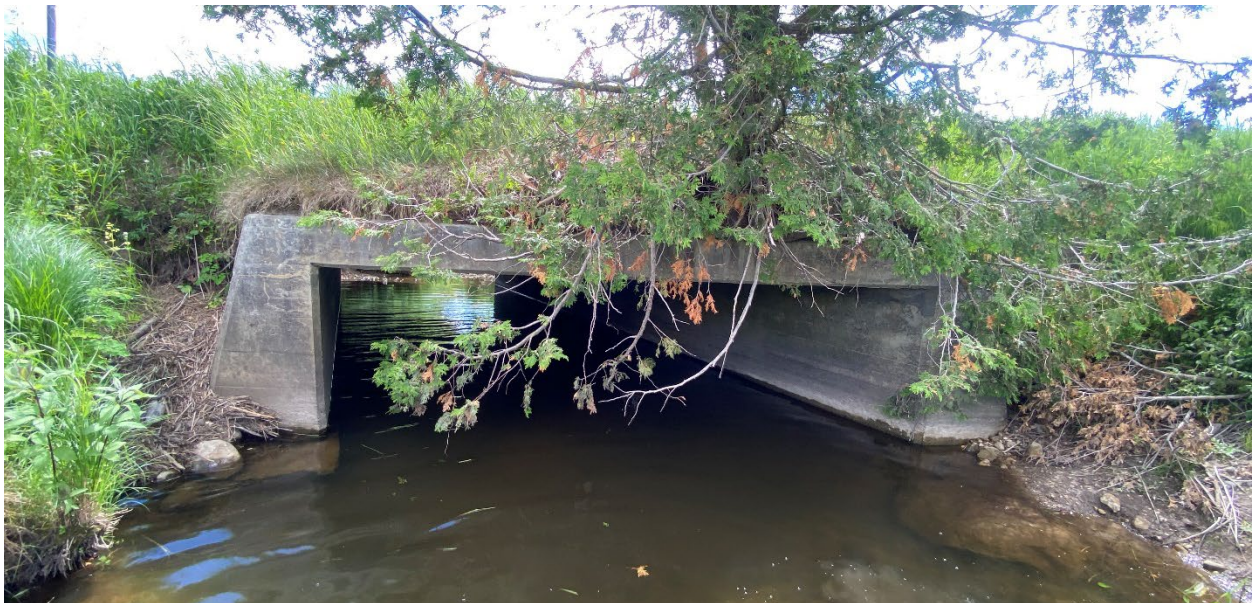
Structure 2033 is generally in good condition however, the existing embankments are eroded, very steep and appear unstable. Based on the span, and low clearance, a rehabilitation is not recommended and replacement of the structure is recommended once the BCI reaches 40, in approximately 17 years. However, it is recommended that the Township consider constructing headwalls, retaining walls, and placing slope protection within 1 year to avoid potential failure of the embankments and loss of road material. Consideration should also be given to investigating the need for a steel beam guide rail system with end treatments to help protect oncoming traffic.

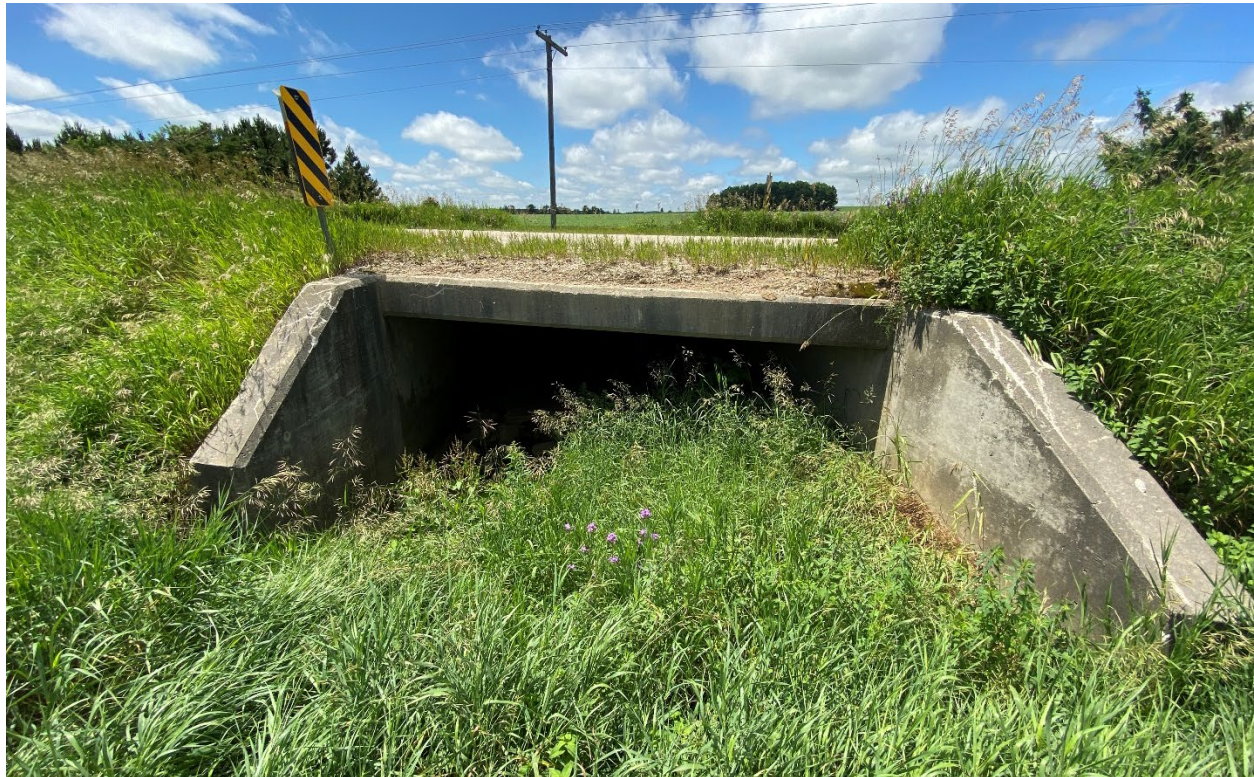
Structure 2034 is generally in good to fair condition but is demonstrating signs of concrete deterioration specifically on the original portion of the structure. Based on the span and low clearance, a rehabilitation is not recommended and replacement of the structure is recommended once the BCI reaches 40, in approximately 13 years. However, the repairs listed above may be completed to help extend the lifespan of the structure.

**Recommendation:** No Capital Works is estimated to be required within the next 10 years.

Maintenance Need	Element and Comments	Estimated Cost
Bridge Cleaning	Remove overgrown vegetation blocking waterway	\$2,500.00
Erosion Control	Repair erosion on SE embankment	\$1,000.00
Hazard Signs	Install additional hazard warning signs at structure	\$500.00
<b>Maintenance Needs Total</b>		<b>\$4,000.00</b>

Rehabilitation/Repair Required	Priority	Estimated Cost
Type A concrete repairs to deck top,	N/A	\$5,000.00
Type B concrete repairs to soffit,	N/A	\$15,000.00
Type C concrete repairs to abutment walls,	N/A	\$15,000.00
Waterproof and pave	N/A	\$25,000.00
Add slope stabilization	N/A	\$12,000.00
General Items - Insurance, Mobilization, Access etc.	N/A	\$75,000.00
<b>Rehabilitation Cost Subtotal</b>		<b>\$147,000.00</b>
