Re: **Vegetation Protection and Restoration Plan Addendum & Response #1 to Peer Review
Comments– 537086 Main Street, Horning’s Mills, Township of Melancthon
(Project No. 300056814.0000)**

Figure 2A – Vegetation Protection Plan (Updated)

Figure 2B – Tree Grouping Assessment Details (Updated)

Figure 3 – Vegetation Restoration Plan (Updated)

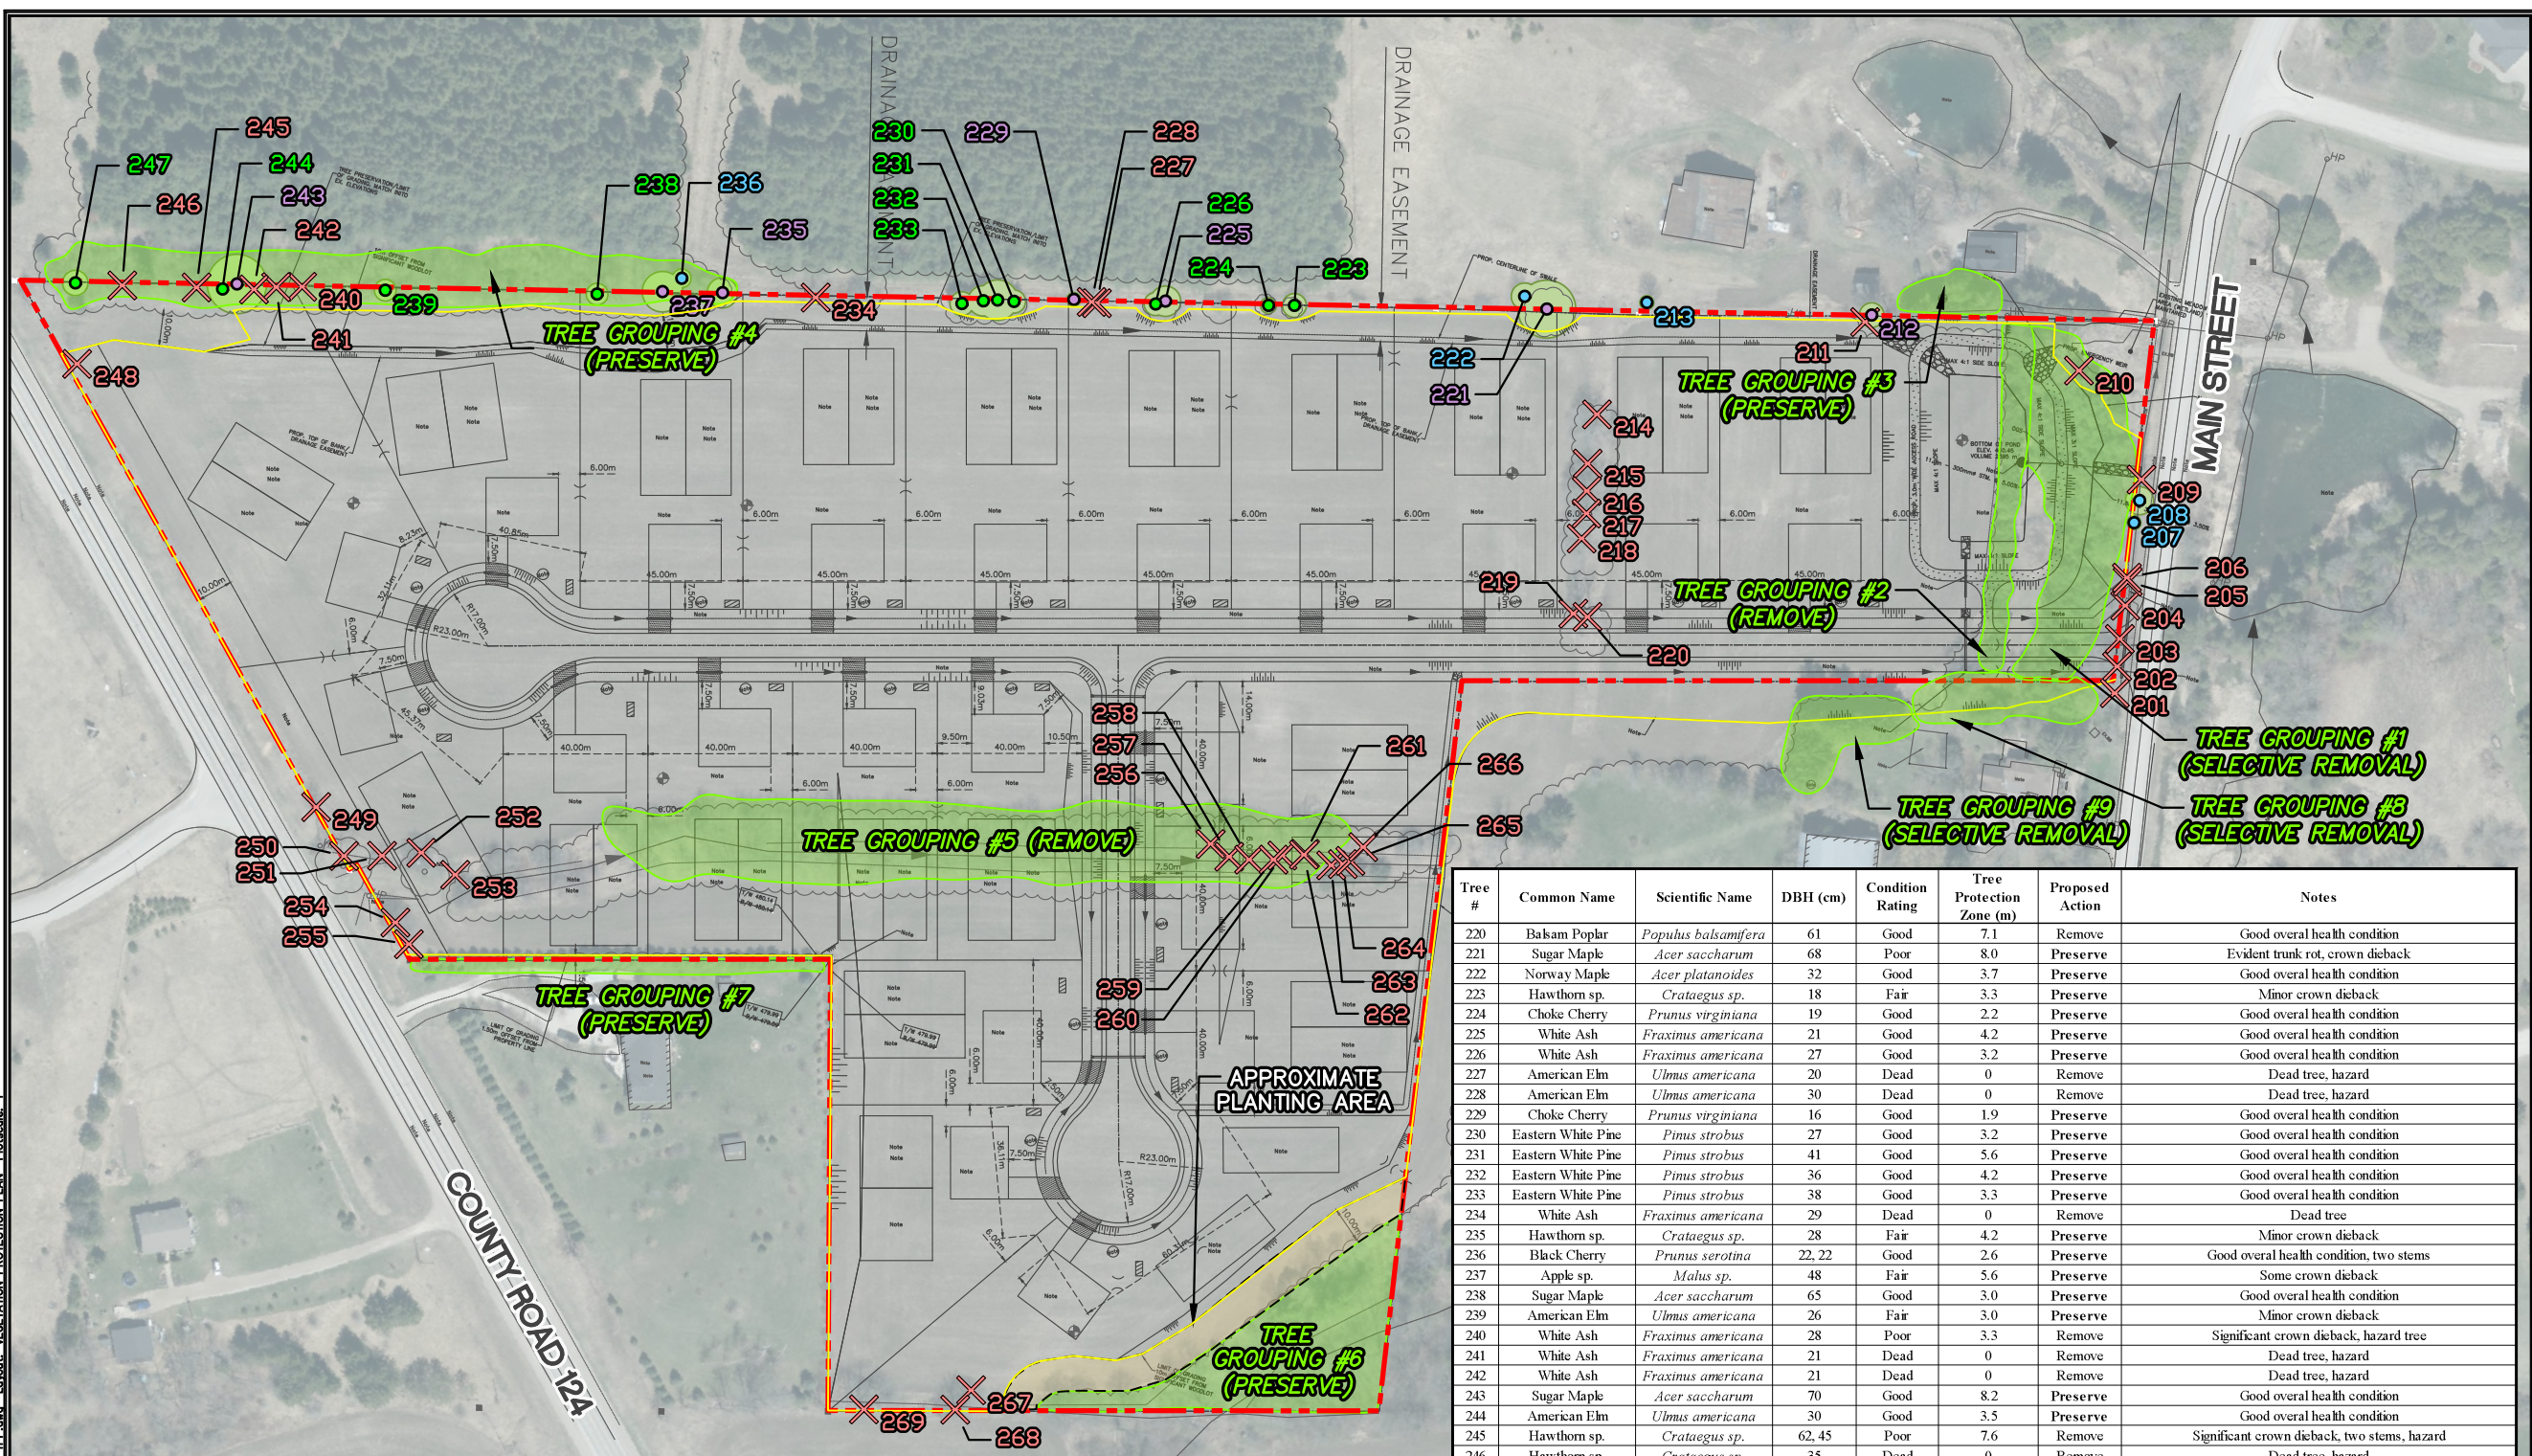
- APPROX. PROPERTY BOUNDARY
- EXISTING TREE TO BE PRESERVED - LOCATED ON PROPERTY
- EXISTING TREE TO BE PRESERVED - LOCATED ON PROPERTY LINE
- EXISTING TREE TO BE PRESERVED - LOCATED OFF PROPERTY
- ✕ EXISTING TREE LOCATION TO BE REMOVED
- TREE GROUPING
- ROOT PROTECTION ZONE - INDIVIDUAL TREES
- APPROX. PLANTING AREA
- VEGETATION PRESERVATION FENCING

NOTES:
 1. FOR TREE GROUPING DETAILS, SEE TABLE 2 ON FIGURE 2B.

The proposed edge of grading and associated tree protection fencing have been revised in the southwest property adjacent the hedgerow to permit an additional 1.5m of setback to the property line on the north edge of the property in this location, where the grading is closest to the trees. This is reflected in the updated Figure 2A of the Vegetation Protection and Preservation Plan (attached). The maximum tree size in this hedgerow is 25cm DBH, as noted in Table 2, Figure 2, and these trees were noted to be located on adjacent lands (*i.e.* south of the property boundary), albeit very close to the property boundary. Therefore, given the maximum tree size, ensuring a minimum of 1.5m along this line preserves a minimum of 75% of any single Tree Protection Zone of a tree in this hedgerow, preventing harm to these trees in a post-construction scenario. This revised grading and tree protection fencing is consistent with the standards of Section 4.0 of the Vegetation Protection and Preservation Plan.

The alignment of the tree protection fencing, limit of grading and swale positioning along the north property boundary have been revised to avoid conflicts between grading, tree protection and swale construction. See updated Figure 2A of the Vegetation Protection and Preservation Plan.

Figure 2 (Vegetation Protection Plan) has been corrected to ensure Tree Protection Fencing does not cross through the retained wetland feature and its buffer in the northeast portion of the property.

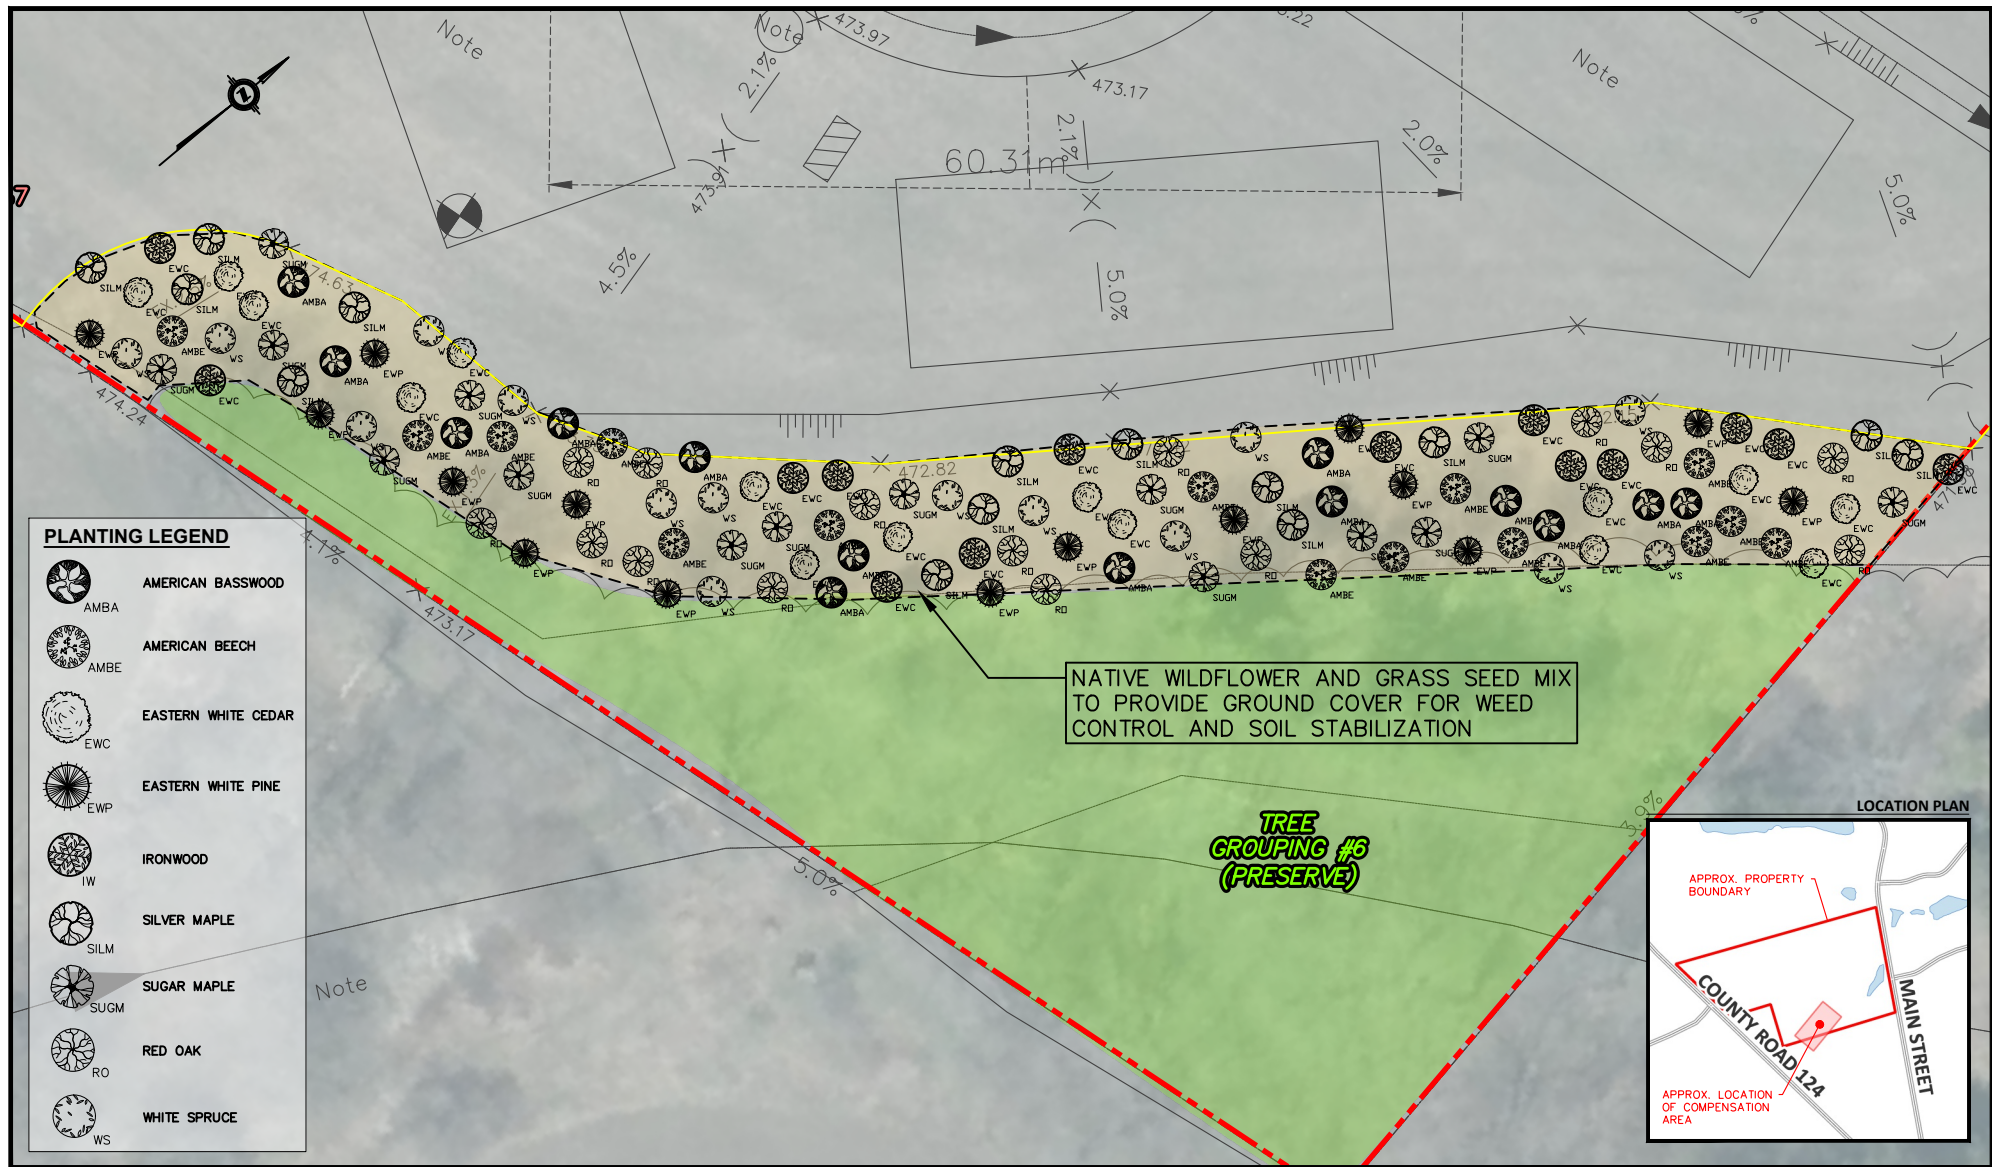
VEGETATION RESTORATION PLAN

PLANTING LEGEND

AMERICAN BASSWOOD
	AMERICAN BEECH
	EASTERN WHITE CEDAR
	EASTERN WHITE PINE
	IRONWOOD
	SILVER MAPLE
	SUGAR MAPLE
	RED OAK
	WHITE SPRUCE

NATIVE WILDFLOWER AND GRASS SEED MIX TO PROVIDE GROUND COVER FOR WEED CONTROL AND SOIL STABILIZATION

TREE GROUPING #6 (PRESERVE)

It should also be noted that, in addition to the above, another 45 trees have been added to the compensation as discussed within Azimuth’s response to Burnside VPRP Comment #4 (below). Refer to updated Figure 3 of the Vegetation Protection and Preservation Plan. The adjusted total number of trees required for compensation has been updated to 132 to accommodate these revisions.

Based on the footprint of proposed grading south of the property boundary, thirty (30) trees associated with Tree Grouping #8 and fourteen (14) trees associated with Tree Grouping #9 are expected to require removal. Further, based on the proposed outflow on the SWM pond to the east towards Main Street, Azimuth also notes that Tree #209 will require removal. Based on a 1:1 tree replacement ratio noted in Burnside VPRP Comment #3, 45 trees have been added to the proposed planting plan to accommodate removals associated with Tree Groupings #8, #9, and Tree #209. Combined with the original 72 compensation trees + 15 additional trees required by Burnside VPRP Comment #3, a total of 132 compensation trees are now included in the updated Figure 3.
